Capel River Action Plan

1999

Prepared for Geographe Catchment Council - GeoCatch
and the Capel Land Conservation District Committee

by
Kirrily White and Sarah Comer
in association with
Evangelisti & Associates

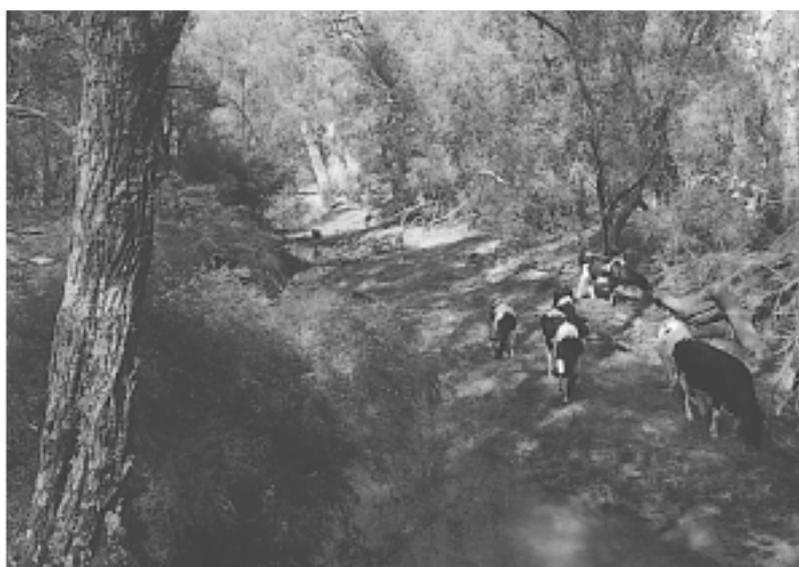
The degradation of a river valley continues when stock access becomes more regular. Understorey species are trampled or eaten, exotic weeds are spread more prolifically. Localised soil exposure may also lead to the risk of erosion. An example of uncontrolled stock access on the Capel River foreshore is illustrated in Plate 3 (page 12).

Plate 3: Uncontrolled access leads to a degraded river foreshore.

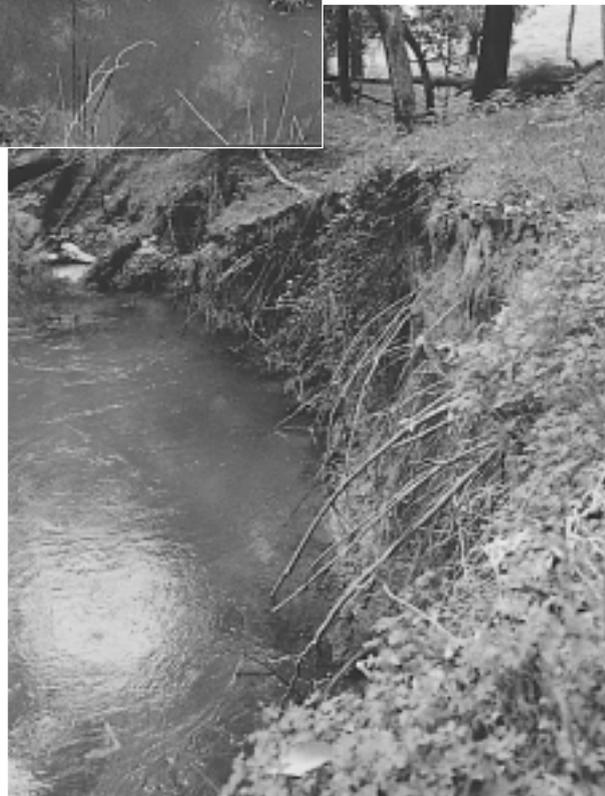
Plate 4: Subsidence or slumping of the river bank.

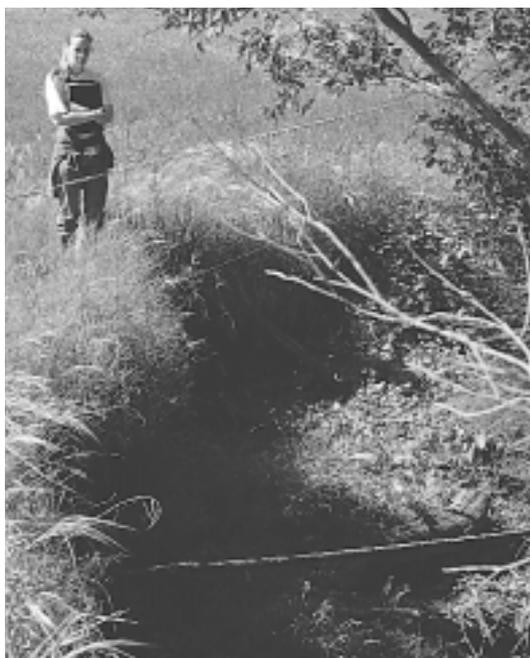
In addition to these, social issues of concern include the loss of fences as the river course deviates (Plates 9 and 10, page 21); the loss of valuable soil; reduced visual amenity associated with the river; and a potential for the limitation of beneficial uses, such as fishing, marroning and water supply, as water quality deteriorates.

Plate 9: Loss of fence-lines due to subsidence.

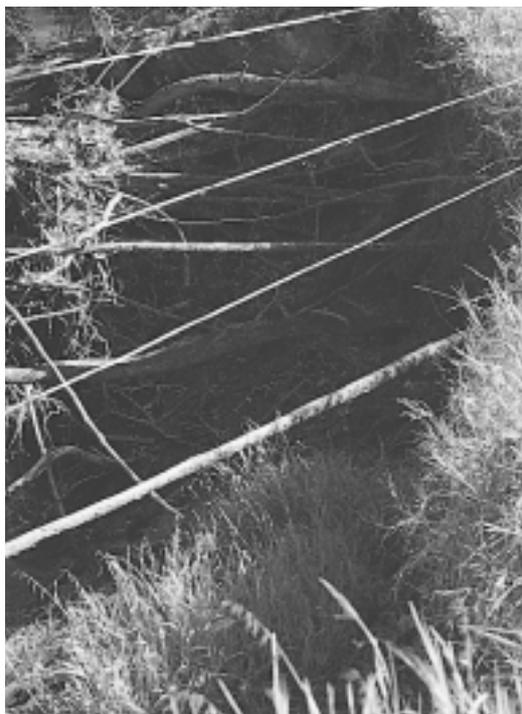
Plate 10: Close up of fence-line and subsidence.

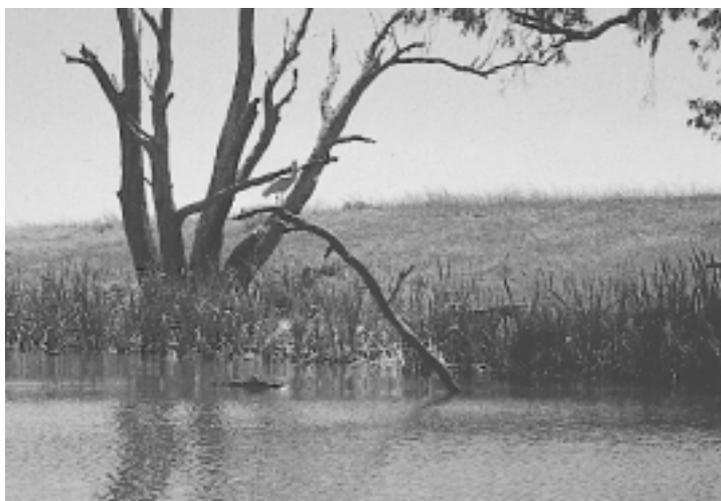
Plate 11: The lower Capel foreshore with *Typha* and Kikuyu.

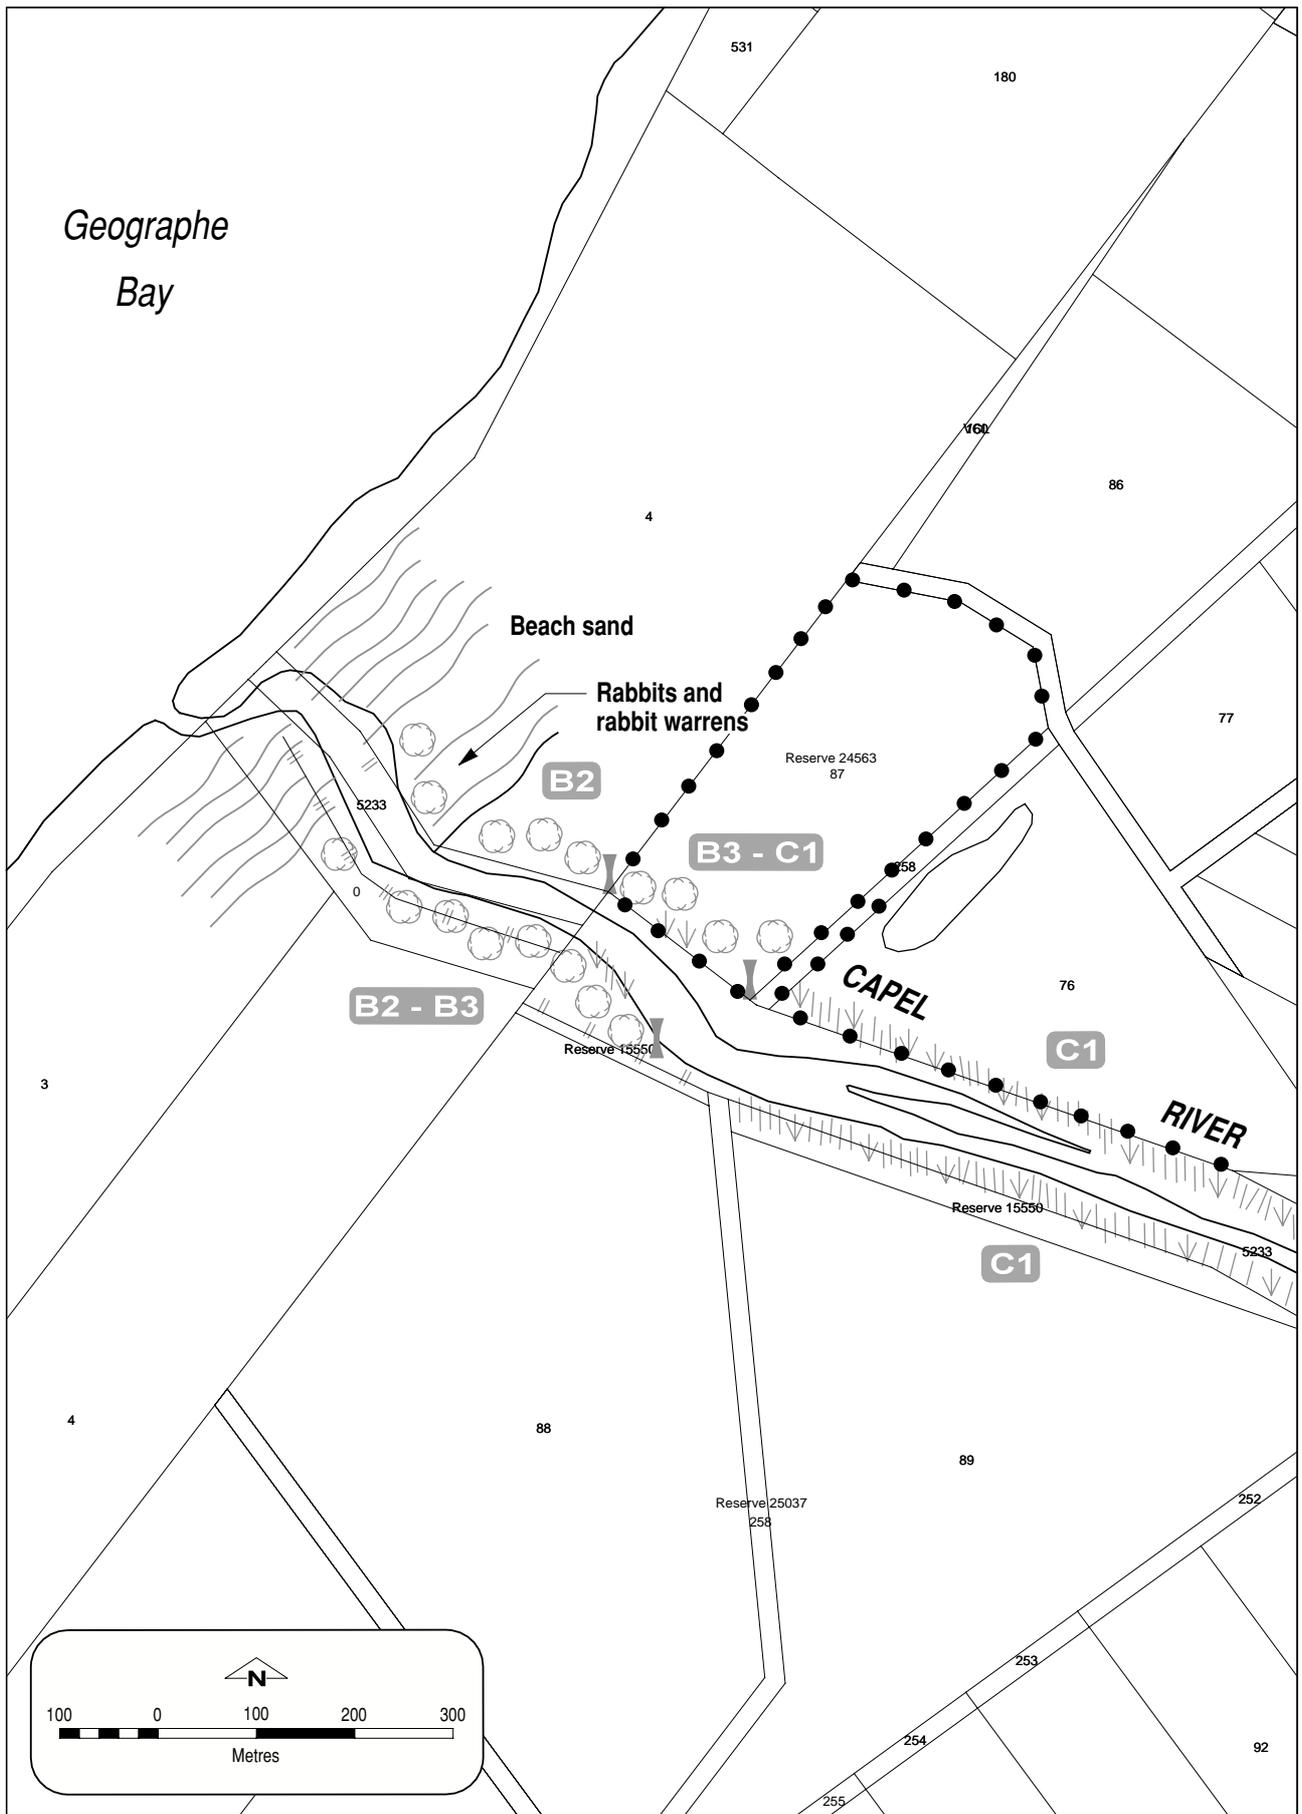
Capel River Map 1

Issues	Comments	Management Advice
General foreshore condition	River mouth and coastal dunes are well vegetated though degraded (channel to river mouth is artificial with a raised embankment). The reserve is grazed on both sides.	N/A
Fencing	The lower section has been fenced although the fencing is now in poor condition, and is set well back from the river bank. It is possible that stock may still have access to these areas. The upper section is not fenced.	Fencing is required to exclude horses and cattle on the north bank. Length of fencing recommended: ~ 900 m.
Erosion	N/A	
Revegetation requirement	The Capel River acts as a flood channel in this section, thus precluding the area from revegetation.	N/A
Weed invasion	Reserve 24563: thistles and Pelargonium observed (not on foreshore).	Refer to Specific weed management advice Chapter 8.1.2 point 16 (page 25).
Other comments	The foreshore area is dominated by Kikuyu, yet this is stabilising the banks.	N/A

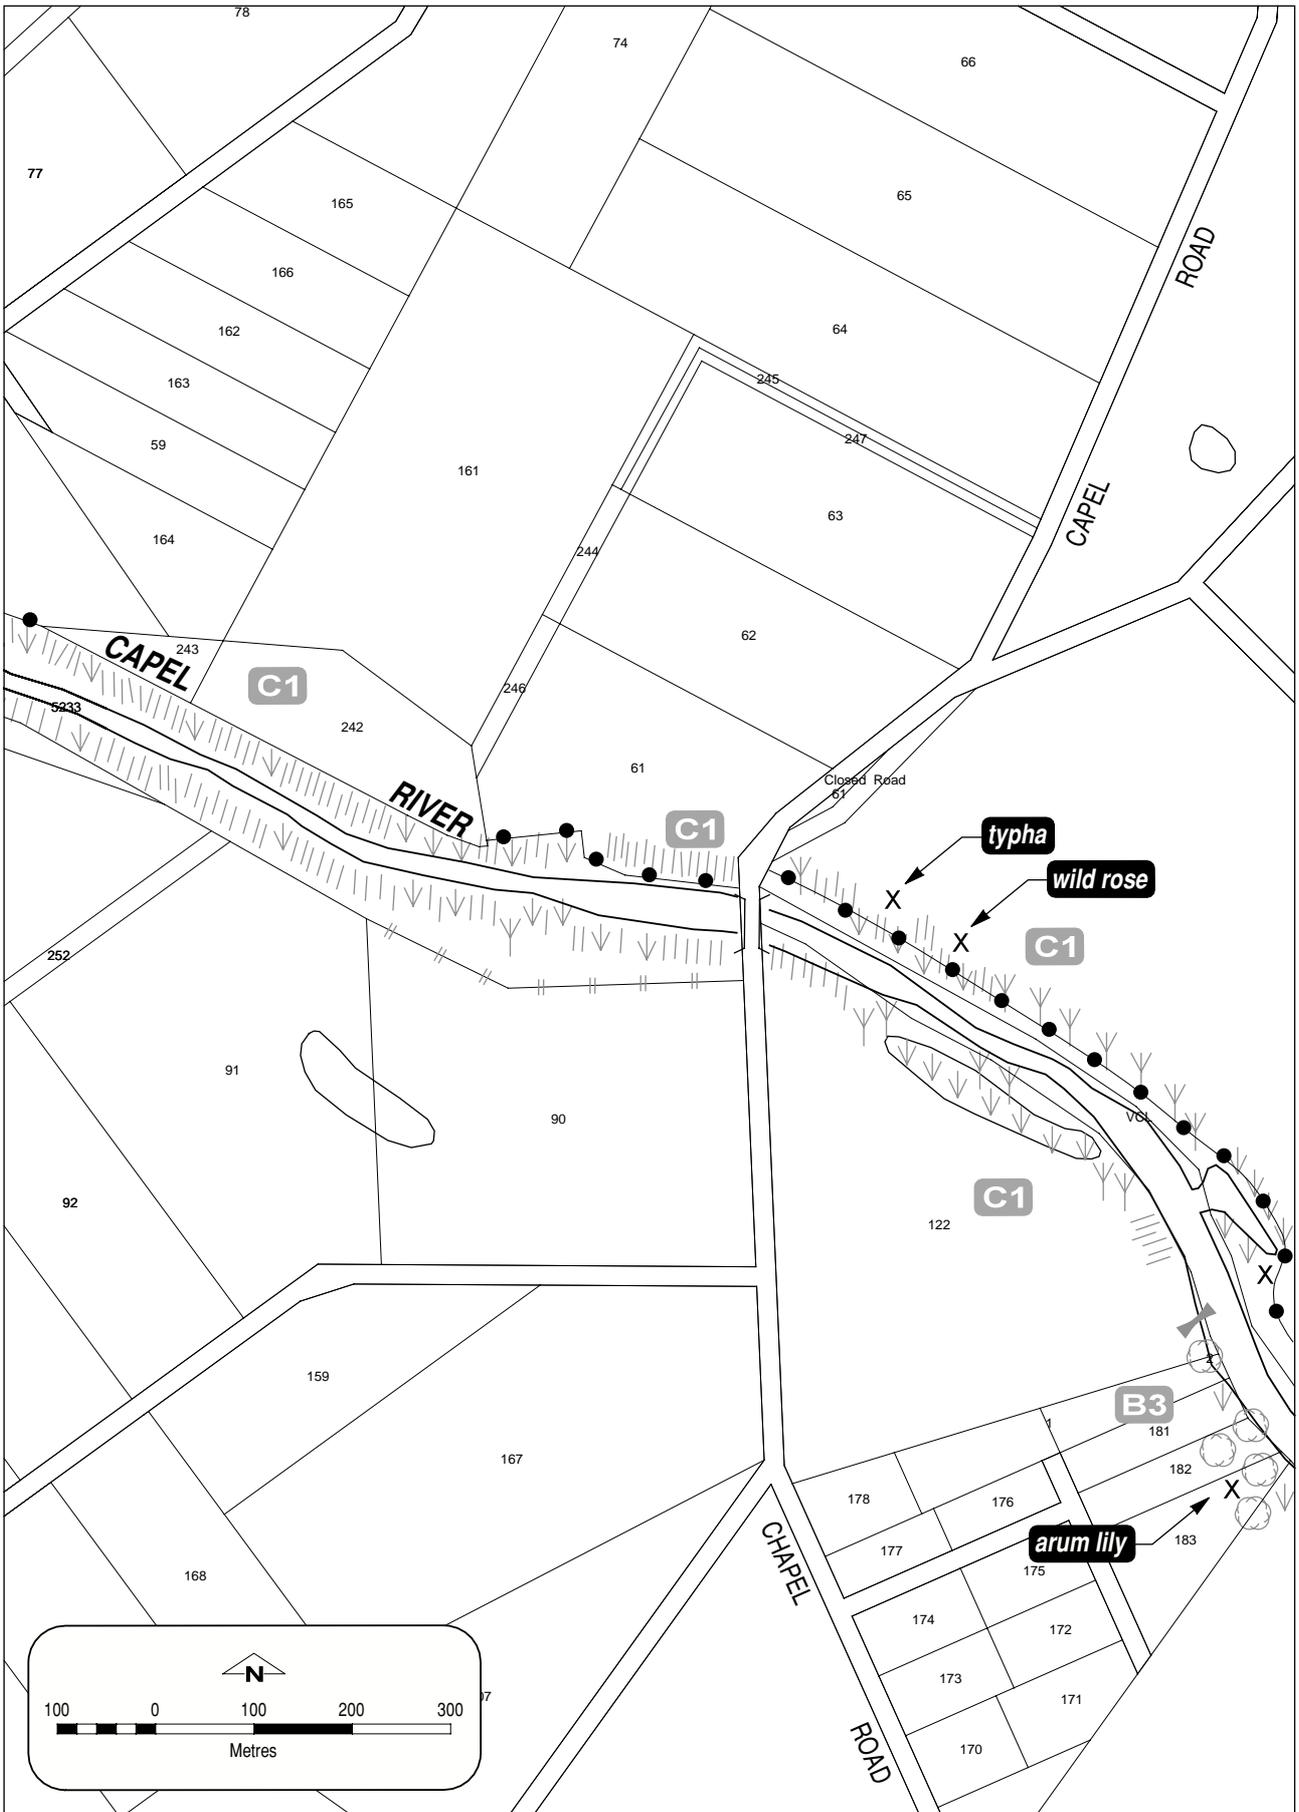
Capel River Map 2

Weed invasion	<i>Typha orientalis</i> was common in this area, particularly in the upper section. Arum lily and wild rose were also recorded in this area.	Refer to Specific weed management advice Chapter 8.1.2 points 2, 17 and 19 (page 23 - 26).
Other comments	The club-rush <i>Bolboschoenus caldwellii</i> was recorded in this section. <i>B. caldwellii</i> can congest waterways, and is invasive in disturbed areas.	Monitor spread of this rush.

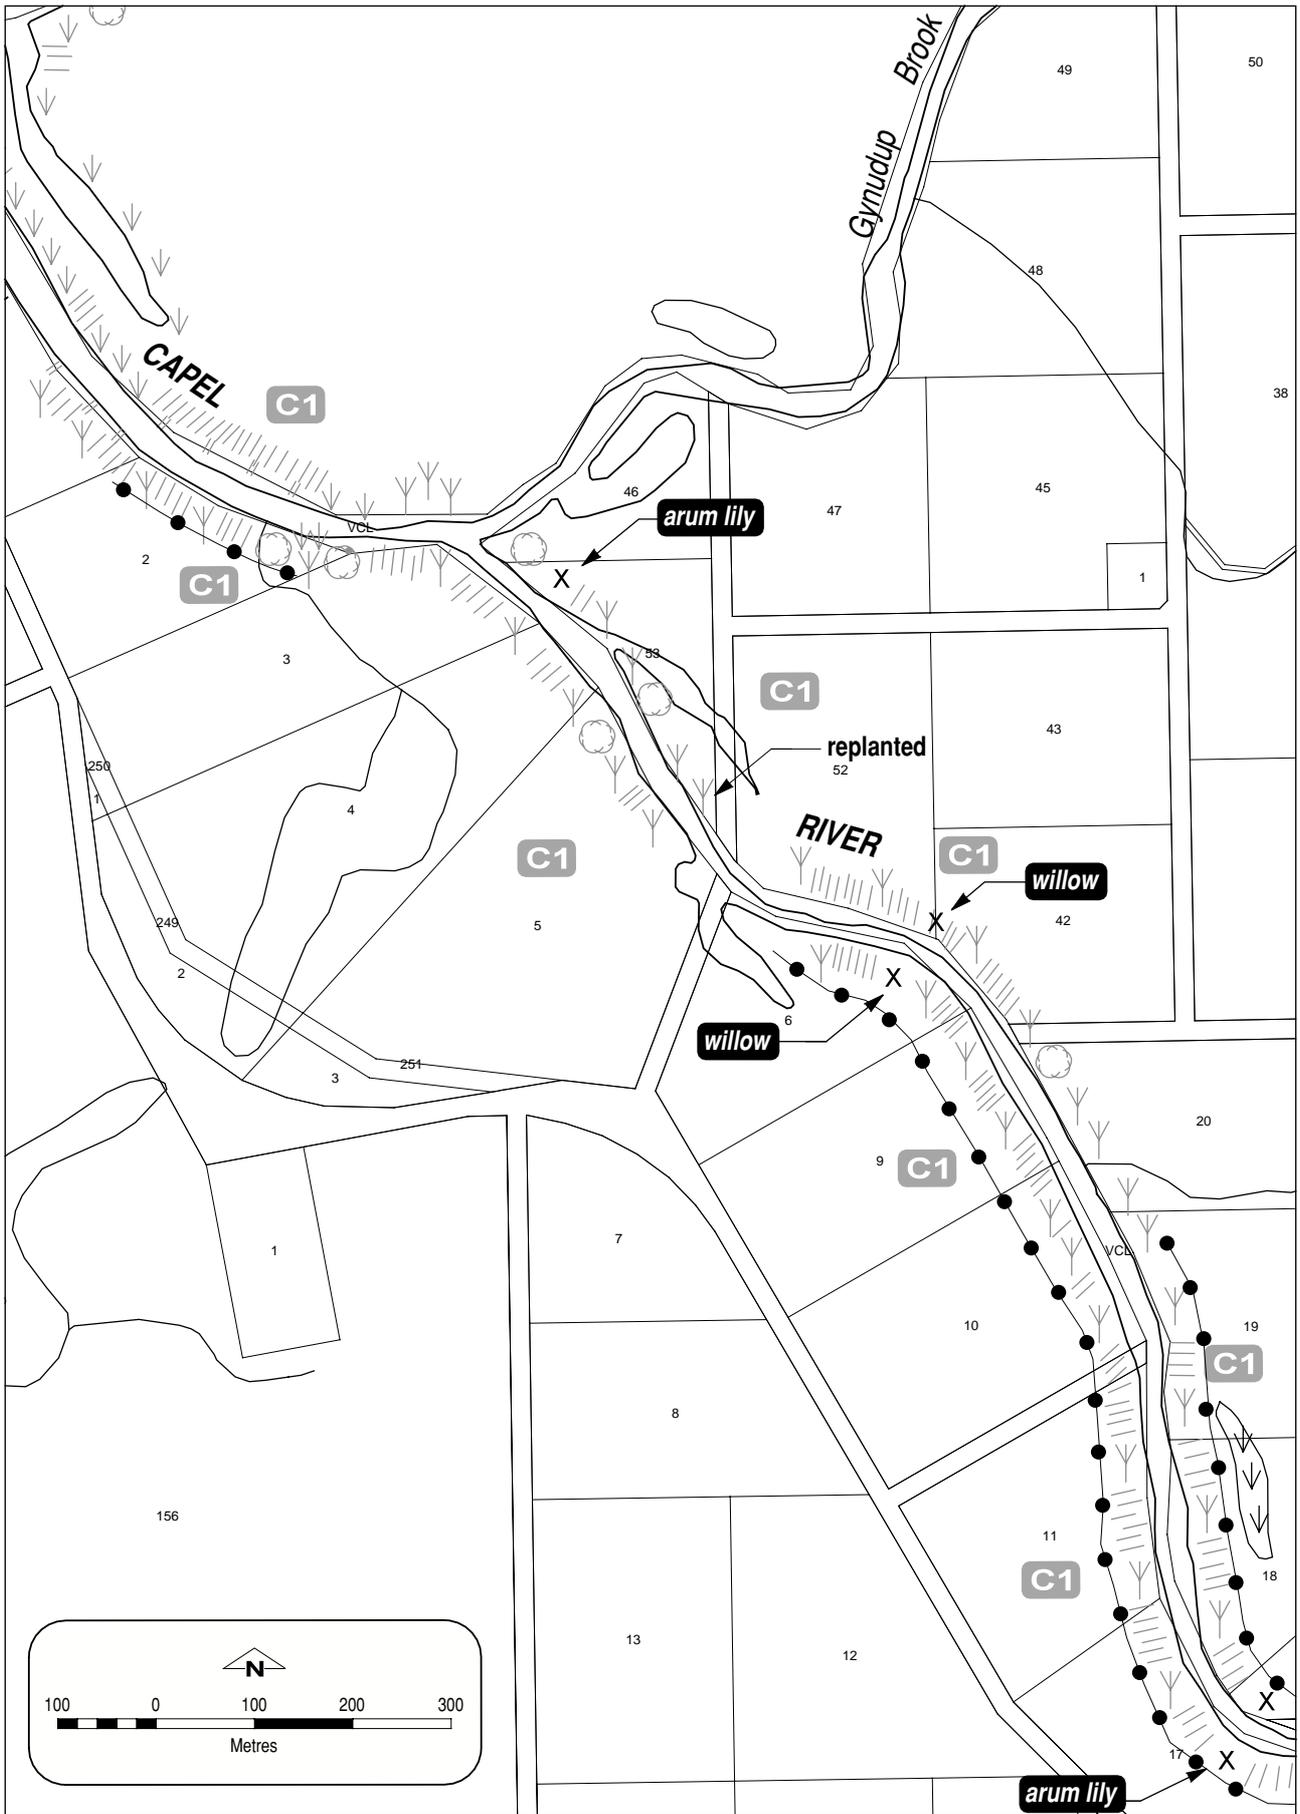
Capel River Map 4

Issues	Comments	Management Advice
General foreshore condition	Narrow foreshore, isolated trees, little or no understorey.	
Fencing	Some sections were fenced close to the foreshore, in other areas fencing was absent or set well back from the foreshore. The smaller lots in the upper section were not stocked at the time of survey.	Fencing is recommended along sections of the north and south bank. Length of fencing recommended: south bank ~1000 m, north bank ~ 600 m.
Erosion	N/A	
Revegetation requirement	Understorey is particularly sparse in this area, a narrow band of flooded gum lined the foreshore, with isolated clumps of rushes and sedges.	Revegetation with understorey and sedge species is recommended. This should include widening the riparian buffer zone to allow natural regeneration to occur. Select species for replanting from community types 1 & 4, Table 8.1 (pages 28 & 32).
Weed invasion	Typha was common in the lower section. Large willows were recorded in the middle reaches of this section. Occasional arum lilies were also recorded	Treat arum lily and Typha; consider removing willows and replacing with native trees such as flooded gum, or peppermint. Refer to Specific weed management advice Chapter 8.1.2 points 2 and 17 (page 23 & 25).

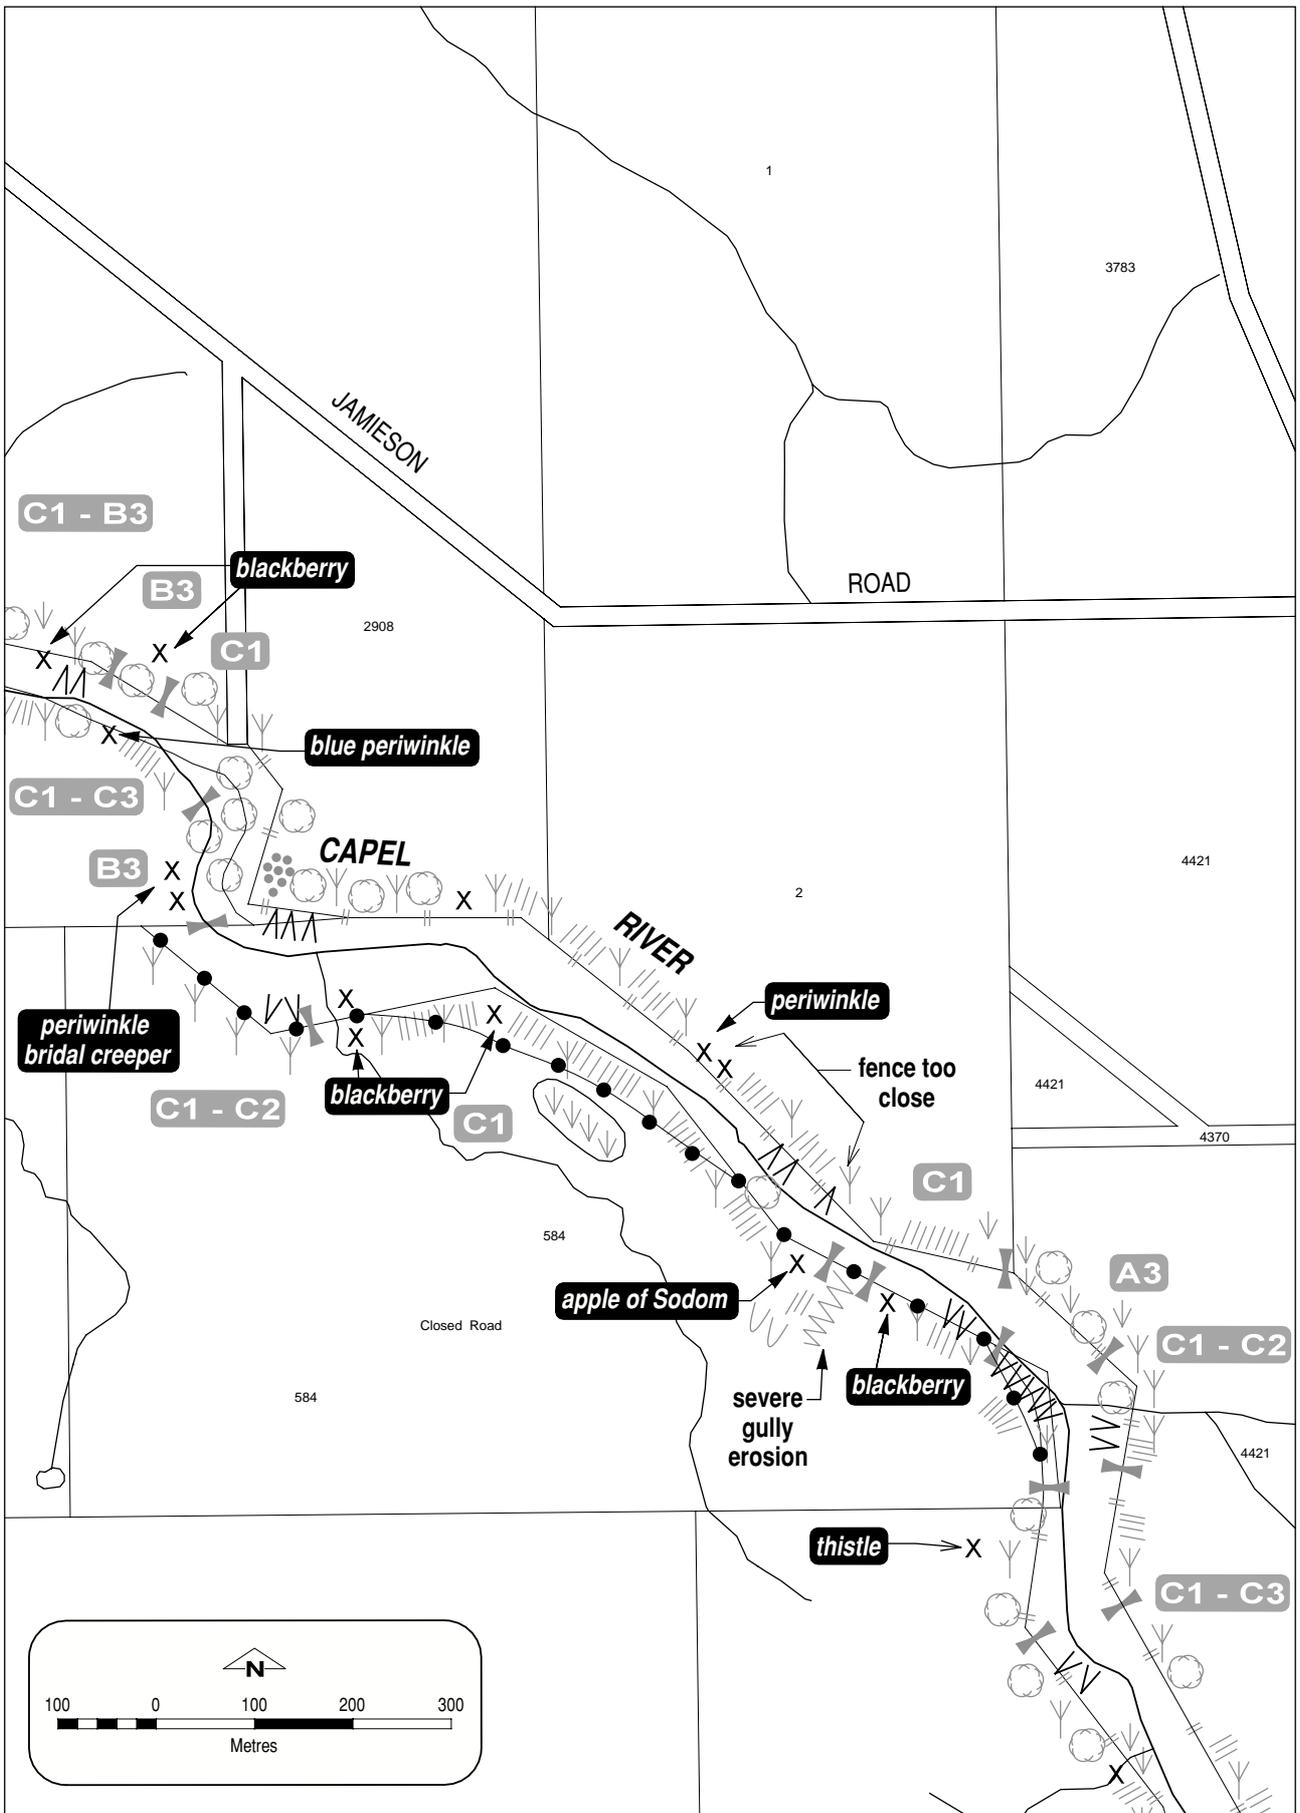
Capel River Map 8

Issues	Comments	Management Advice
General foreshore condition		
Fencing	Fencing recommended along much of the southern foreshore of this section. Fence too close to the riverbank on some sections of the northern foreshore.	Length of fencing recommended: south bank ~ 1300 m
Erosion	Frequent sites of scouring along this section. Also, two small areas of sheet erosion noted on the southern bank. Some severe gully erosion and sheet erosion on the southern foreshore of this section.	Refer to Erosion control Chapter 8.3, points 1 and 2 (page 33).
Revegetation requirement	Revegetation of understorey species recommended along much of this section.	Select species from community type 2 & 3, Table 8.1 (pages 29 - 31).
Weed invasion	Bridal creeper, blackberry, apple of Sodom, periwinkle, figs and thistles.	Refer Specific weed management advice Chapter 8.1.2 points 1, 5, 3, 4, 10, and 16 (pages 23 - 25).
Other management comments	Small area of excellent vegetation on northern foreshore could be used as potential seed source for revegetation.	Complete detailed vegetation survey of this area.

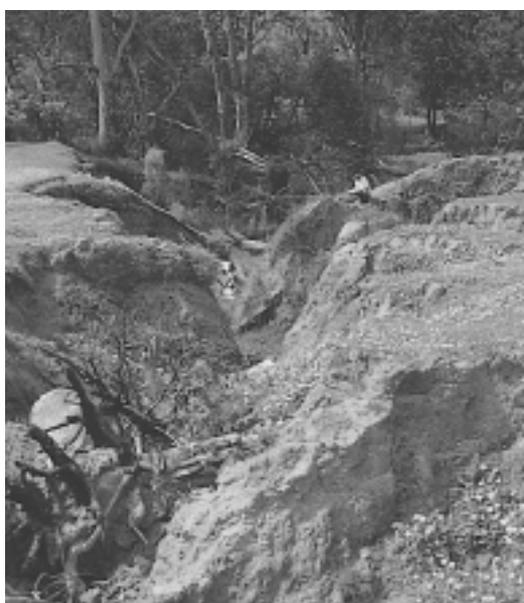
Plate 12: Severe gully erosion on the Capel River.

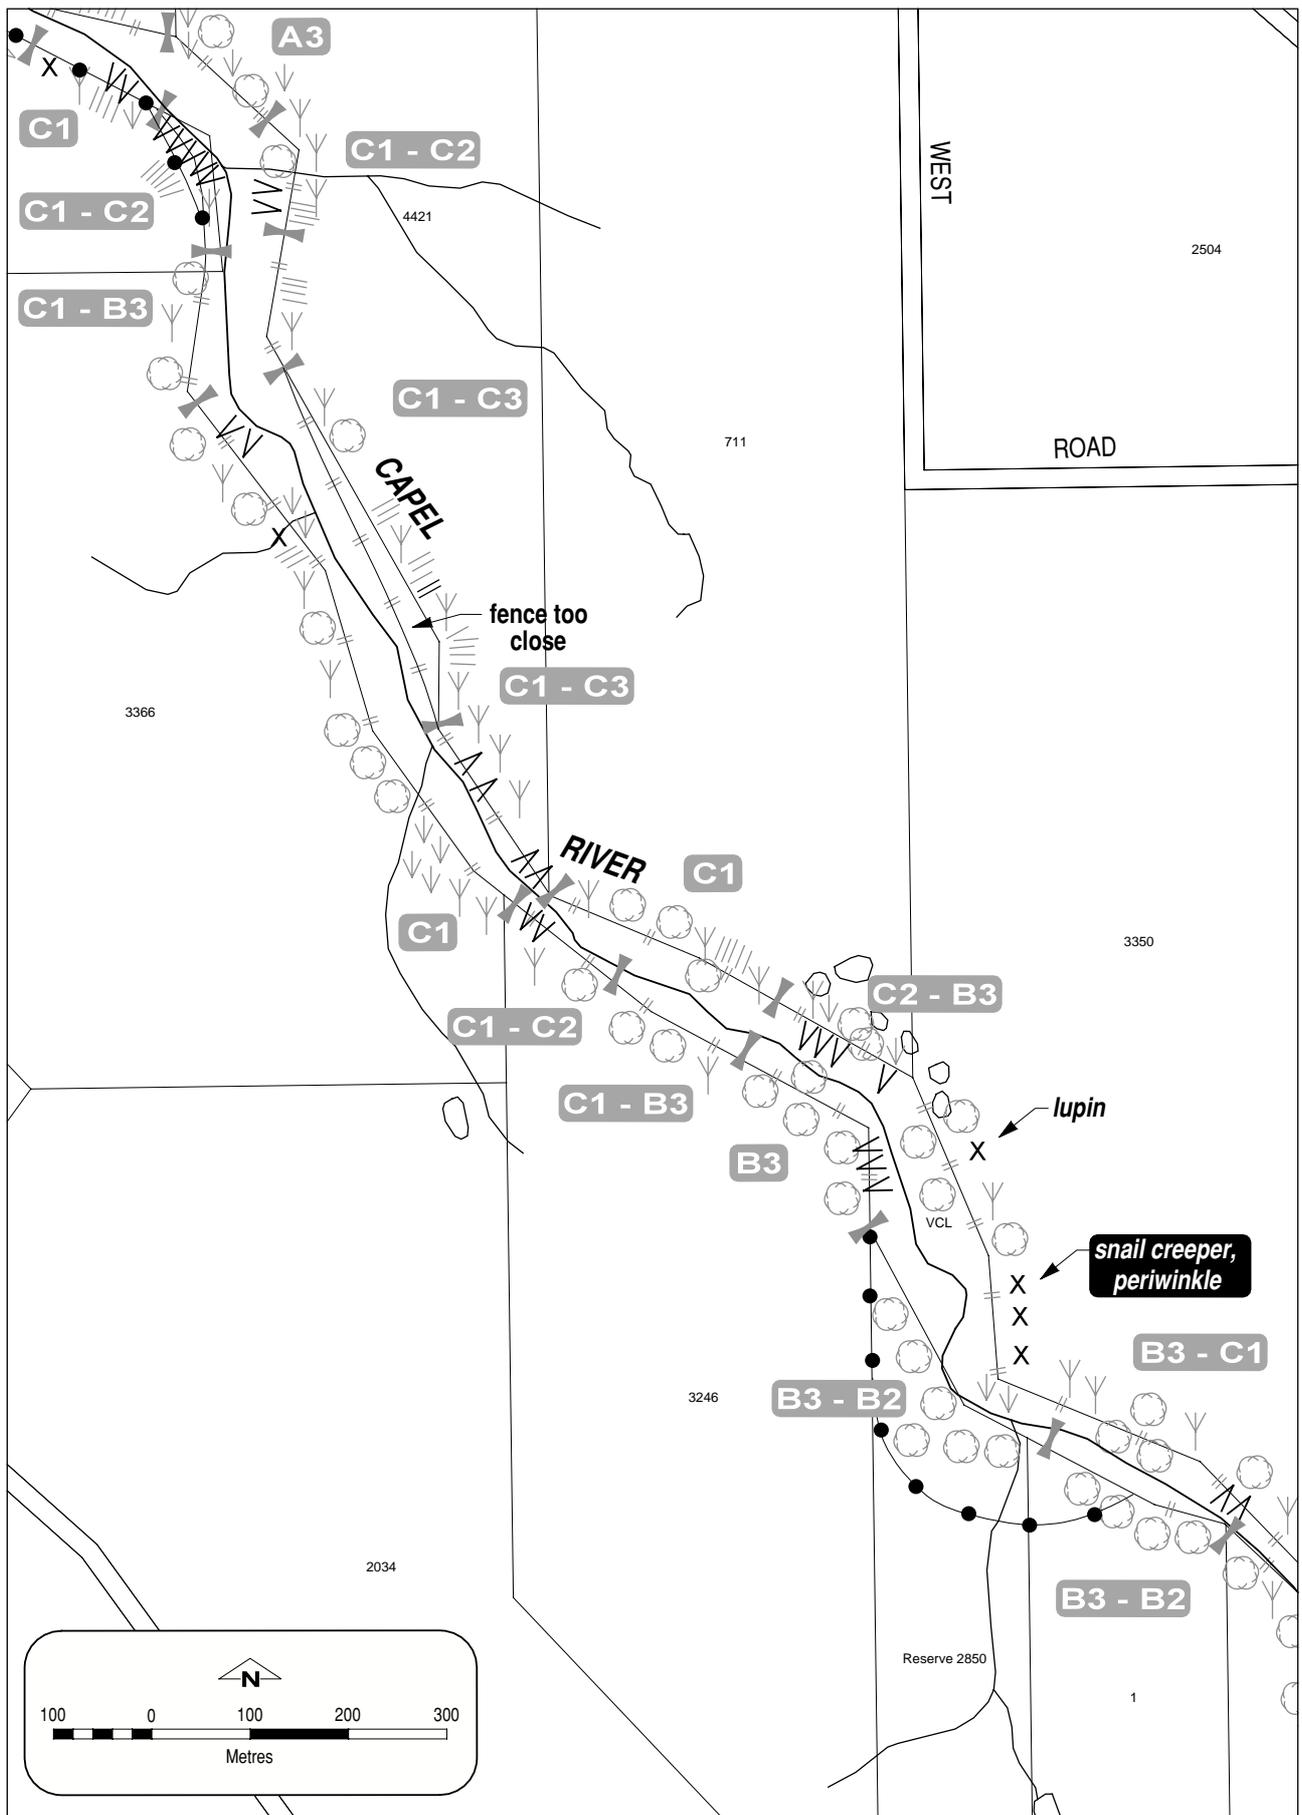
Capel River Map 9

Weed invasion	Periwinkle, snowdrops and snail creeper.	Refer to Specific weed management advice Chapter 8.1.2 points 4, 14 and 13 (pages 23 & 25).
Other management comments	Good source of seed for revegetation around soaks on reserve 2850.	Complete detailed vegetation survey of vegetation surrounding the soak on reserve 2850.

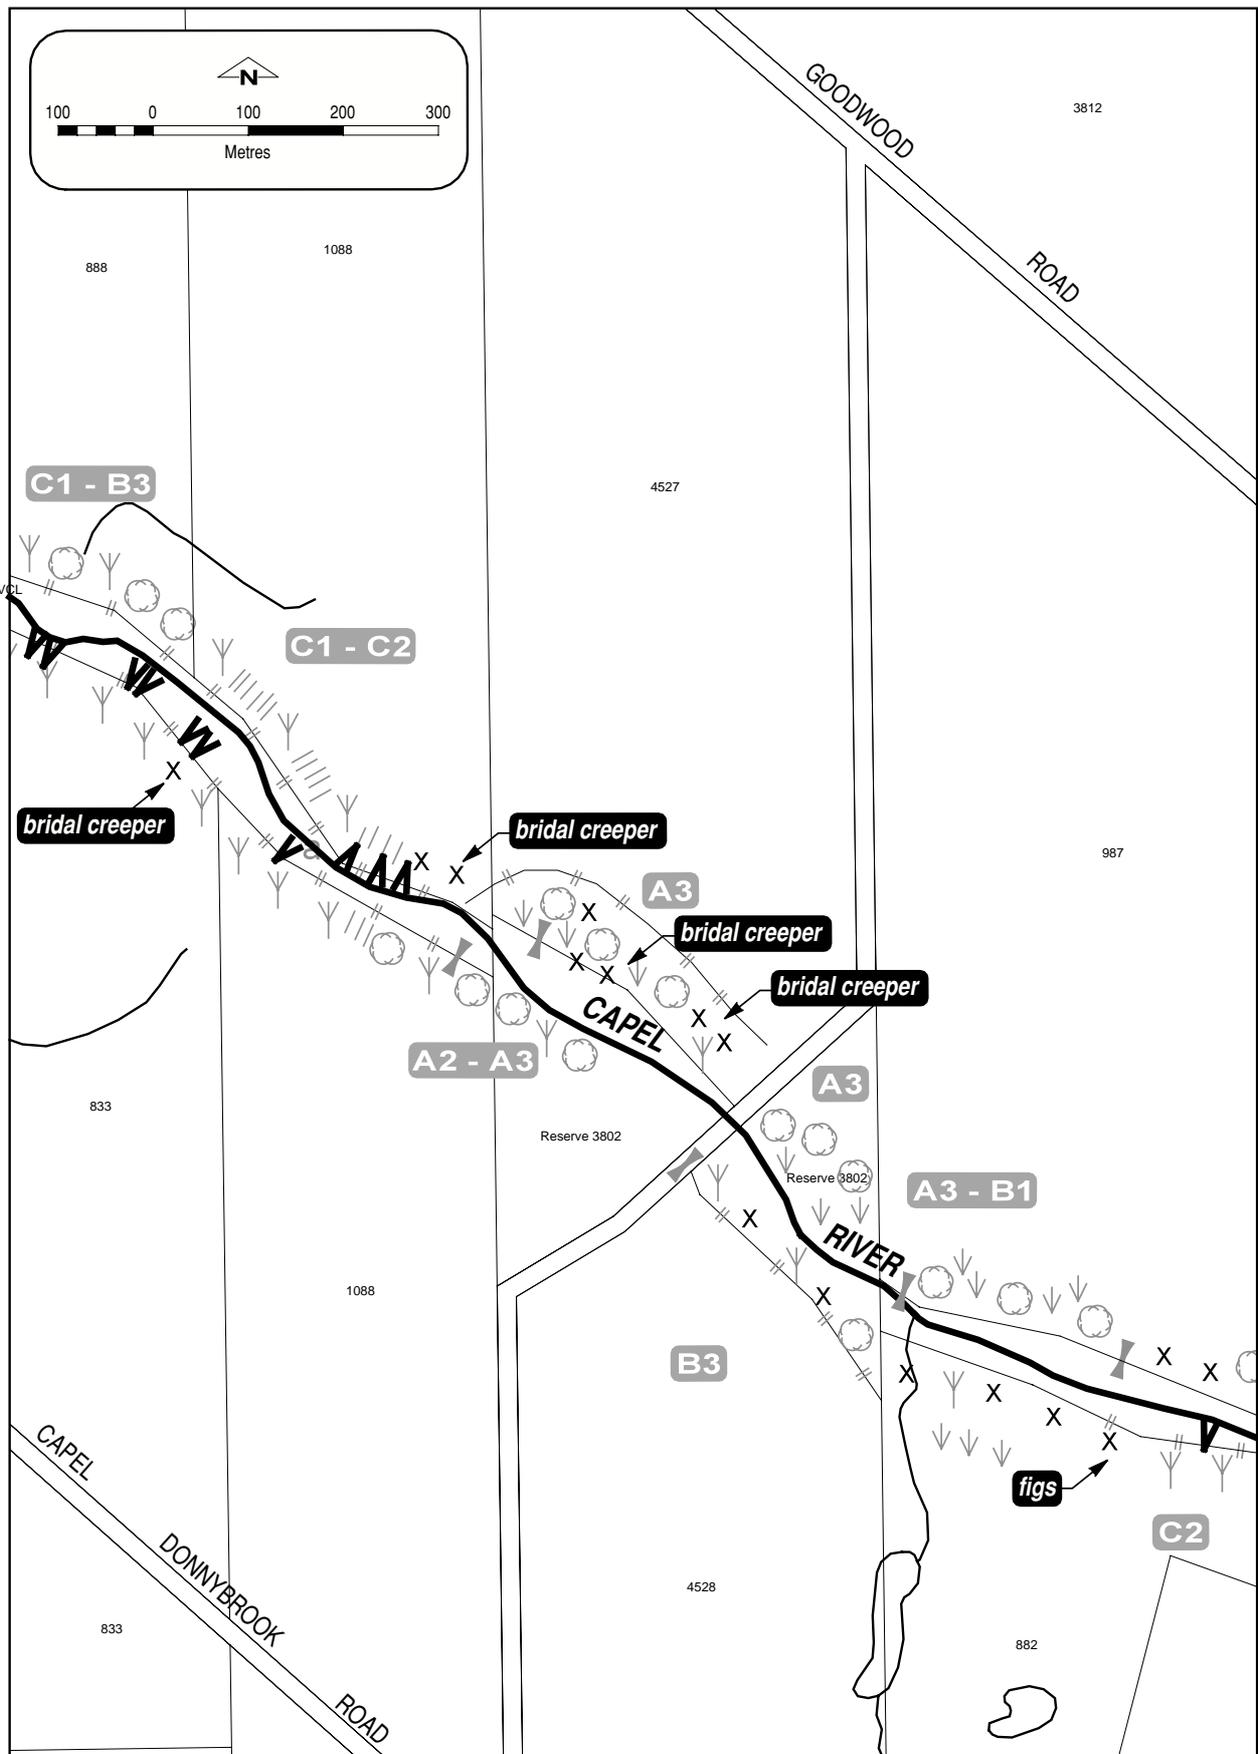
Capel River Map 12

Weed invasion	Some arum lily and bridal creeper, occasional Pittosporum and patches of figs found in this section.	Refer to Specific weed management advice Chapter 8.1.2 points 2, 5, 10 and 15 (pages 23 - 25).
Other management comments	Stock access point needs maintenance to limit area of access on foreshore. Reserve 3802 contains good quality remnant vegetation.	Complete a detailed vegetation survey of reserve 3802.

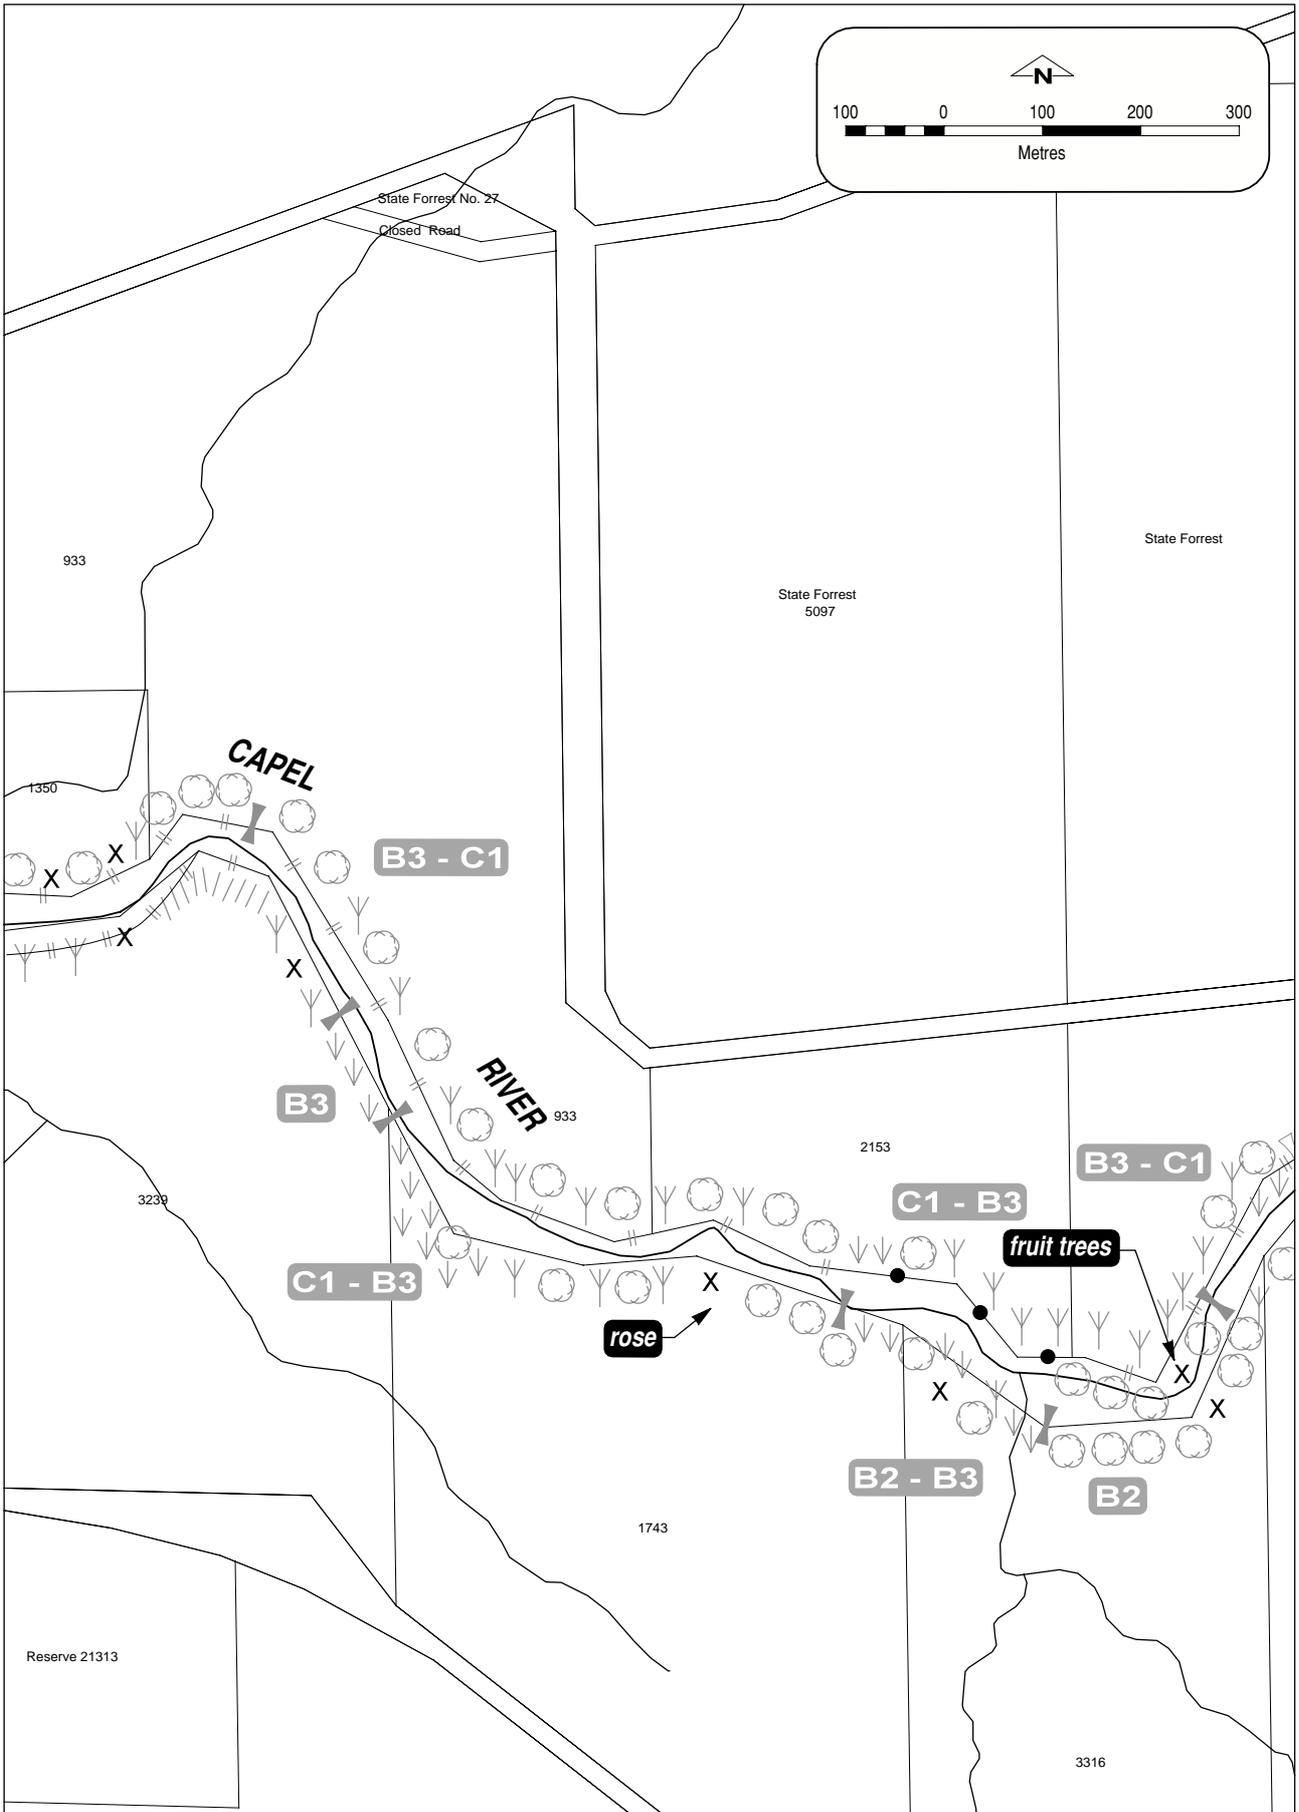
Capel River Map 14

Issues	Comments	Management Advice
General foreshore condition	Some good areas of remnant vegetation remain on the southeastern foreshore in this section.	N/A
Fencing	Much of this section either fenced or does not require fences due to nature of land use.	Length of fencing recommended 200 m on north bank.
Erosion	N/A	
Revegetation requirement	Revegetation with understorey species would increase diversity and improve vegetation structure in areas on this map. On the south-west section of this map some canopy species could be planted.	Select species from community type 1 on the riparian fringe & 2 on the floodplain, Table 8.1 (pages 28 - 30).
Weed invasion	Fruit trees, wild rose, arum lily, bridal creeper, and cotton bush found on this section.	Control weeds where possible. Refer to Specific weed management advice Chapter 8.1.2 points 12, 19, 2, 5 and 8 (pages 23 - 26).
Other management comments

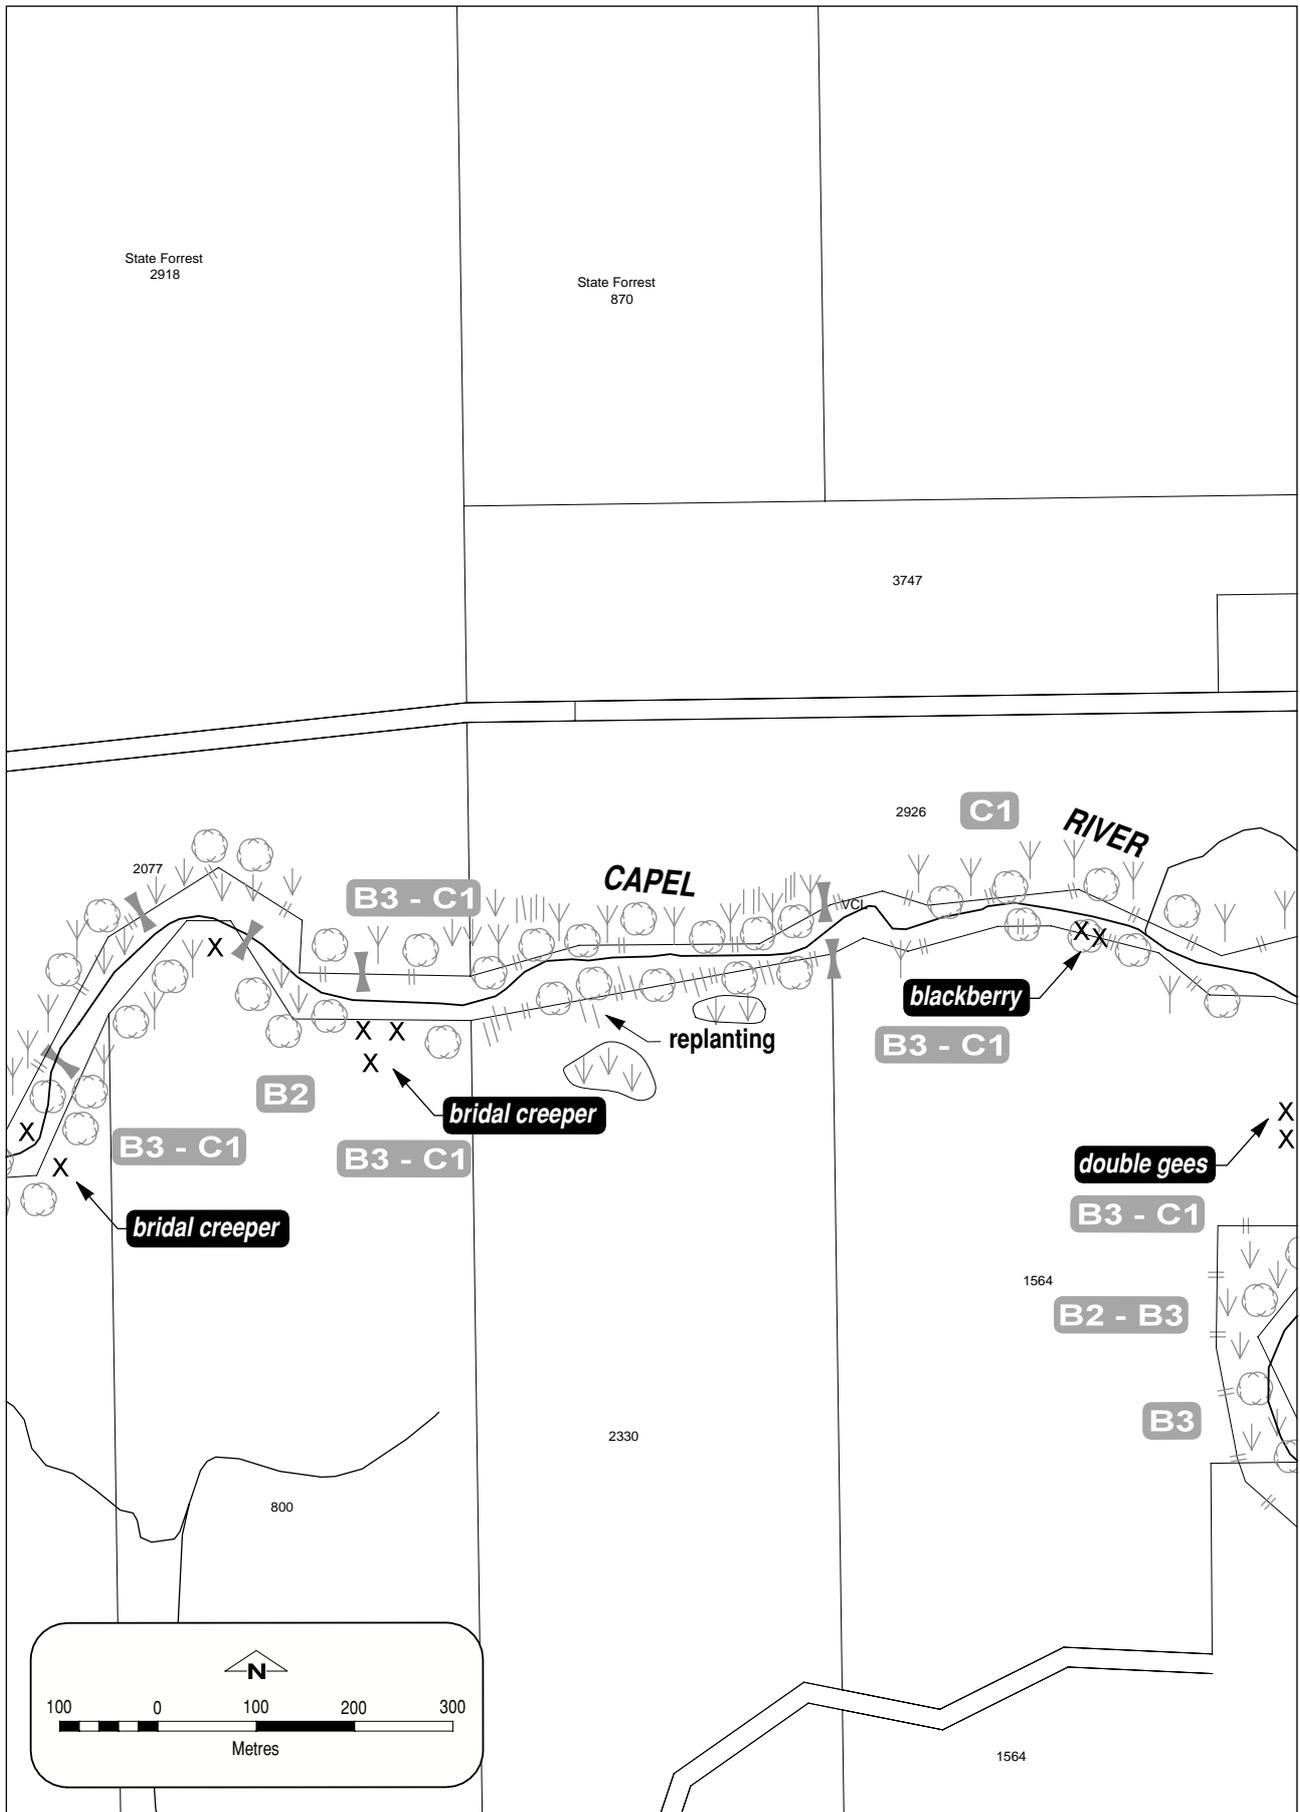
Capel River Map 15

Issues	Comments	Management Advice
General foreshore condition	Some good areas of remnant vegetation remain on the northwestern foreshore in this section.	N/A
Fencing	Only a short section of fencing recommended on the southeastern bank of this section.	Length of fencing recommended ~ 200 m on southern bank.
Erosion	N/A	
Revegetation requirement	Understorey species lack diversity along much of this map.	Revegetate with understorey species, and sedges and rushes. Select species from community type 1 on the riparian fringe & 2 on the floodplain, Table 8.1. (pages 28 & 29)
Weed invasion	Bridal creeper, blackberry and double gees found on this section.	Control weeds where possible. Refer to Specific weed management advice Chapter 8.1.2 points 5, 3, and 9 (pages 23 & 24).
Other management	Previous control of blackberry requires follow-up as regeneration was observed. comments
