Capel River Action Plan

1999

Prepared for Geographe Catchment Council - GeoCatch
and the Capel Land Conservation District Committee

by
Kirrily White and Sarah Comer
in association with
Evangelisti & Associates

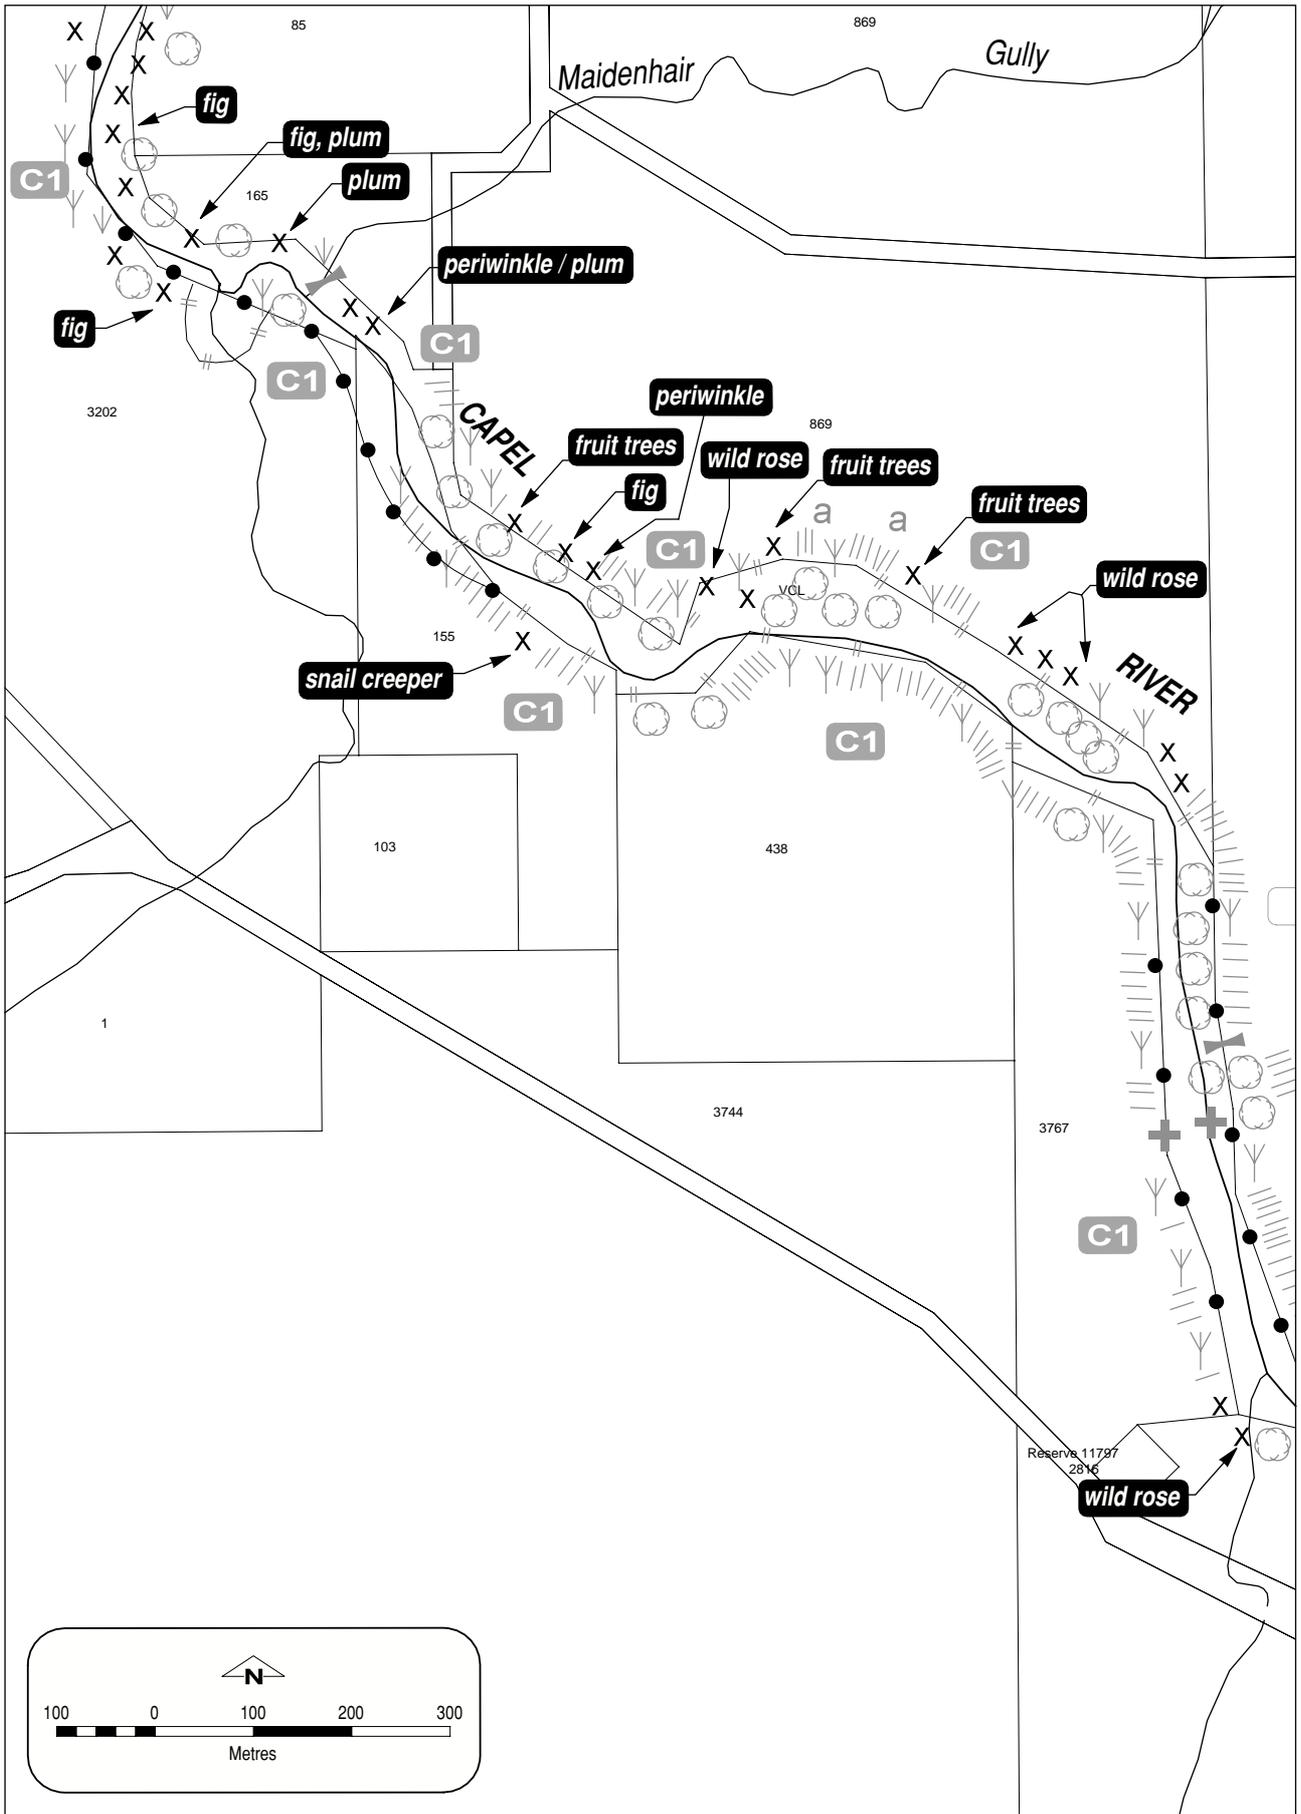
Capel River Map 17

Issues	Comments	Management Advice
General foreshore condition	Much of the southern bank limited to trees with grassy weeds in the understorey.	
Fencing	The majority of this section was fenced, although stock have access to the river shore at a few properties.	Length of fencing recommended, north bank ~ 1350 m, south bank ~ 450 m.
Erosion	N/A	
Revegetation requirement	Understorey species absent or lacking diversity along much of this section.	Revegetate with understorey species, and sedges and rushes. Select species from community type 1, Table 8.1 (page 28).
Weed invasion	Plum, fig, periwinkle and wild rose.	Refer to Specific weed management advice Chapter 8.1.2 points 12, 10, 4 and 19 (pages 23 - 26).
Other management comments	Fencing only recommended where stock access obviously a problem - much of this section was orchard. Issues which might be relevant to the river include use of chemical sprays. Old stock crossing on lot 3767 has been stabilised
