## Summary of river condition: Vasse River 2017/18

An assessment of ecological condition of the Vasse River was conducted in the 2017/18 spring to summer season. The assessment supports the implementation of the Revitalising Geographie Waterways program, which aims to improve water quality, waterway health and management of Geographie waterways. Key actions of the program include implementation of best management practices in agriculture to reduce nutrient export, streamside revegetation, and fencing of streamside vegetation to prevent damage by stock.

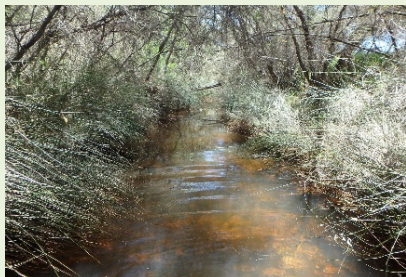
Upper Vasse  
VR94VASS1

Upper Vasse River – near Price Road.

The Upper Vasse site has high ecological value. It is a good example of landholders implementing best management practice by fencing off the riparian zone to protect it from damage by stock. This has enabled protection of remnant natural vegetation, regeneration of vegetation, as well as protection of the bank structure and instream habitat.

As a result, this site had complex habitat and optimal water quality. This was reflected in the fish, crayfish, and aquatic macroinvertebrates found. The fish and crayfish community was healthy and dominated by native species. The macroinvertebrate community had a diverse community structure, incorporating taxa that are sensitive to poor water quality.

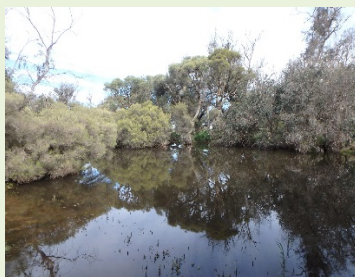
Lower Vasse 2  
VR64VASS2

Lower Vasse River – near the Busselton Bypass road.

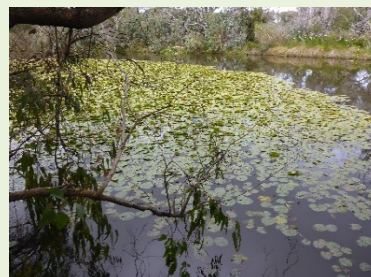
Lower Vasse 1  
VR64VASS1

Lower Vasse River – near the city centre. Site was under heavy cover of the invasive Mexican lily.

At Lower Vasse 1 there was an invasion of the exotic Mexican lily (*Nymphaea mexicana*). Although this plant may offer additional habitat complexity and structure for biota (when not in excess), it is an invasive exotic that has detrimental impacts on river ecology. Specifically, other studies have found very low oxygen concentrations under dense stands of this plant, owing to a lack of photosynthetic activity within the water, limited replenishment from the air, and high levels of decomposition (oxygen being consumed as bacteria breakdown plant material).

Despite the heavy cover of Mexican lily, the Lower Vasse 1 site had a notably higher abundance of most fish species. This is likely due to the additional habitat complexity, and more abundant food sources of invertebrates in the lilies (including terrestrial invertebrates such as spiders and frogs), and also due to a small adjacent backwater (increased habitat diversity).

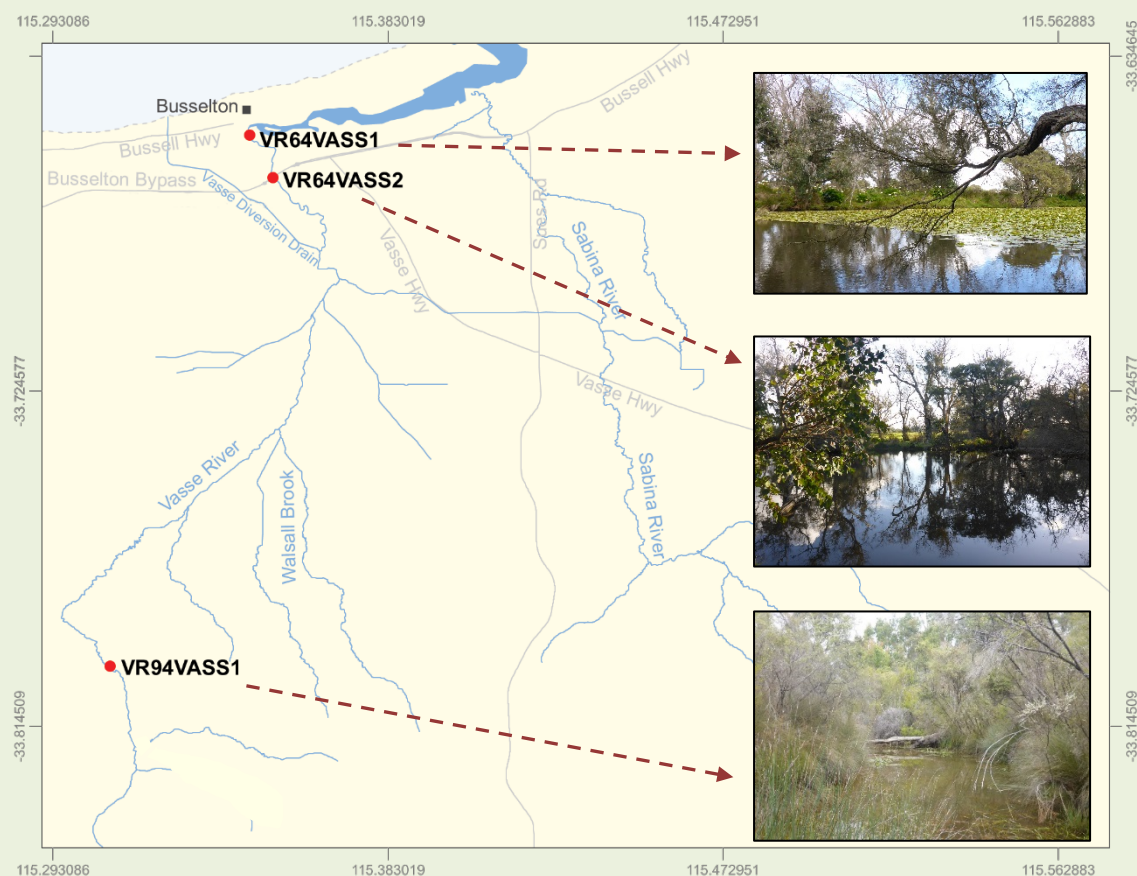
The main site assessments were undertaken at three sites along the river from 9 to 12 October 2017. The assessments were undertaken along 100 m of river length at each site.

Additionally, long term water quality loggers were deployed at two sites (Upper Vasse and Lower Vasse 2, see map) to measure dissolved oxygen, temperature, specific conductivity and pH every 30 minutes from 11 October 2017 to 27 March 2018.

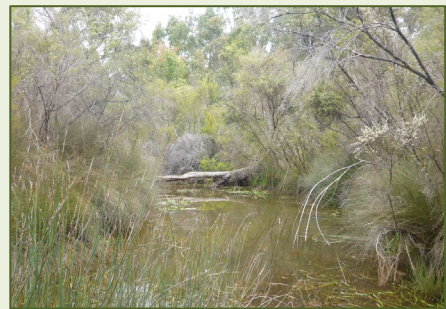
The upper Vasse River site is an example of where fencing out of stock and reestablishment of a riparian zone has benefited water quality, and all other aspects of ecological health.

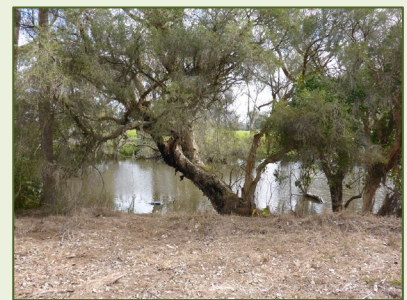
The lower Vasse River showed evidence of impacts including degraded water quality and macroinvertebrate community. However, implementation of riparian zone vegetation improvement, and catchment wide best management practices to reduce nutrient input could help address these to ensure the fish and crayfish community is protected.

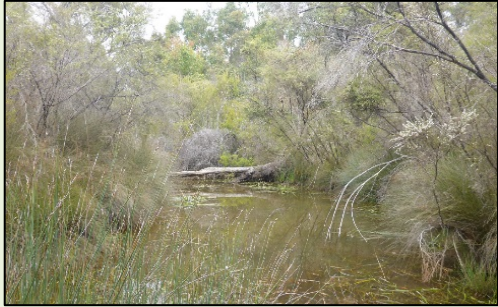
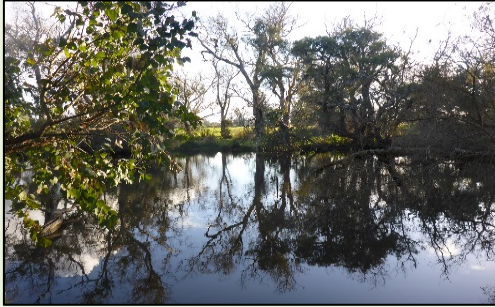
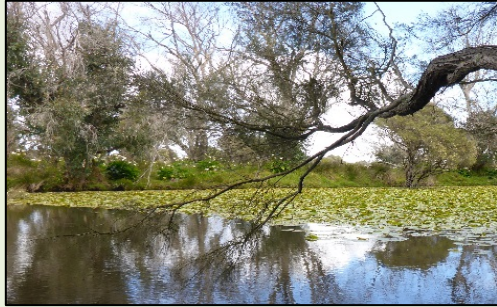
| | Upper Vasse (VR94VASS1) | Lower Vasse 2 (VR64VASS2) | Lower Vasse 1 (VR64VASS1) |
|---|--|--|--|
| Water quality | Good water quality. Dissolved oxygen concentrations acceptable over the warmer months. | Low dissolved oxygen concentrations over the warmer months (often below 2 mg/L).<br>High nitrogen and phosphorus concentrations. | Low dissolved oxygen concentrations over the warmer months likely a problem (not measured).<br>High nitrogen and phosphorus concentrations. |
| Riparian vegetation | Good coverage of vegetation in the streamside zone (0-10 m from river). Moderate vegetation cover in the broader riparian zone (up to 100m from river). Vegetation providing shading and bank stabilisation. | Reduced coverage of vegetation in the streamside zone (0-10 m from river) and in the broader riparian zone (up to 100m from river). Vegetation providing some shading and sufficient bank stabilisation. | Reduced coverage of vegetation in the streamside zone (0-10 m from river) and in the broader riparian zone (up to 100m from river). Vegetation providing some shading and sufficient bank stabilisation. |
| Macroinvertebrates | Varied community composition, including four sensitive taxa. | Dominated by taxa tolerant of poor water quality. Only one sensitive taxa recorded. | Indicative of degraded aquatic conditions - dominated by taxa tolerant of poor water quality. No sensitive taxa. |
