# Sediments of the Vasse Estuary exit channel

A study of the characteristics and feasibility of removing sediments

Department of Water and Environmental Regulation  
June 2019

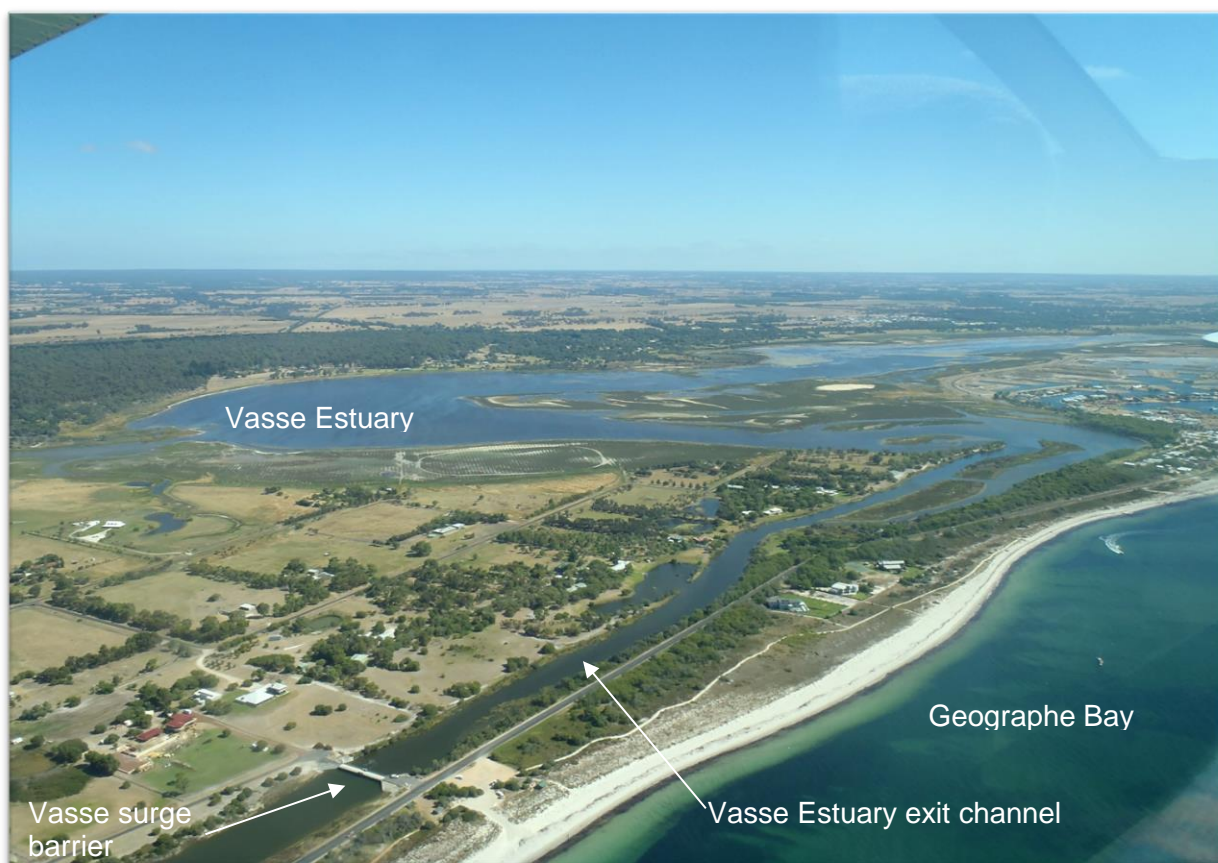
**Figure 1**      *The Vasse Estuary and its exit channel*

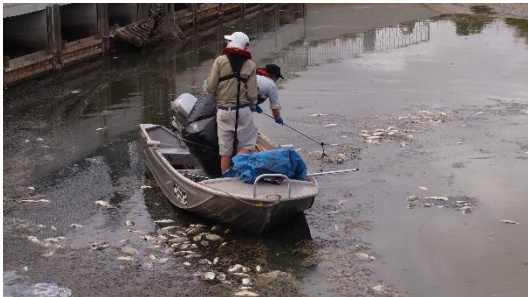
Issue	Example photograph
<p>Most known mass fish kill incidences in the Vasse Wonnerup Wetlands have been described as occurring within or close to the exit channel of the Vasse Estuary.</p> <p>The causes of these fish kills have been identified as low oxygen levels, toxic phytoplankton blooms or a combination of both.</p>

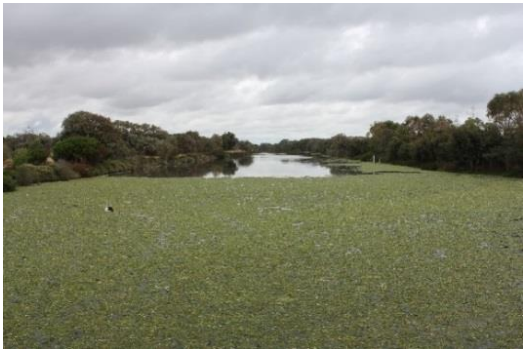
<p>Floating blooms of macroalgae such as this <i>Ulva</i> bloom have a tendency to accumulate at the surge barrier and at the south end of the channel near Estuary View Drive. It is possible that south-westerly summer prevailing winds push floating material in towards the barrier and towards the northern banks. This material eventually sinks to the bottom of the channel and rots, adding organic content to the sediment layer and helping to form sulfidic black ooze. More recent management has involved regular suction and removal of floating material at the surge barrier to minimise the formation of nutrient-rich organic sediments forming via these processes.</p>

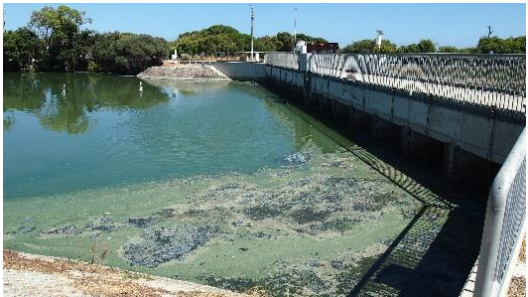
<p>Scum from phytoplankton blooms tends to accumulate within the channel and particularly at the surge barrier. These scums are unsightly and contribute to odour problems as they collapse and decompose.</p> <p>At times, benthic scums (that have formed over the surface of sediments) have also risen to the surface, contributing to severe odour issues. Similar to floating macroalgae, they contribute to the accumulation and formation of sulfidic black ooze.</p>

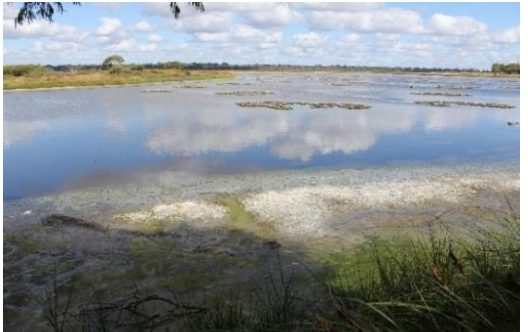
<p>Sulfidic black ooze sediments associated with strong hydrogen sulfide odour are present at the start of the exit channel near Estuary View Drive. Residents in this area have expressed concern over odour and poor visual amenity of these sediments for many years. The problem is exacerbated when water levels are very low.</p> <p>The shallow conditions around Estuary View Drive have precluded this site from the regular water quality monitoring program undertaken by DWER.</p>

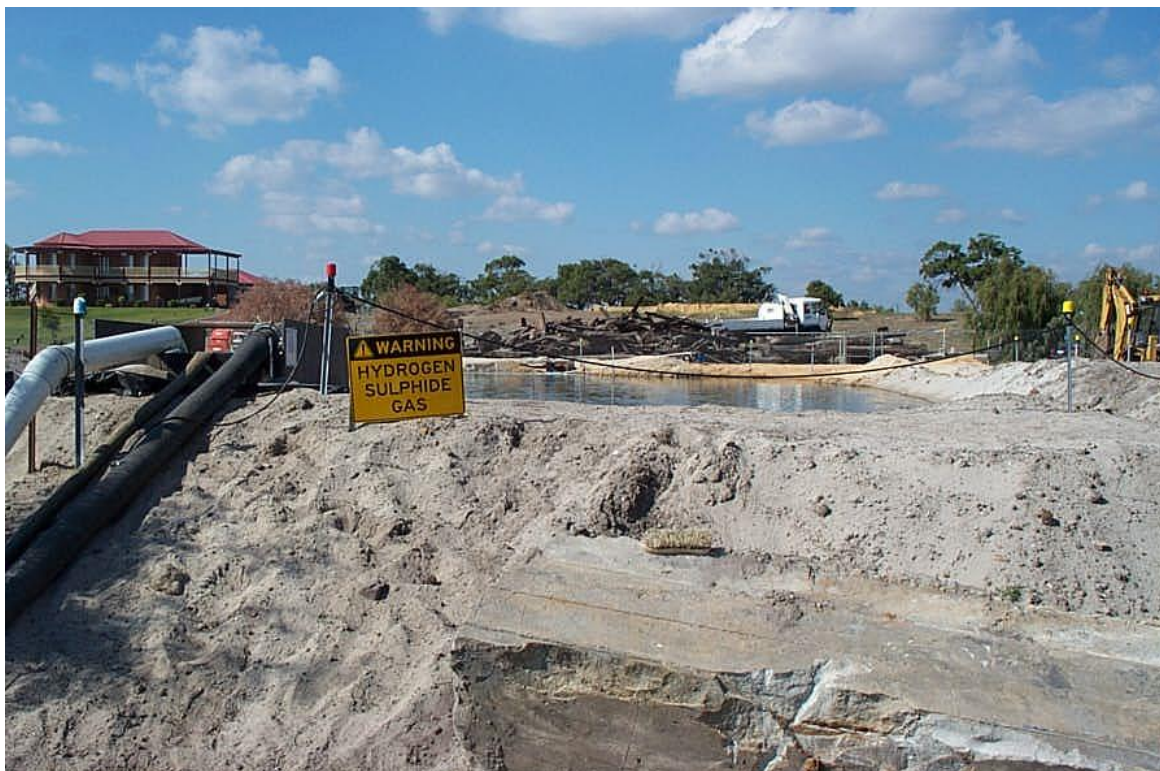
**Figure 5** Turkey nest dam constructed on the foreshore of the Vasse Estuary exit channel used for dewatering of the channel during the construction of the new surge barrier (Photo: R McClean)

During 2004, the previous Vasse floodgates were replaced with the current surge barrier. As part of this process, sediment was removed from a 30 m section of the channel upstream and downstream of the existing surge barrier (R McClean pers. comm. 2016) (Figure 5 and Figure 6). This section was separated from the main body of the exit channel and Wonnerup Inlet via the construction of sand bunds to form a cofferdam. The area was then dewatered to a turkey nest dam (i.e. a dam built above natural ground level) that was constructed on leased private property adjoining the channel (Figure 5). Acid sulfate risks were managed by aeration, dosing with soda ash and letting sea water into the dewatering area. Dried and excavated sediment was trucked to the landfill in Busselton. As a result of these works, we can accurately conclude that within 30 m of the surge barrier, organic sediments that lie above the clean sand layer have accumulated over a 13-year period (from 2004 to 2017).

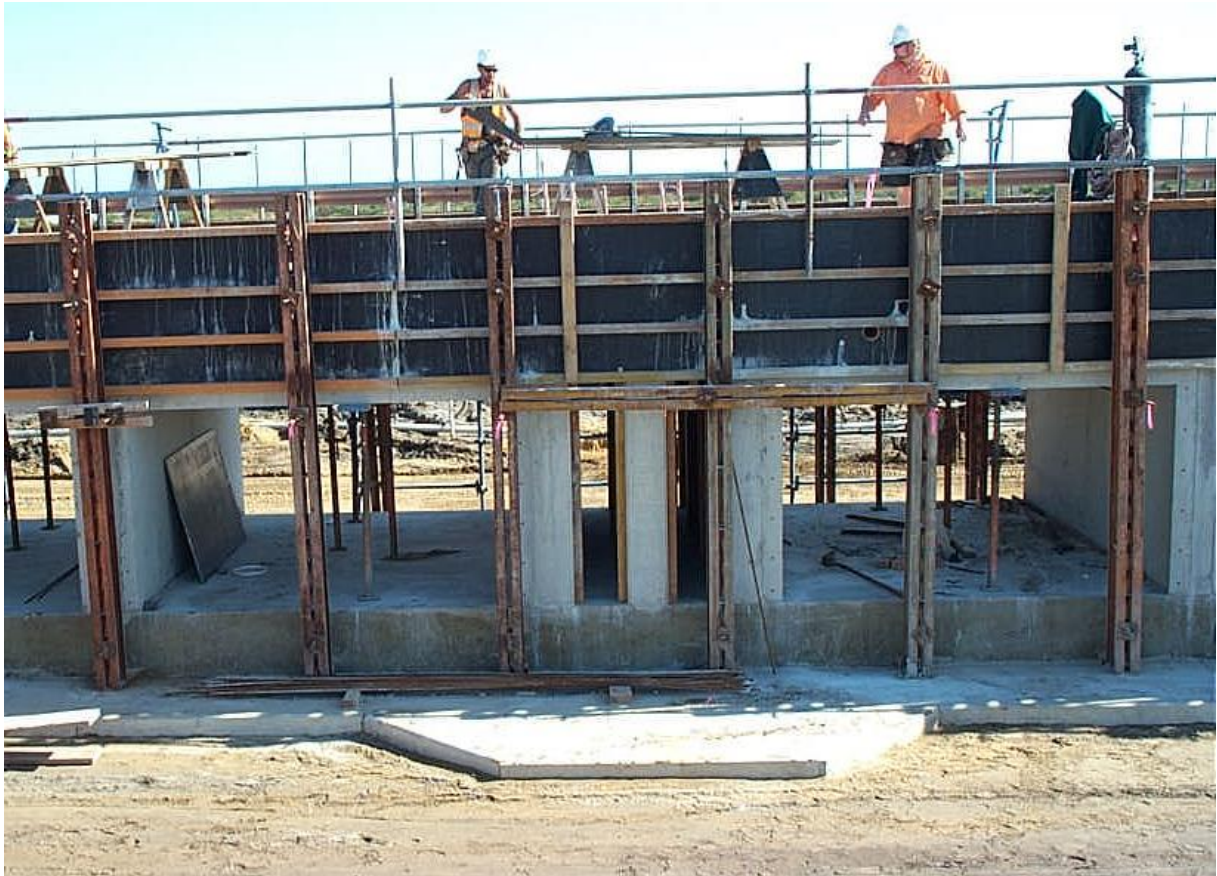
**Figure 6** Vasse surge barrier under construction. Previous sediment accumulation upstream had been removed using an excavator when this section of the channel was dewatered (Photo: R McClean)

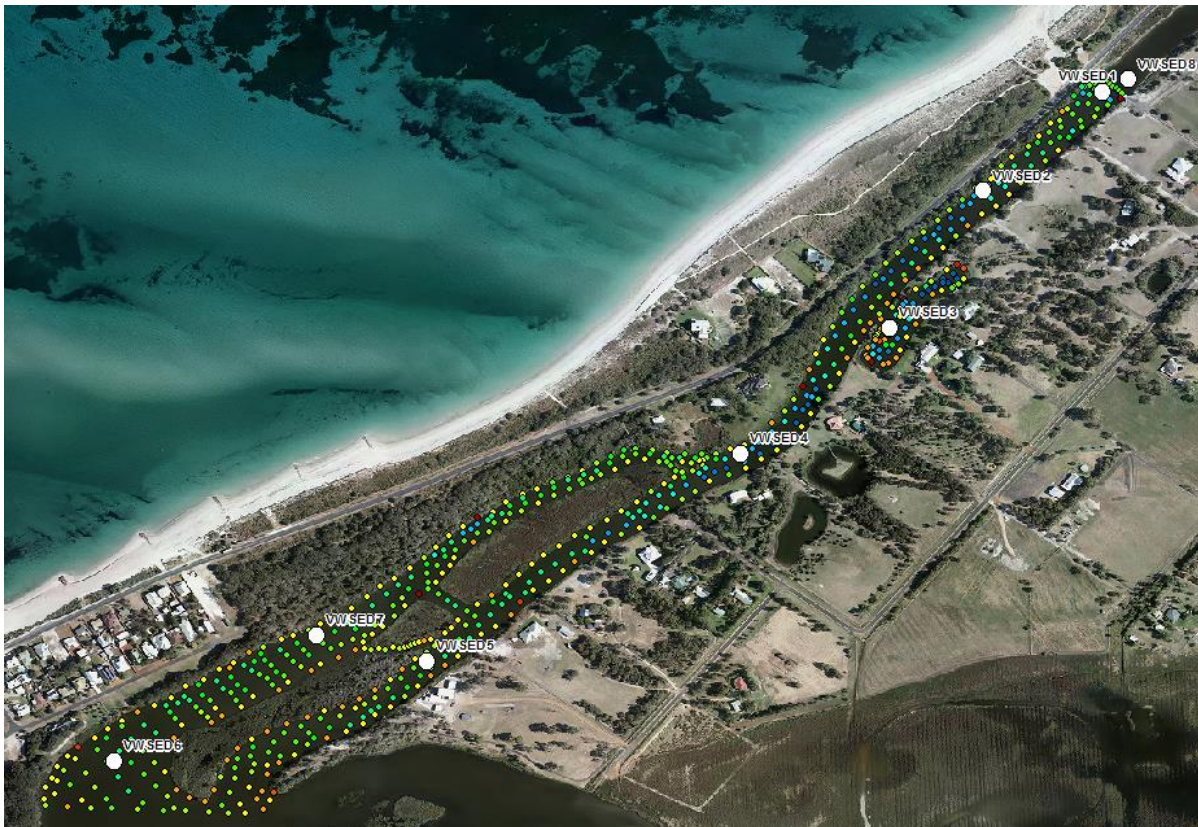
**Figure 7** Coloured points indicate the location of sediment cores taken to measure sediment depth. Points are coloured by water depth. White points indicate the sampling location of sediment (three replicate cores taken at each point)

A survey of sediment depth and volume in the Vasse Estuary exit channel was undertaken in November 2016. The estuary perimeter and survey bounds were established using satellite imagery and mapping software. A grid of 10 m wide and 20 m long cells was overlaid over the area to be surveyed. Two technicians were deployed in a twin-hulled craft, one reading the GPS to determine the grid locations; the other using a sediment corer consisting of a given diameter perspex tube with a valve at one end and a depth scale along its length. The corer was used to establish sediment depths by taking core samples at regular grid intervals (Figure 7) throughout the estuary. Georeferenced location data was recorded for each data point using a GPS. A base profile and a sediment profile of the estuary was generated using the GPS input information. These showed sediment depths and distribution along with the depths of the estuary. Total estuary and sediment volumes were then calculated from these data.

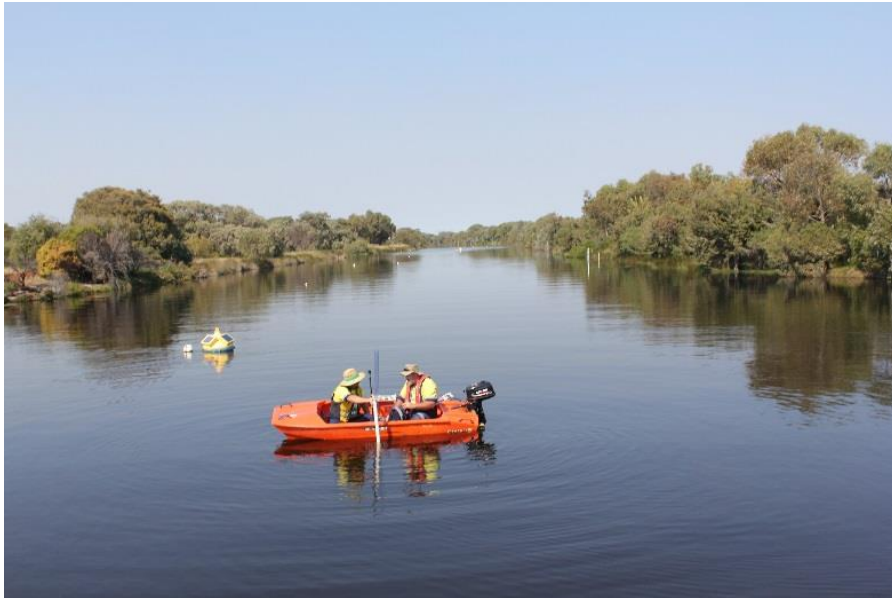
**Figure 8** Contractors collecting a core sample

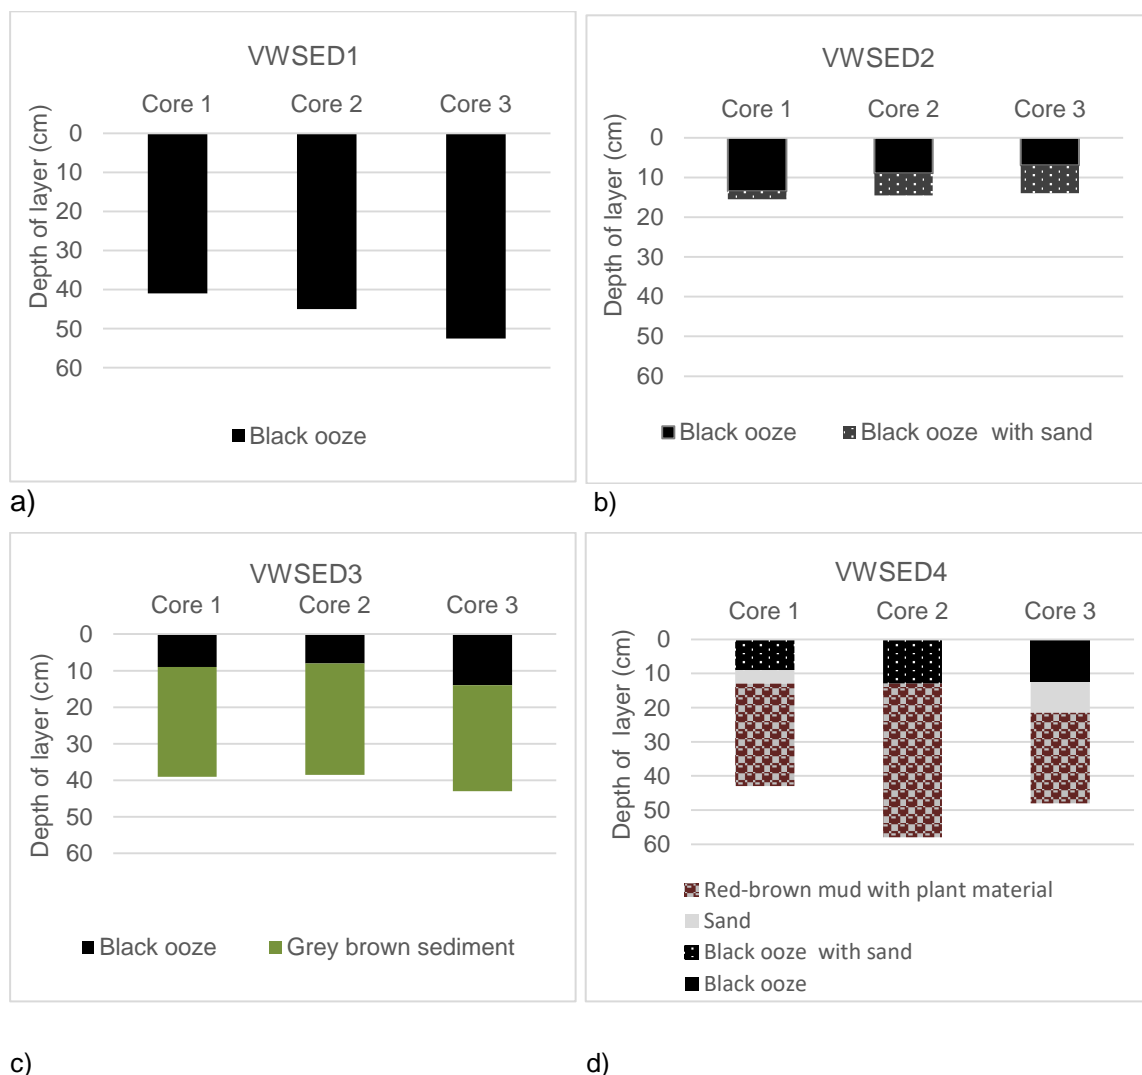
**Figure 11a–h** Sediment profiles in the Vasse Estuary exit channel at sites VWSED1 to VWSED8

Sites VWSED4, VWSED6 and VWSED7 contained a lot of plant material mixed with the lower sediments. It was difficult to determine whether this was seagrass or other plant matter.

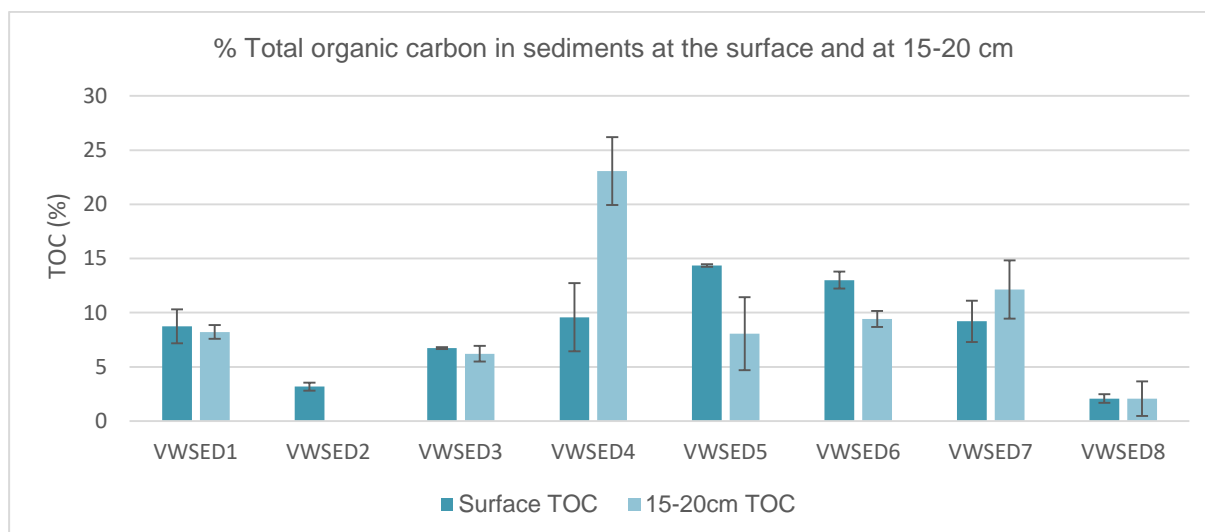
**Figure 15** Total organic carbon in sediments at the surface and at 15–20 cm. Error bars represent standard deviation of triplicate measurements. Sediment depth at VWSED2 was less than 15 cm

Total organic carbon (TOC) concentrations ranged between 5 and 15 per cent at most sites. Some extremely high TOC values in the range of 20–25 per cent were measured at site VWSED4 in deeper sediment layers where large amounts of non-degraded plant material were identified. However, due to the low reactivity of this material, the high values are no major concern in these particular sediment layers.

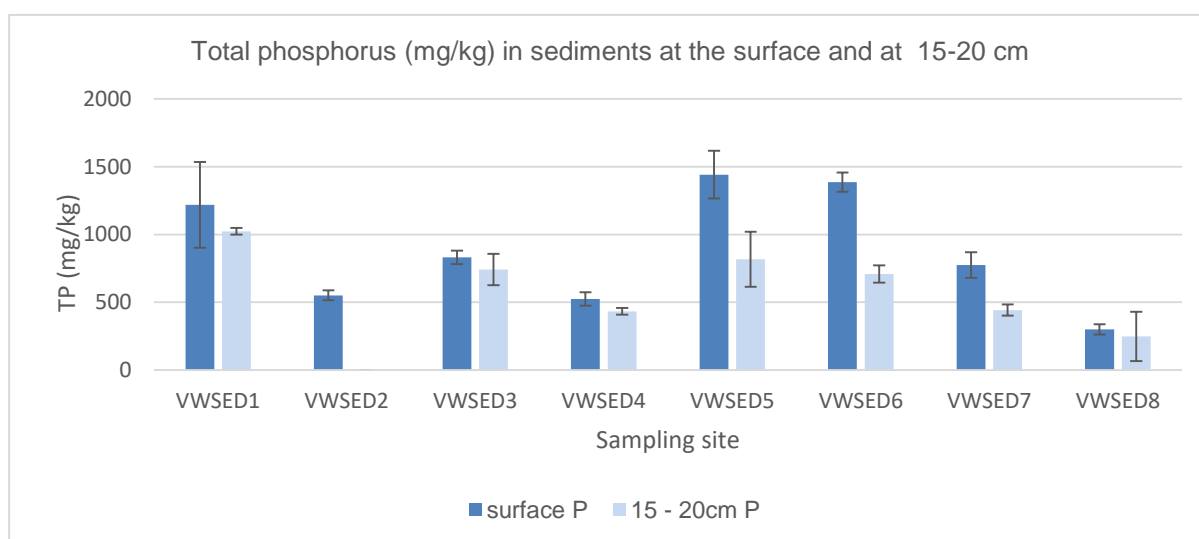
**Figure 16** Total phosphorus in sediments at the surface and at 15–20 cm. Error bars represent standard deviation of triplicate measurements. Sediment depth at VWSED2 was less than 15 cm

TOC, total phosphorus (TP) and total nitrogen (TN) concentrations in sediments followed similar patterns to the AVS content and were generally elevated at sites VWSED1 (Vasse surge barrier), VWSED5 (next to the channel islands) and VWSED6 (Estuary View Drive) compared to all other sites (Figure 15, Figure 16 and Figure 17). The site with the lowest percentage of all three parameters was VWSED8 located downstream of the Vasse surge barrier in Wonnerup Inlet.

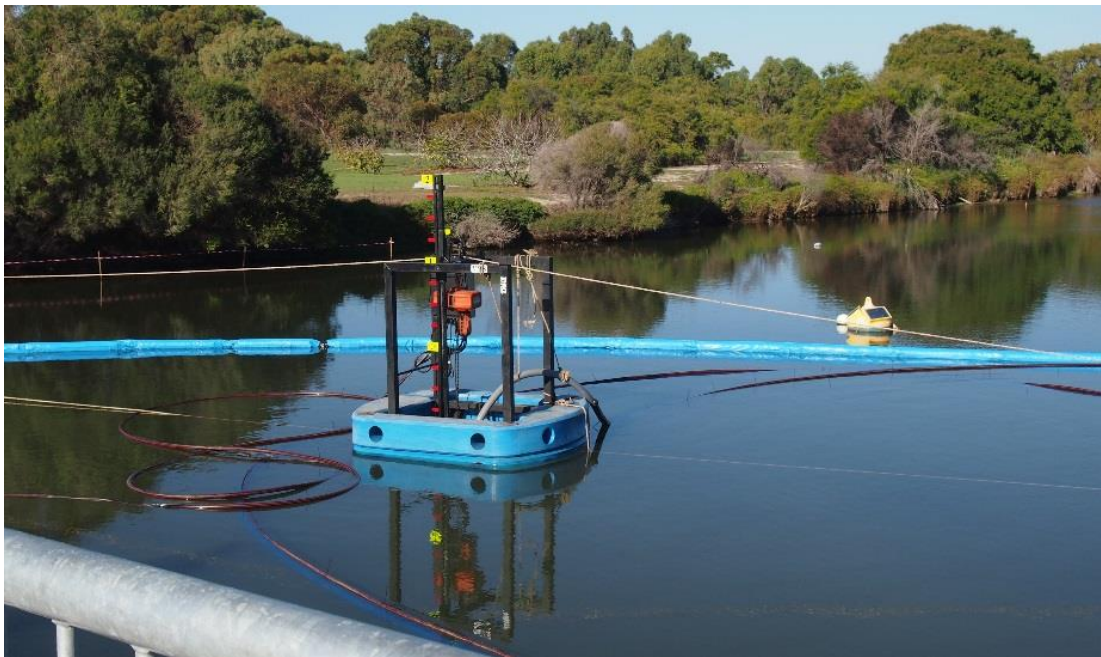
**Figure 18** *A floating pontoon and sediment curtain used during sediment removal works*

A suction pump was mounted on floating pontoon and a sediment curtain was erected on the upstream side of the works area (Figure 18). The slurry of sediment and water suctioned from the channel was then transferred into trucks for transport to the licensed sludge drying beds at the Water Corporation's Busselton WWTP (Figure 19). The slurry was added to other sewerage sludge at the treatment plant where subsequent drying, mixing and disposal of the waste took place as part of the Water Corporation's standard operations (Figure 20 and Figure 21).

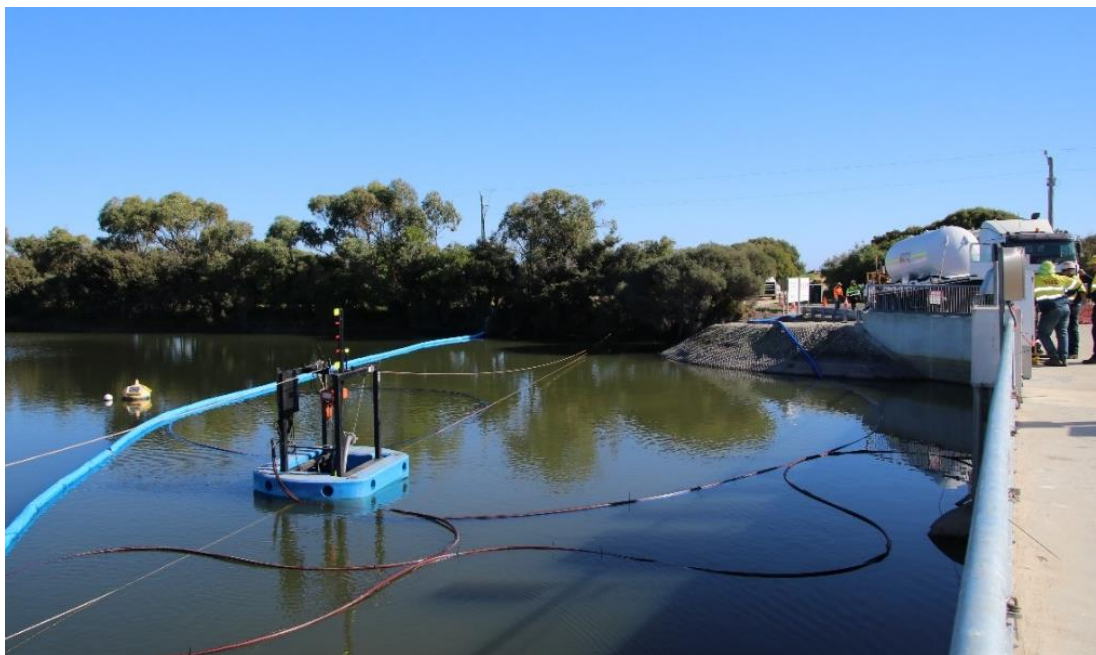
**Figure 19** Sediment being pumped directly to waiting tankers for transport away from site

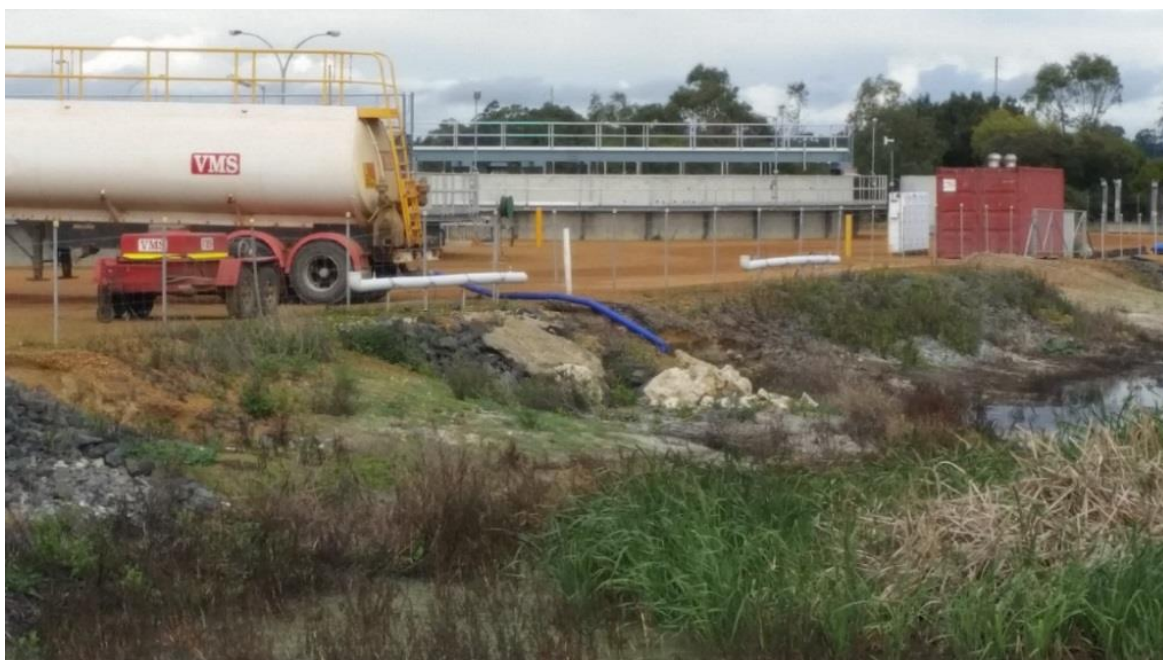
**Figure 20** Tankers at the wastewater treatment plant transfer sediment slurry into drying ponds

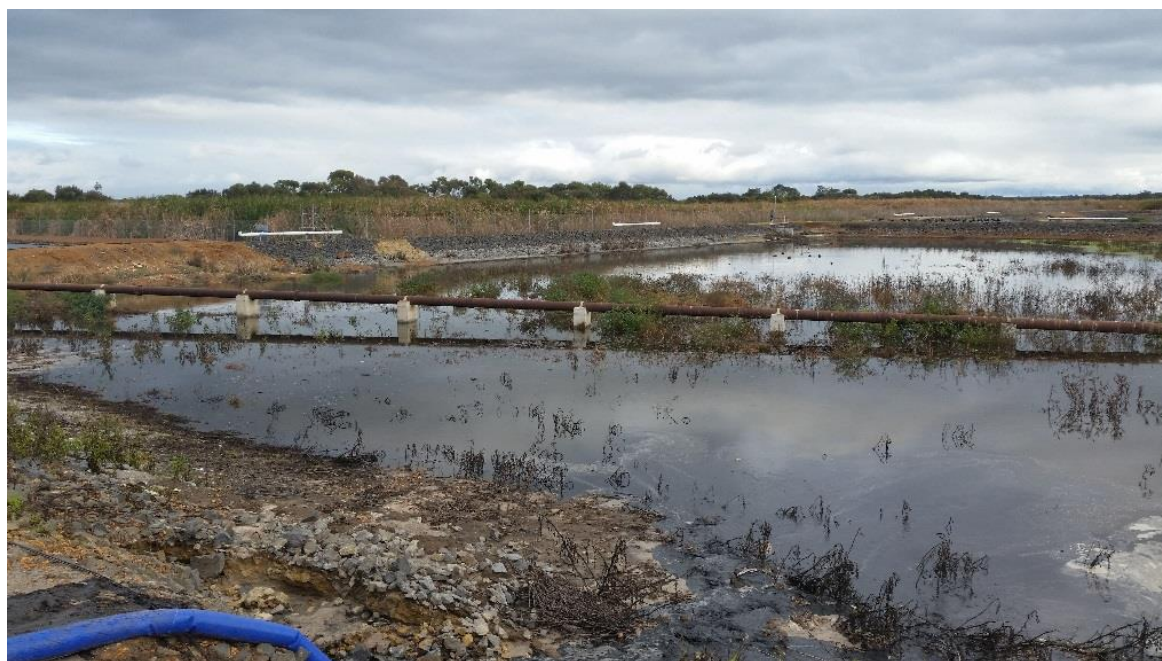
**Figure 21** *Sediment in the ponds will be incorporated with sewage sludge for drying and disposal*

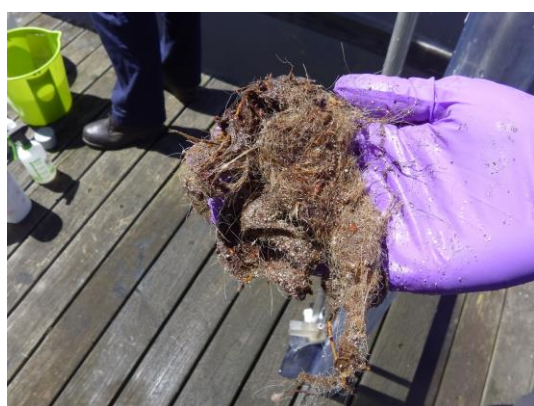
Plant material at base of VWSED7 cores

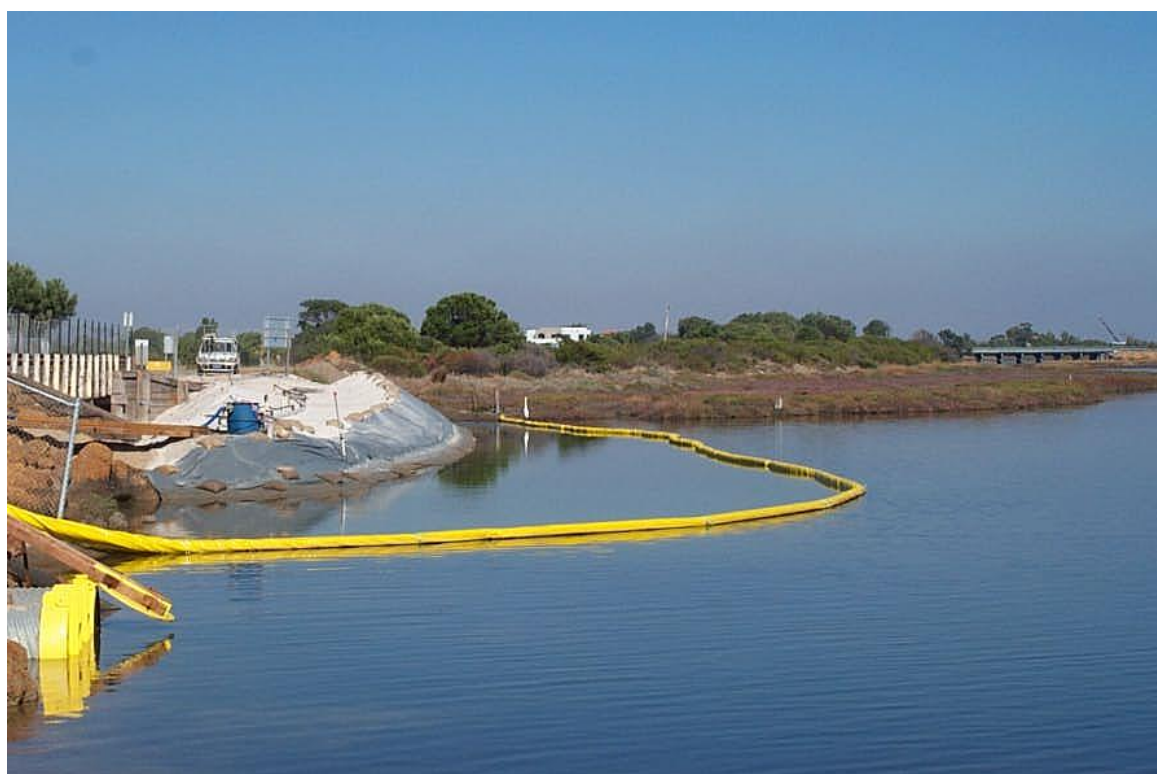
**Figure C2** A sand bund and silt curtain in place downstream of the Wonnerup surge barrier during drainage and excavation works undertaken during replacement of the structure

Drainage and excavation of sediments would involve construction of either one or two sand bunds, depending on the location of sediment removal (e.g. Figure C2). This technique was used at both the Vasse and Wonnerup surge barriers when these structures were replaced in 2004. A dry works area was required to carry out these works, and accumulated sediment was removed from these areas at the same time.

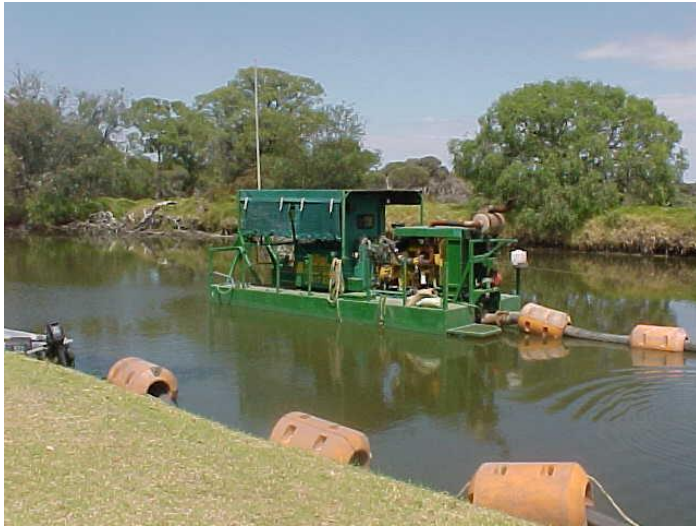
**Figure C3** A small dredge working in the Lower Vasse River circa 2001

This technique would involve the use of a micro-dredge with sediment being pumped to a series of drying ponds constructed on the estuary foreshore. Sediment slurry would be allowed to dry out in the ponds; therefore, these works would need to be undertaken in late spring or early summer. Once drying had occurred, the sediment could be excavated from the pond(s) and trucked away for disposal. Sediment pond construction would require a turkey nest design (i.e. constructed above natural ground level) since groundwater levels are naturally high at this location. This technique was previously trialled in the Lower Vasse River in 2001 (Figure C3).

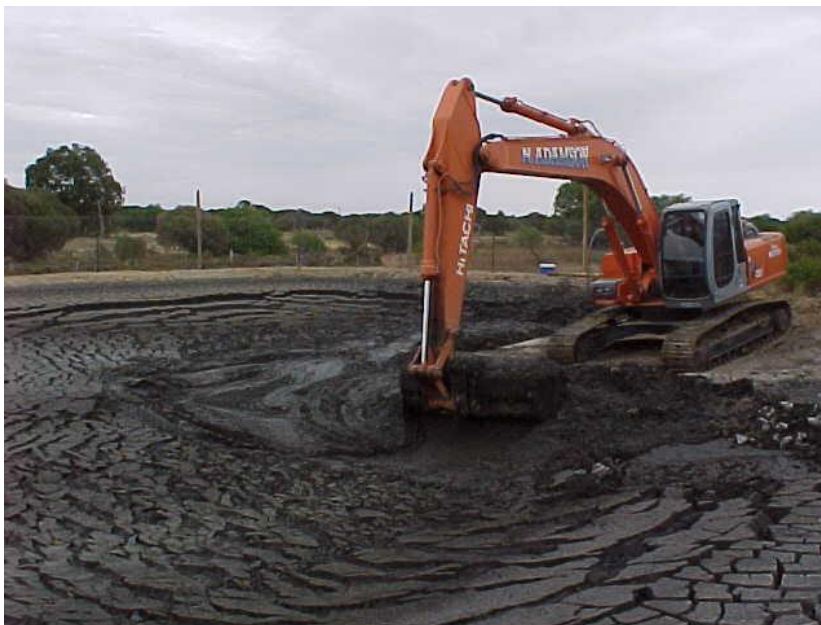
**Figure C4** Dredge spoil being removed from drying ponds adjacent to the Lower Vasse River circa 2002

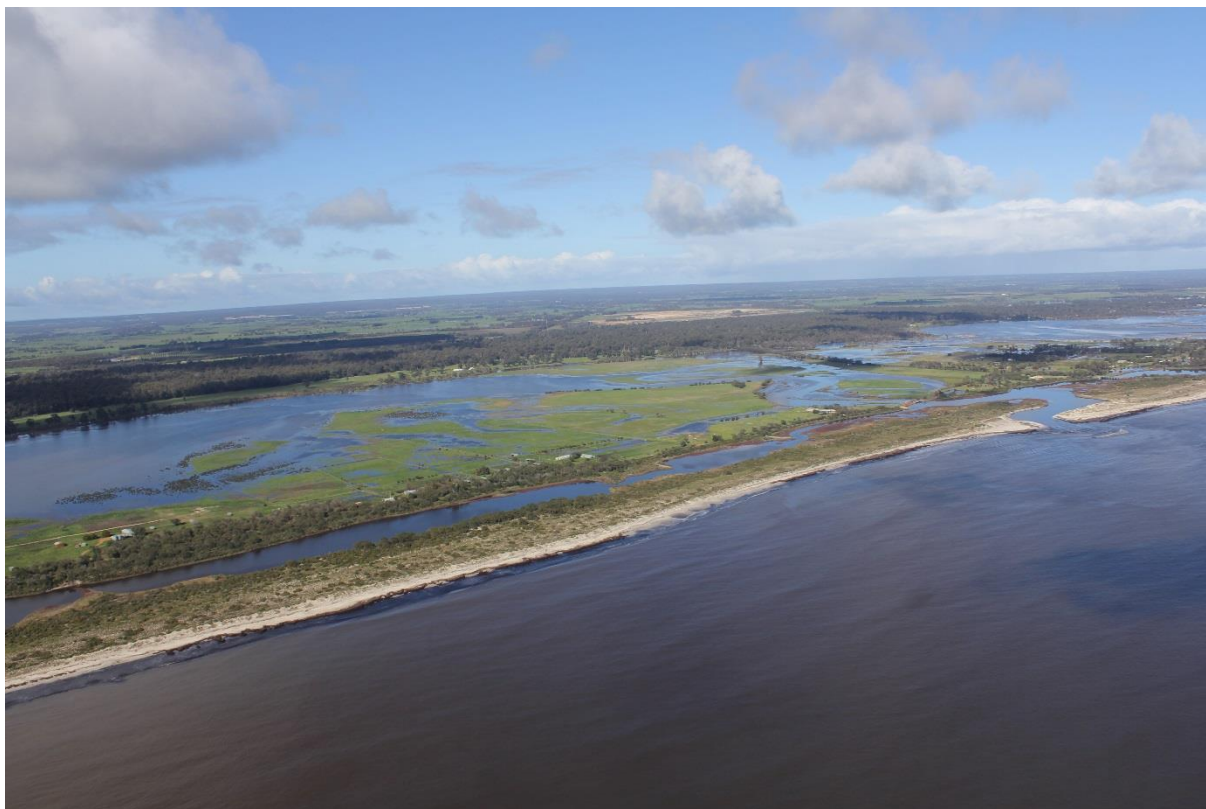
**Figure C5**     *Plume of sediment transported into Geographe Bay, July 2016*

Following extreme high rainfall events, large loads of sediment are at times exported into Geographe Bay via drains, rivers and estuaries of the catchment (Figure C5). These events generally occur in winter when seagrass meadows are dormant and residence time of water in the bay is relatively small.
