# Toby Inlet Sediment Study

Prepared for the City of Busselton

by K. Hastings and R. Paice

July 2020

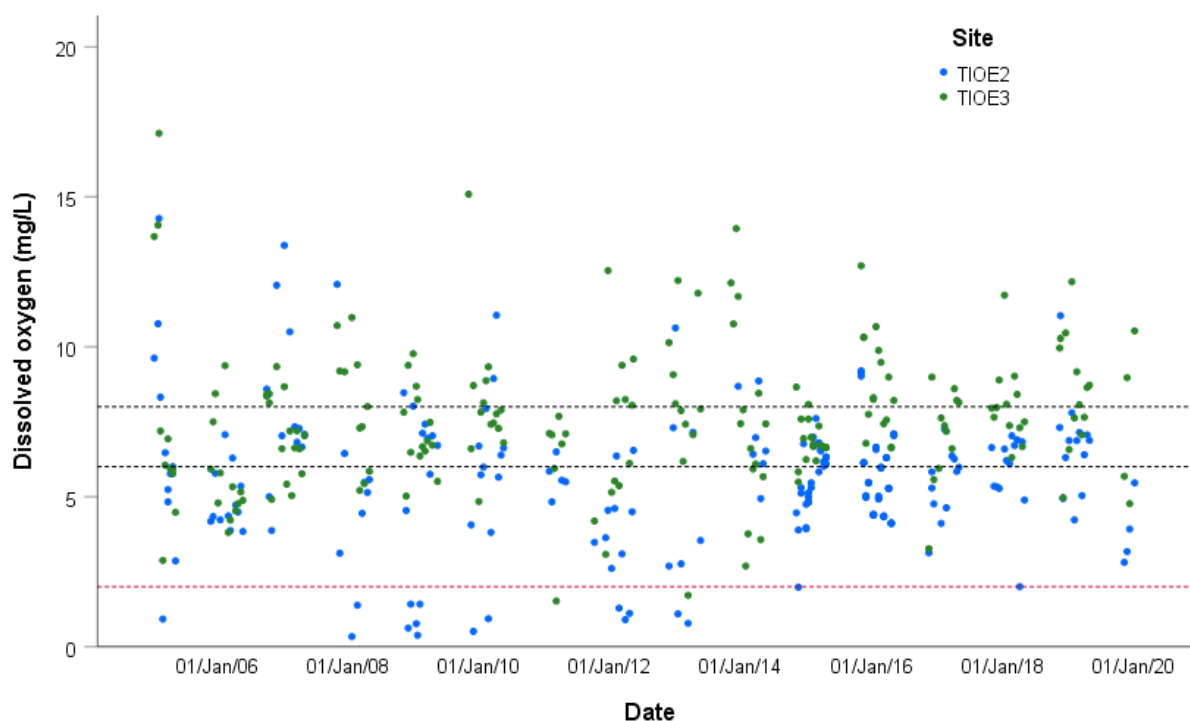
Figure 2: Dissolved oxygen in the Toby Inlet (mid reaches) between 2006 and 2020. Black dashed lined indicate ANZECC & ARMCANZ 2000 ecosystem protection guideline range for estuaries. Red dashed line is critical threshold level for aquatic organisms (Boulton et al. 2014). DWER sampling locations TIOE2 and TIOE3 are equivalent to sampling sites TISED7 and TISED6 in this report respectively

Toby Inlet has experienced water quality issues over a long period of time. Blooms of macroalgae, unpleasant odour, loss of amenity and fish kills have all lead to community concern regarding the health of the inlet (COB, 2019). A review of dissolved oxygen data collected as part of DWER regular monitoring indicates that low dissolved oxygen levels occurred regularly in summer at monitoring sites for many years and are a possibly cause of previous fish kills (Figure 2). Improved management of the sand bar at the mouth of the inlet since 2018 appears to have improved water quality in recent years.

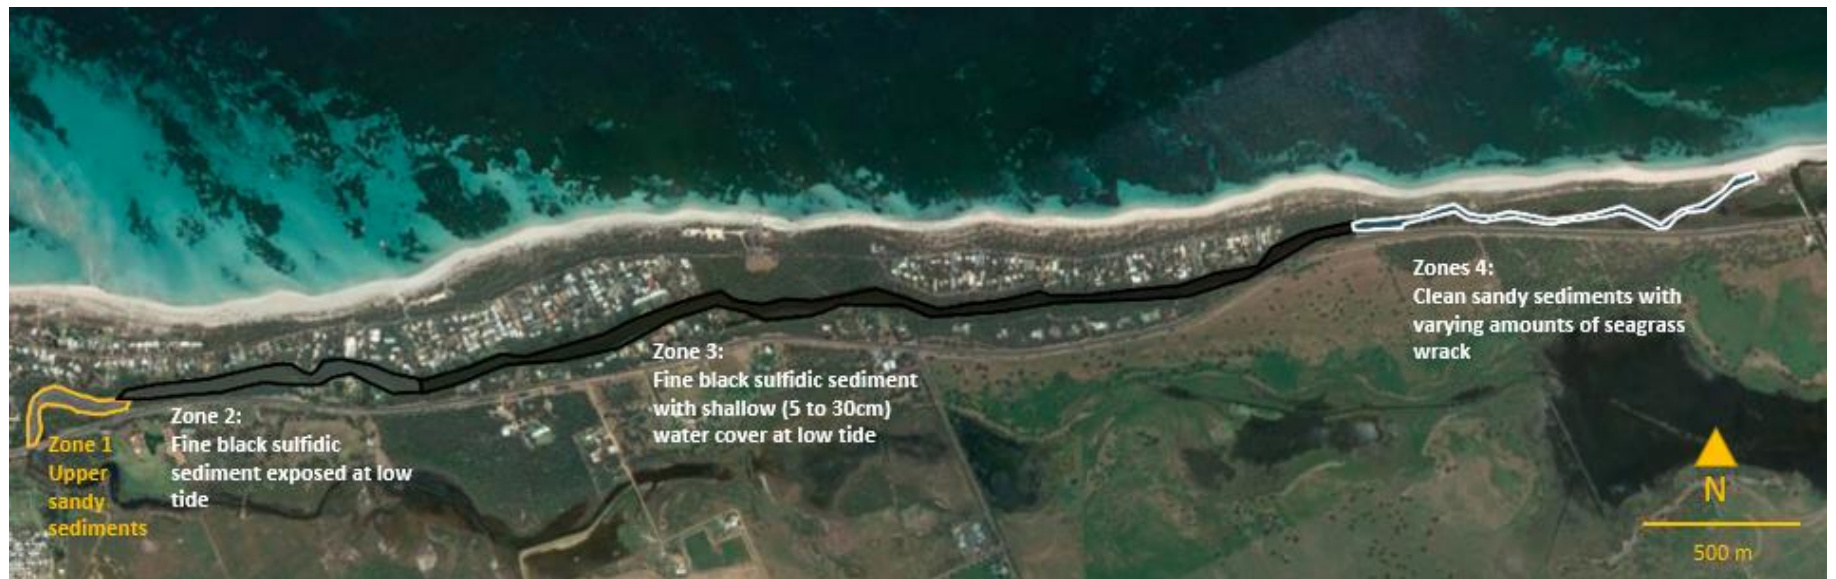
Figure 6: Summary of sediment condition in Toby Inlet.

A reconnaissance visit undertaken on November 7 2019 confirmed that different areas of Toby Inlet comprise sediments of different materials. These include sand and silt washed from the catchment as well as sulfidic black sediments (monosulfidic black ooze), which have likely formed in the estuarine sediments due to eutrophication and limited flushing. Both forms of sediment are the subject of community concern. For the purposes of describing the condition of sediments in Toby Inlet, four separate zones have been defined (Figures 6 to 11). These include:

- Zone 1 – sandy sediments of the upper catchment. A variety of wading water birds were observed feeding in these areas. Dead melaleucas in this upper zone may be indicative of historical hydrological change (or changes to salinity regime) and there is substantial weed invasion within the riparian vegetation in this zone. Important samphire communities (subtropical and temperate coastal saltmarsh) have colonised the edges of the upper inlet and these are protected via their listing at state level as a priority ecological community, and threatened ecological community at a federal level.

- Zone 3 - Fine black sediment with shallow water cover. The reaches of the Toby Inlet, between the footbridge and Stone Street, visual amenity is less severely affected than upstream due to deeper water over laying sediment, but overall visual amenity is moderate to poor. Some fish life was observed in the shallow water lying above sediments in this zone, although the shallow water means they are vulnerable to predation. The depth of sulfidic sediment remains between 50 and 80 cm, severely impacting recreational boating access and providing limited habitat for aquatic species. The length of this zone was 2800m.

- Zone 4 - Clean sandy sediments with varying amounts of seagrass wrack in the lower inlet. Downstream of the footbridge through to the mouth of the inlet the sediments are clean and sandy with patches of seagrass wrack. Fish were abundant in this area and crabs were also observed. Downstream of the footbridge a longer term accumulation of seagrass wrack has created a small island and this possibly influences tidal exchange and flushing.

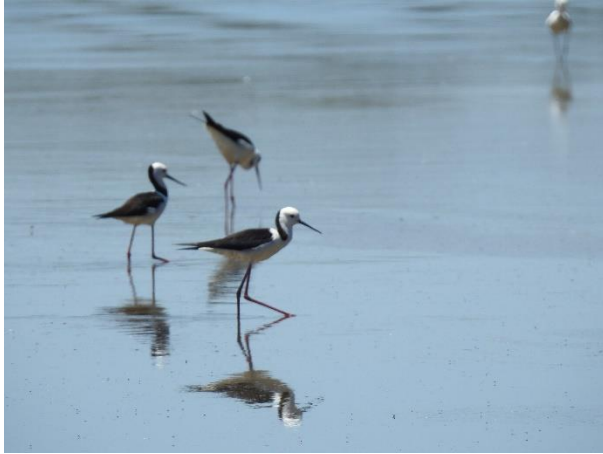
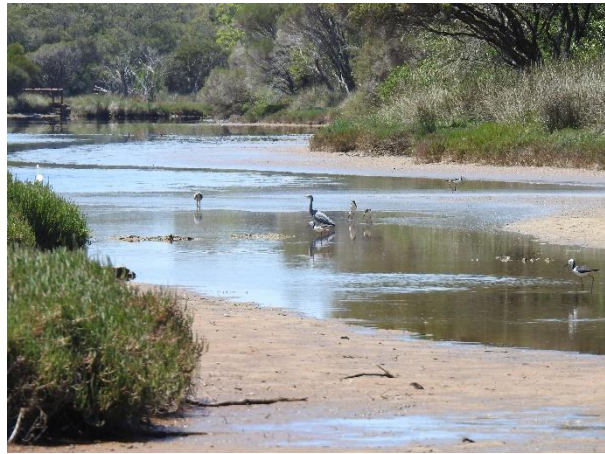
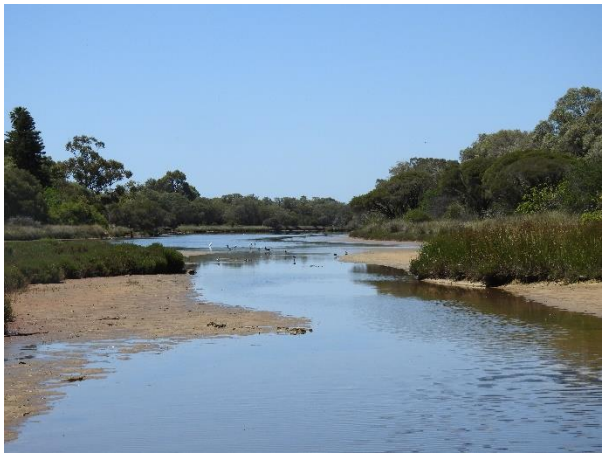
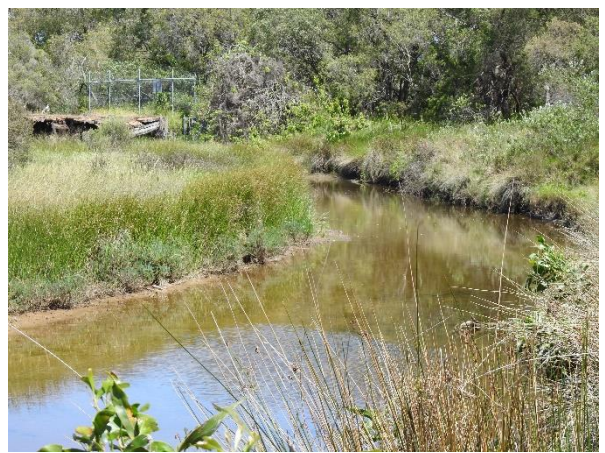
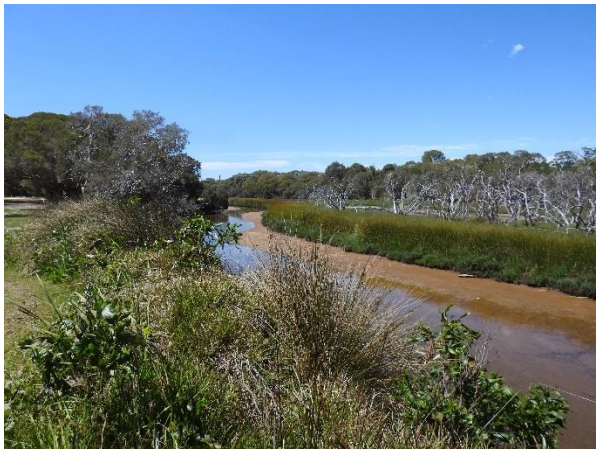
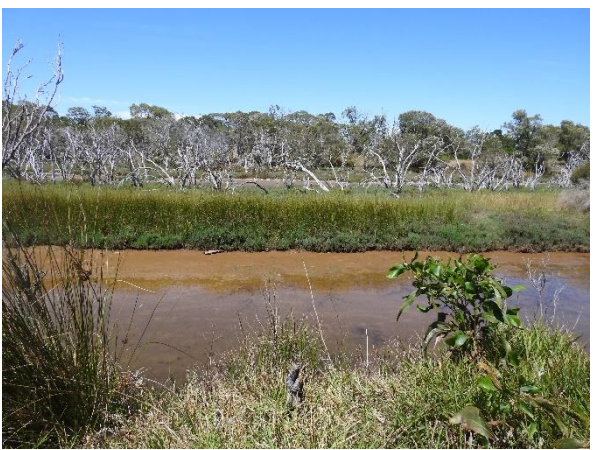
*Figure 7: Zone 1: Sandy sediments have deposited in the upper portion (approx..500 m) of Toby Inlet between the Caves Rd bridge and just downstream of Wilson Ave.*

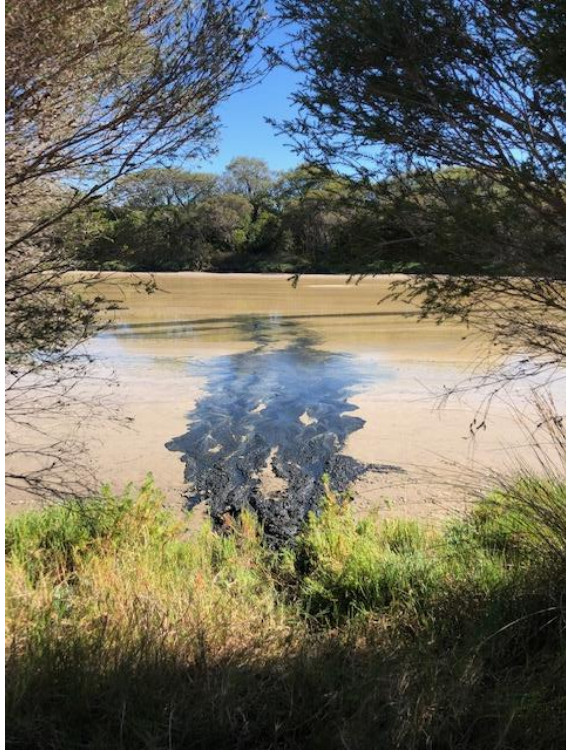
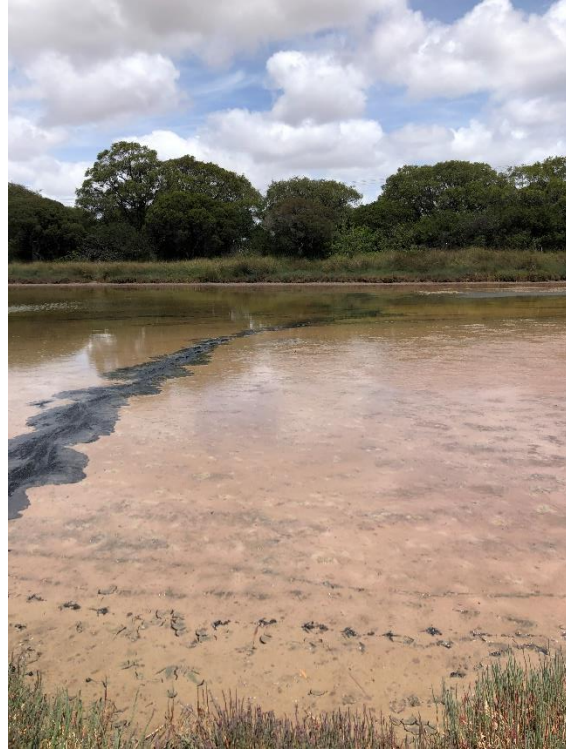
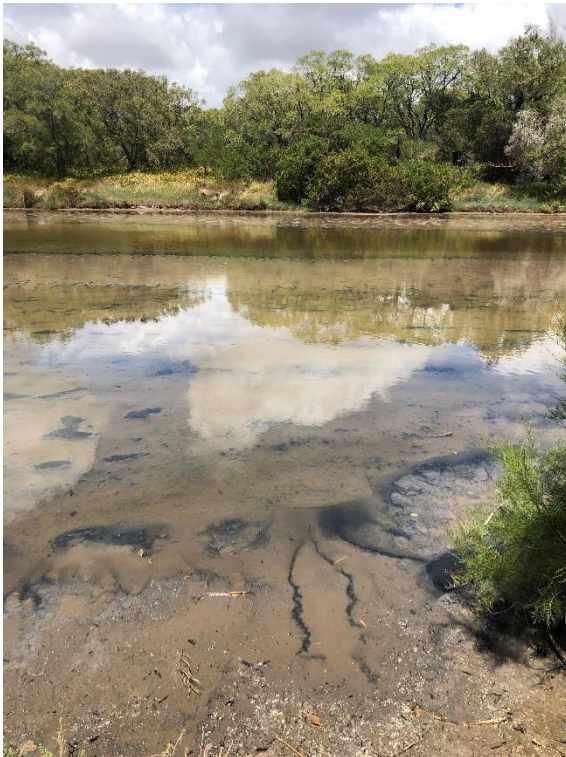
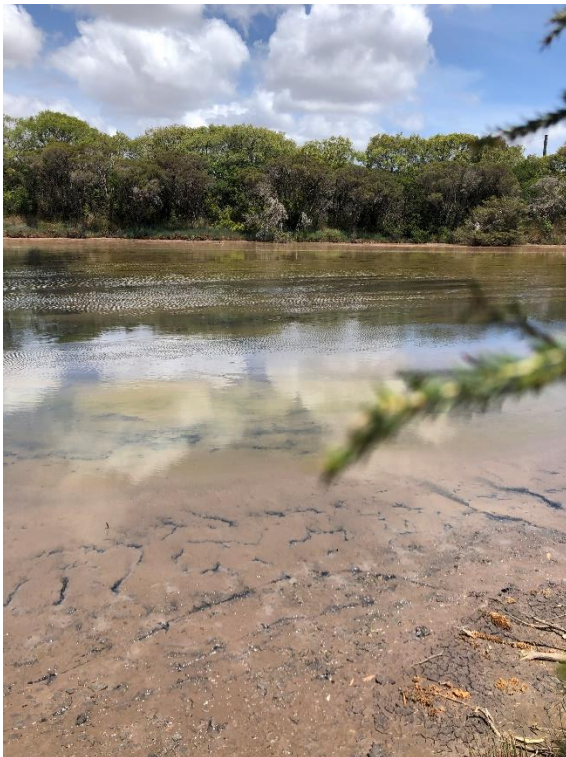
*Figure 8: Zone 2 – Fine black sediments exposed at low tide in the upper inlet between Stone Street and just downstream of Wilson Avenue.*

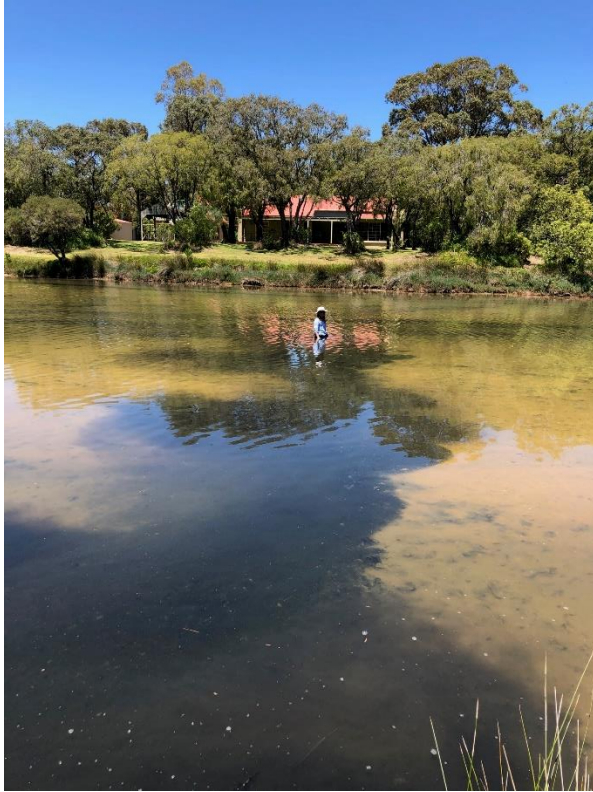
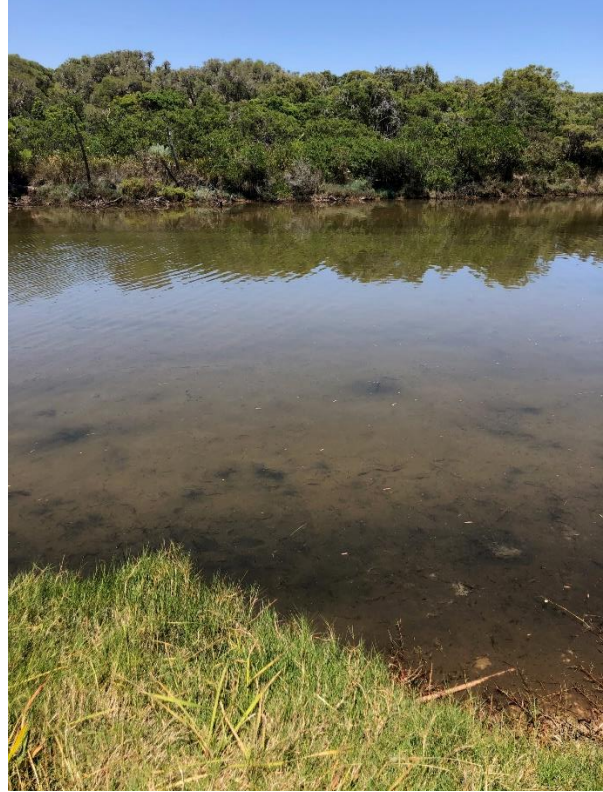
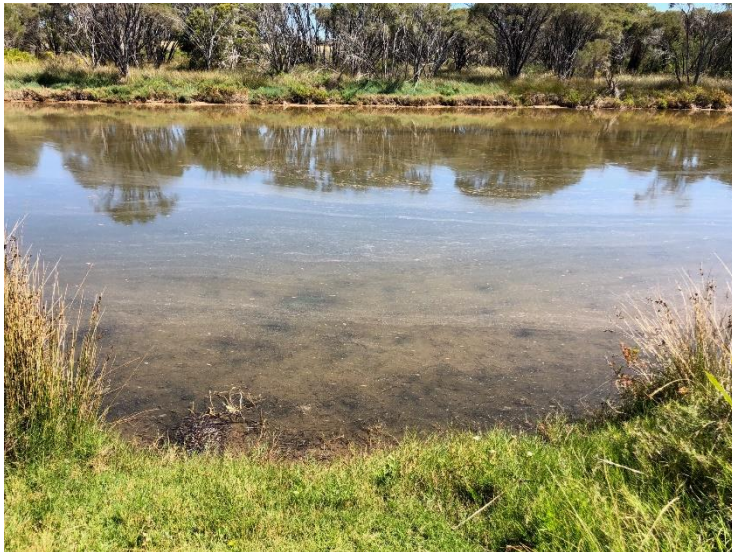
*Figure 10: Zone 3: Fine black sediments covered with shallow water at low tide.*

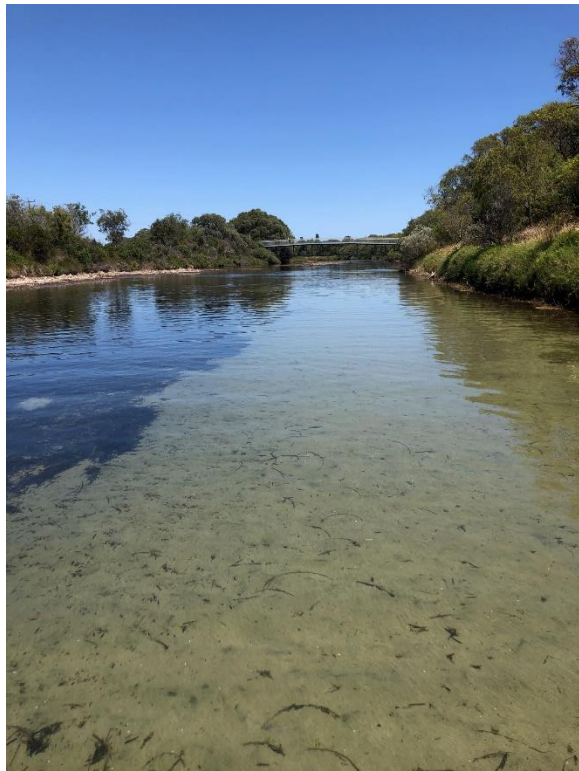
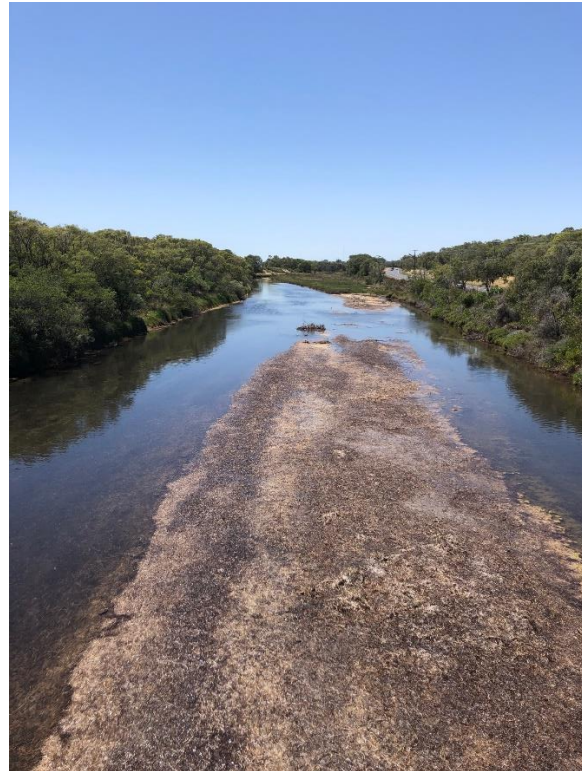
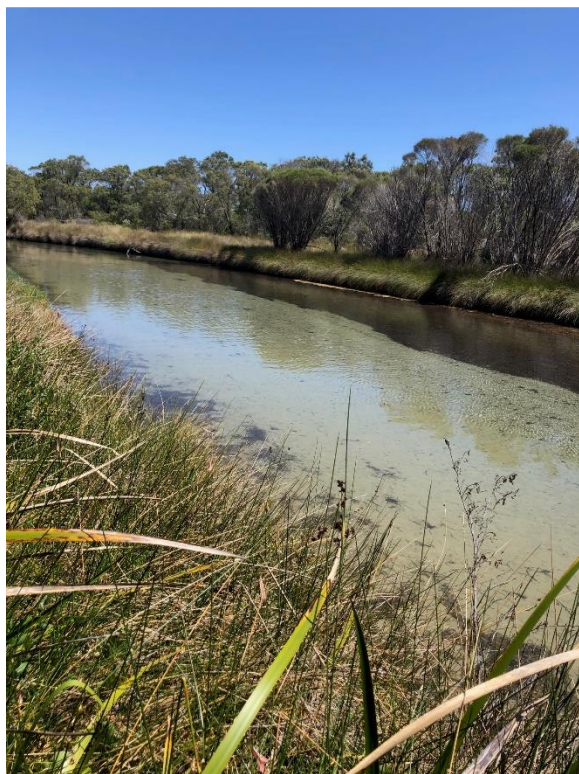
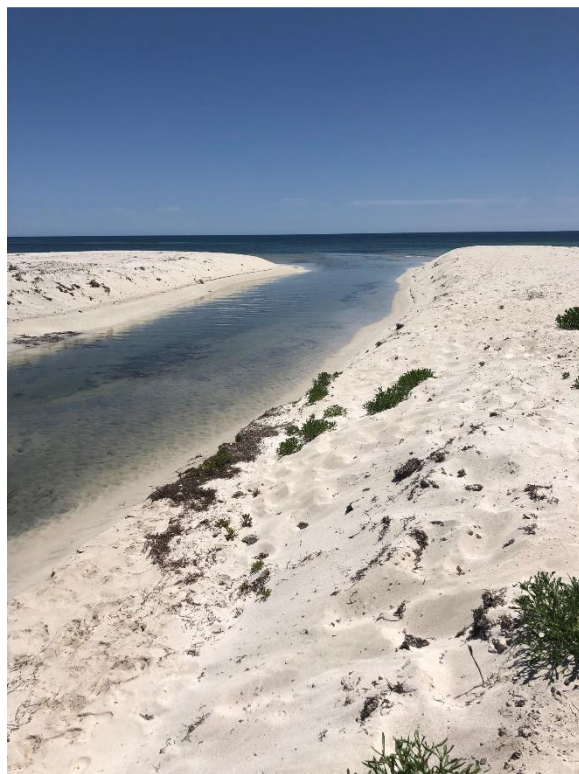
*Figure 11: Zone 4 – Clean sandy sediments of lower inlet.*

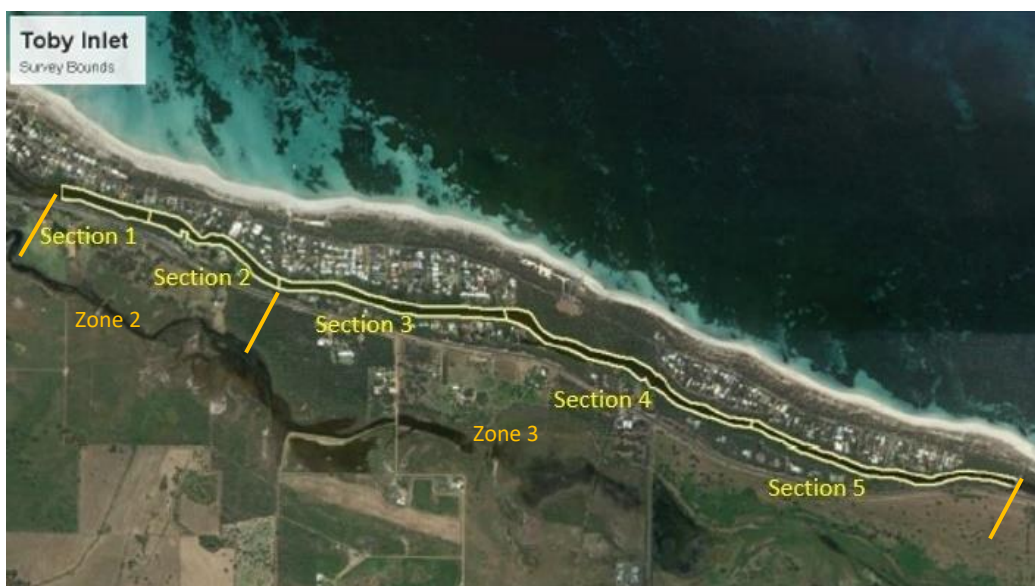
Figure 22: Location of sections of Toby Inlet surveyed for sediment depth. .

Sediment depth and GPS locations were recorded for each site. Using the GPS and depth input information and the specialist mapping software, a base profile and a sediment profile of the estuary was generated. These showed sediment depths and distribution along with the depths of the inlet. The total inlet and sediment volumes were then calculated. This information was then broken down into 5 individual areas. Air photos have been superimposed behind these maps to help the reader orient the locations of maps along the inlet. Note that there are minor inaccuracies between the air photo layers and the mapping layer due to minor air photo distortion.

For comparison with the areas described in the preceding section 'Sediment Condition' Sections 1 and 2 combined correspond with 'Zone 2: Fine black sulfidic sediments exposed at low tide'; while sections 3, 4 and 5 correspond with Zone 3: Fine black sulfidic sediments with shallow water cover at low tide'. Remaining areas were not surveyed sediment depth and volume (Figure 22).

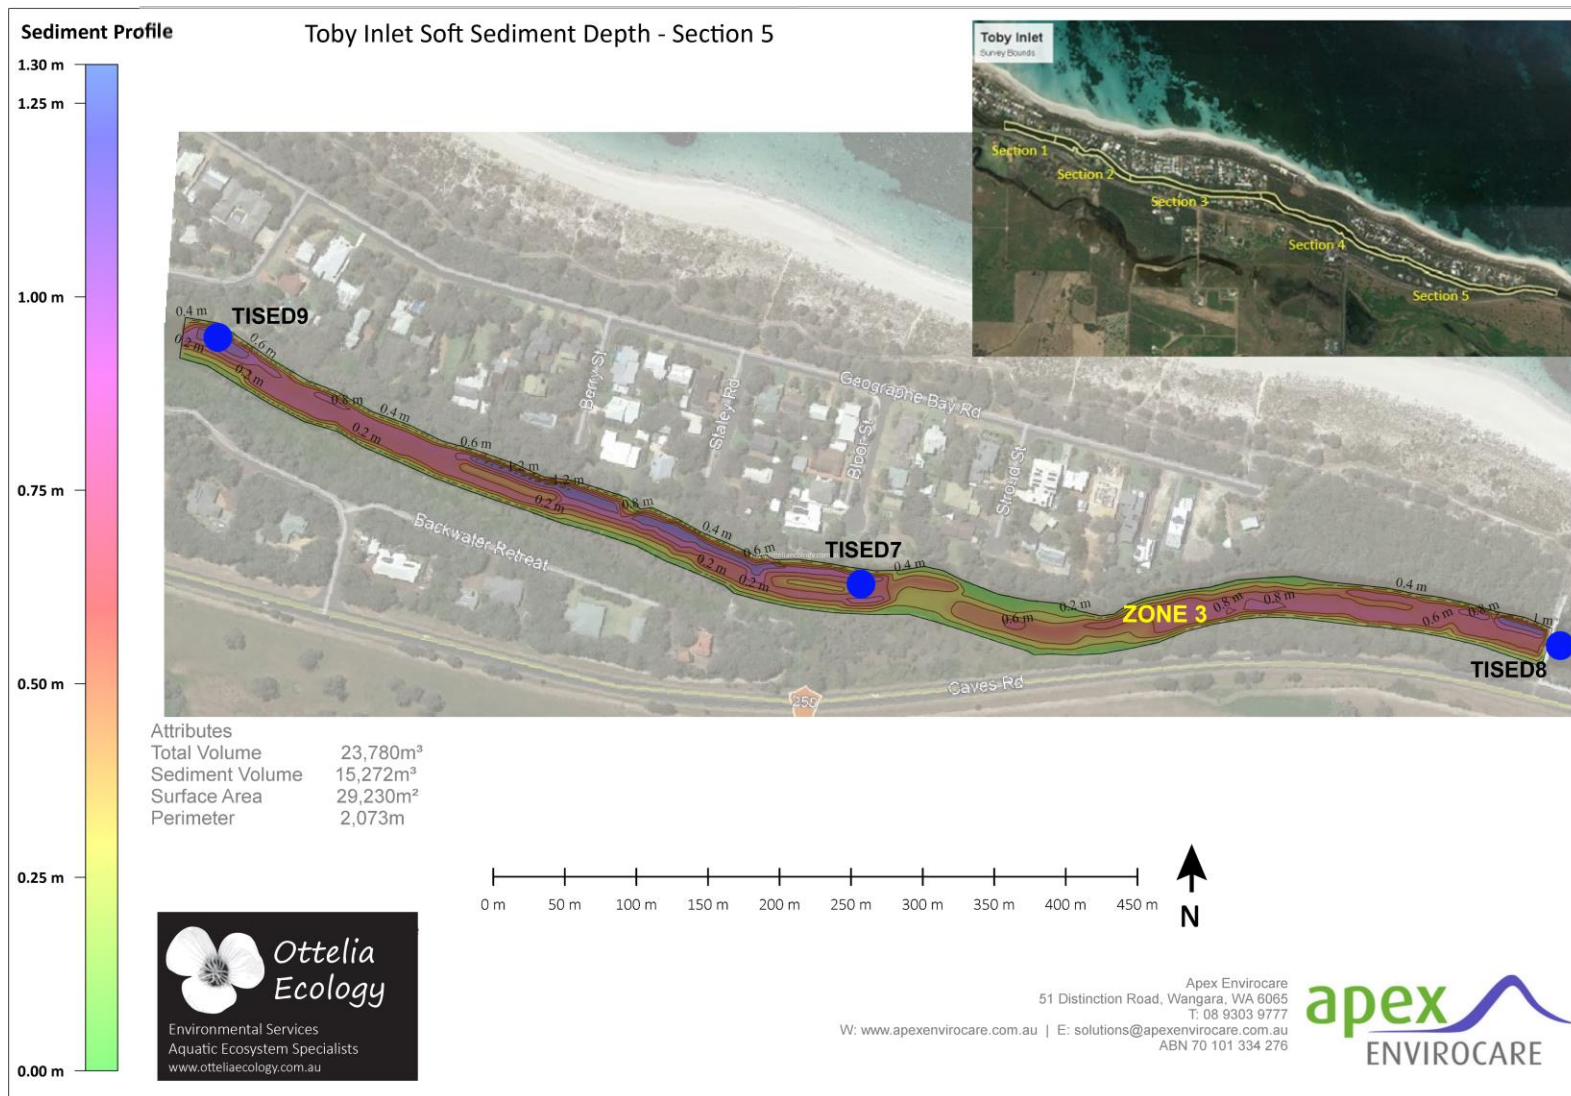
Figure 27: Soft sediment depth in section 5 (located in Zone 3).

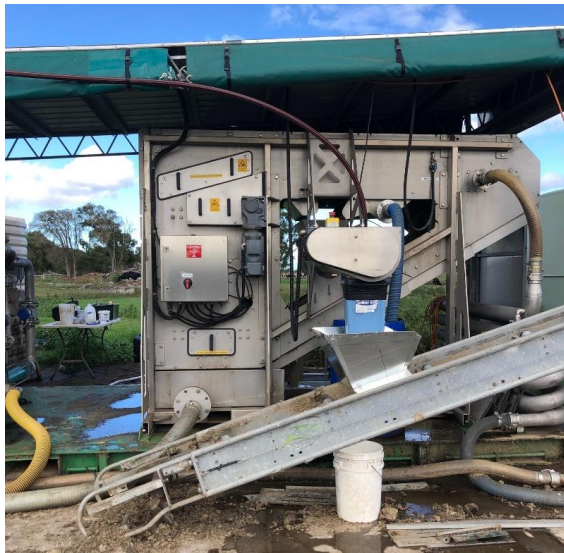
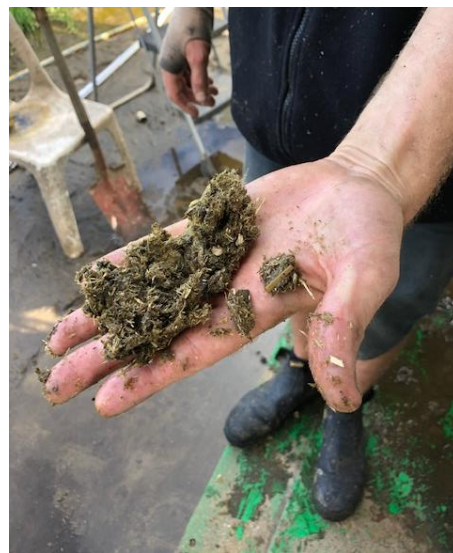
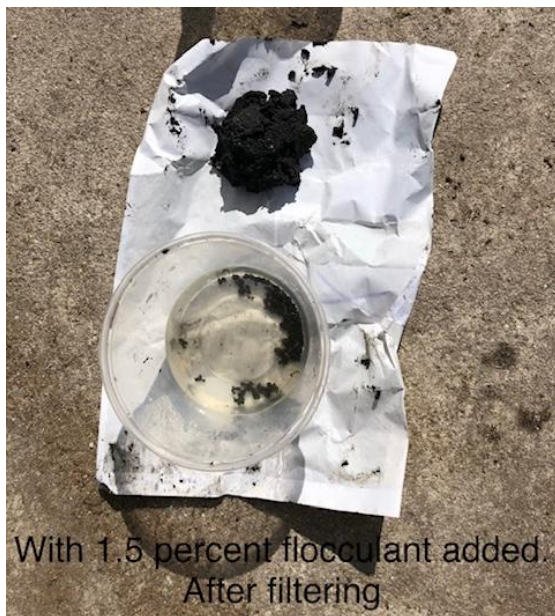
*Figure 25: A to C - Z Filter on the dairy trial site, b) Filtered solids from dairy effluent and c) Filtered sediment from Toby Inlet having passed through a Z Filter sock without compression, with 1.5 percent flocculent added.*

demonstrating promising results in the dairy trial. This is an example of a modified belt press that operates within a Z shaped conveyer belt to compress the slurry through an enclosed filter membrane known as a filter sock. Sediment samples from the Toby Inlet were taken to the trial site and passed through a spare filter sock without compression and, with the aid of a flocculent, the majority of sediment particles were quickly filtered from the sample (Figure 25 a, b and c). The figure below shows photos of the Z filter equipment (Figure 25 a), the dry filter cake after processes dairy wash down effluent (Figure 25 b) and the (largely) clear filtrate that resulted from experimentally passing a sample of Toby Inlet sediment through the equipment's filter sock using a flocculating agent.

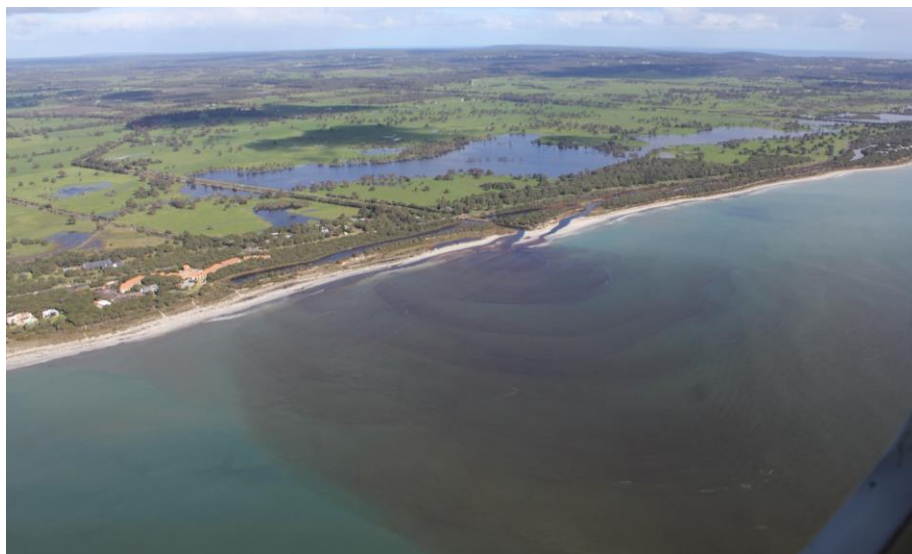
*Figure 26: Plume of dark water flowing from Toby Inlet and Station Gully into Geographe Bay, July 2016 (Photograph by DWER).*

The overall impacts of some sediment dispersal into Geographe Bay during winter would require evaluation though is expected to be fairly low providing a slow and staged approach to removal under the right conditions. Previous modelling has found that sediment particles under 0.3mm are likely to remain in suspension in Geographe Bay and be carried away by currents (Patiaratchi & Wijeratne, 2011). During winter and spring the conditions in Geographe Bay are often very turbid as a result of winter storm surges resuspending seagrass wrack that has accumulated in the meadows over summer and autumn (Oldham et al., 2010). Similarly, recent flood events such as occurred in 2016 appear to have resulted in some scour of sediment from Toby Inlet and subsequent dispersal in Geographe Bay as seen in air photos taken soon after a 1 in ten year rain event in 2016 (Figure 26). Annual monitoring of the seagrass meadows in Geographe Bay found that meadows at the closest site to Toby Inlet have been stable over the past ten years with some minor fluctuations have the highest shoot densities of the monitoring sites (McMahan & Dunham, 2018).
