Capel River Action Plan

1999

Prepared for Geographe Catchment Council - GeoCatch
and the Capel Land Conservation District Committee

by
Kirrily White and Sarah Comer
in association with
Evangelisti & Associates

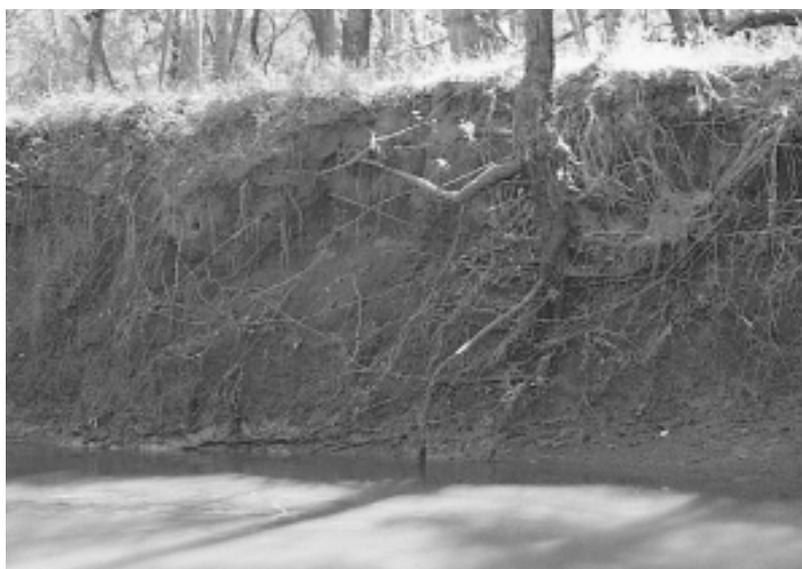
Large roots of trees and shrubs anchor the river embankments in place (Plate 2, page 11). The finer roots of shrubs, sedges and rushes effectively stabilise the riverbanks by reinforcing the river embankments. Well vegetated stream banks are less likely to suffer from undercutting and slumping.

Plate 2: Roots of vegetation provide some anchorage even when scoured.

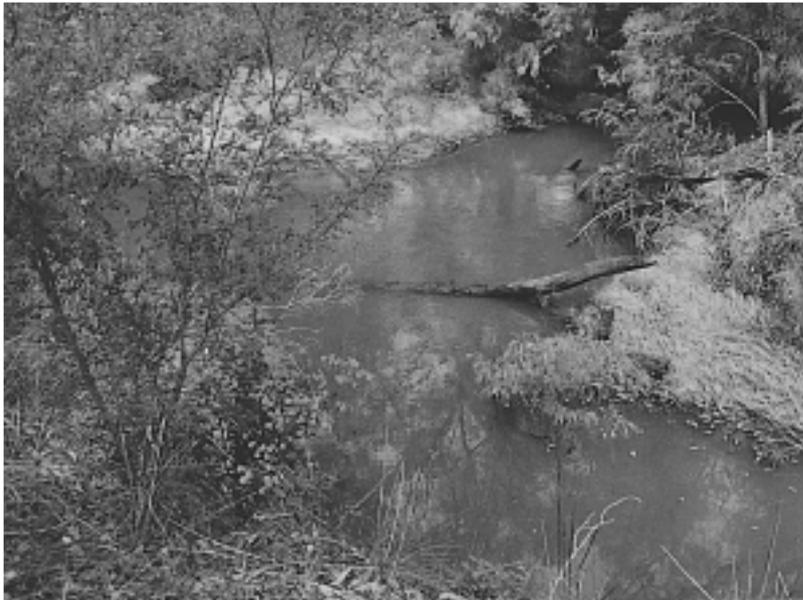
The lack of native vegetation to dissipate flow energy may allow more sediment to be removed from the riverbanks and carried downstream. Here it may accumulate into point bars which deflect flow onto the opposite bank creating a new erosion point, or cause upstream flooding by retarding flow under shallow conditions (Plate 5, page 13).

Plate 5: A vegetated meander showing point bar formation.

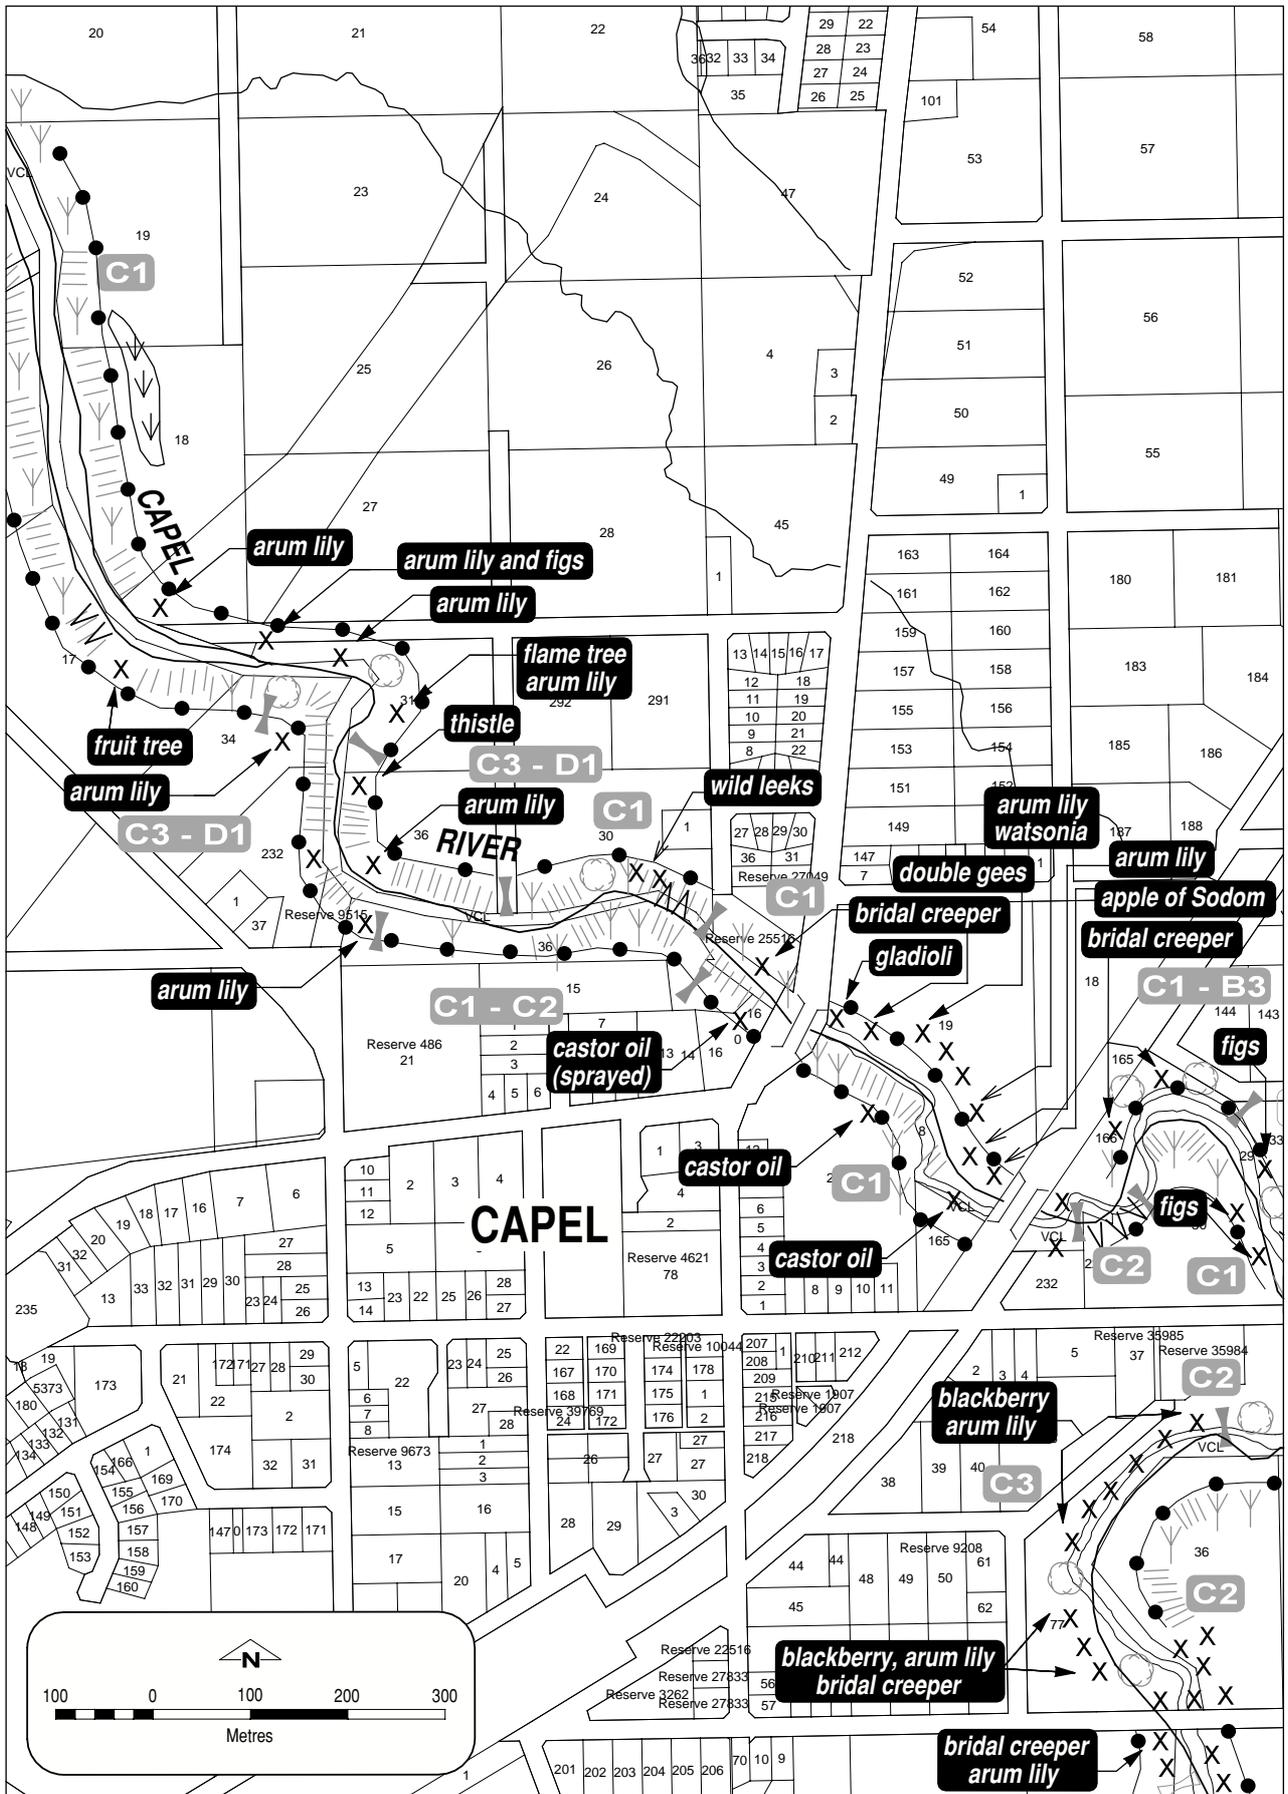
Capel River Map 5

Issues	Comments	Management Advice
General foreshore condition	The foreshore in this section was generally degraded, with little or no understorey, many sites of erosion and scouring, and severe weed invasion.	
Fencing	There was no fencing of the foreshore in this section. However, exclusion of stock from the foreshore reserve would limit the need for fencing in much of this section.	Fencing recommended along both sides of the foreshore in this section. Length of fencing recommended: North bank ~ 2300 m; south bank ~ 2000 m.
Erosion	Several sites of severe scouring were noted in this section.	Refer to Erosion control Chapter 8.3 — points 1 & 2 (page 33).
Revegetation requirement	Understorey is particularly sparse in this area, a narrow band of flooded gum lined the foreshore, with isolated clumps of rushes and sedges.	Revegetation with understorey and sedge species is recommended. This should include widening the riparian buffer zone to allow natural regeneration to occur. Select species from community type 1 & 3, Table 8.1 (pages 28 & 31).

Weed invasion	Arum lily, wild rose, bridal creeper, blue periwinkle, figs, apple of Sodom, double gees all recorded in this section. In addition, wild grapes, wild garlic and easter lilies are problematic in this area.	Refer to Specific weed management advice Chapter 8.1.2 points 2, 19, 5, 4, 10, 1, and 9 (pages 23 -26). Also treat wild grapes, wild garlic and easter lilies.
Other management comments	Due to its proximity and high visibility to the town of Capel this section could be used as a priority site for restoration action. <i>Bolboschoenus caldwellii</i> recorded in this section. <i>B. caldwellii</i> readily invades disturbed areas and can clog waterways.	PRIORITY ACTION SITE Monitor spread of this rush.

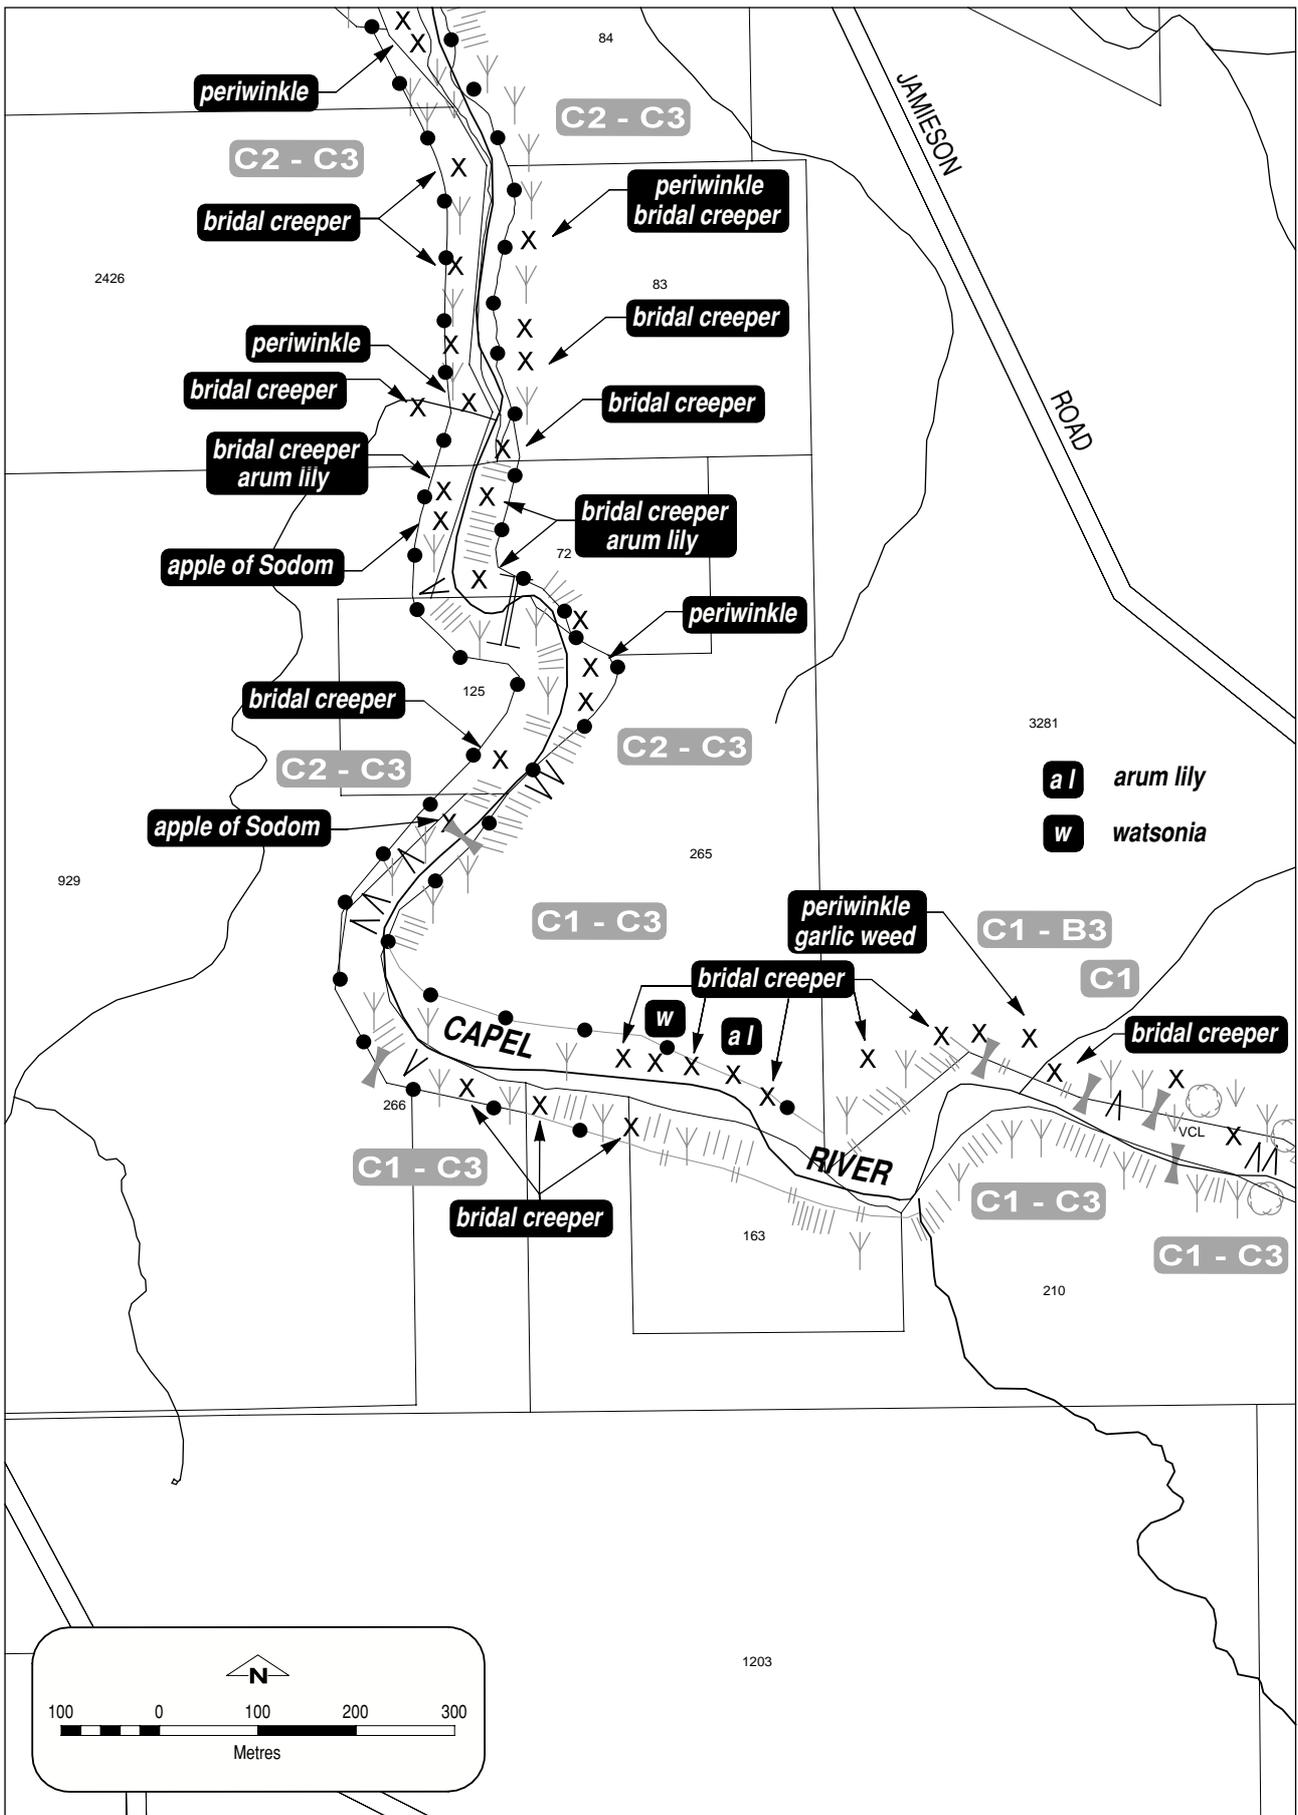
Capel River Map 7

Issues	Comments	Management Advice
General foreshore condition	The foreshore in this section was generally degraded, with little or no understorey, many sites of erosion and scouring, and severe weed invasion.	
Fencing	Fencing of the foreshore was absent or set well back from the foreshore, and not excluding stock.	Length of fencing recommended: south bank ~ 1100 m north bank ~ 1265 m.
Erosion	Severe scouring was recorded at many sites in this section.	Refer to Erosion control Chapter 8.3, points 1, and 2 (page 33).
Revegetation requirement	Understorey is particularly sparse in this area, a narrow band of flooded gum lined the foreshore, with isolated clumps of rushes and sedges.	Revegetation with understorey and sedge species is recommended. This should include widening the riparian buffer zone to allow natural regeneration to occur. Select species from community type 2 and 3, Table 8.1 (pages 29 - 31).

Weed invasion	A variety of invasive weeds were recorded in this section, including blue periwinkle, bridal creeper, arum lily, apple of Sodom, and garlic weed.	Refer to Specific weed management advice Chapter 8.1.2 points 1, 2, 4, and 5 (page 23).
Other management comments

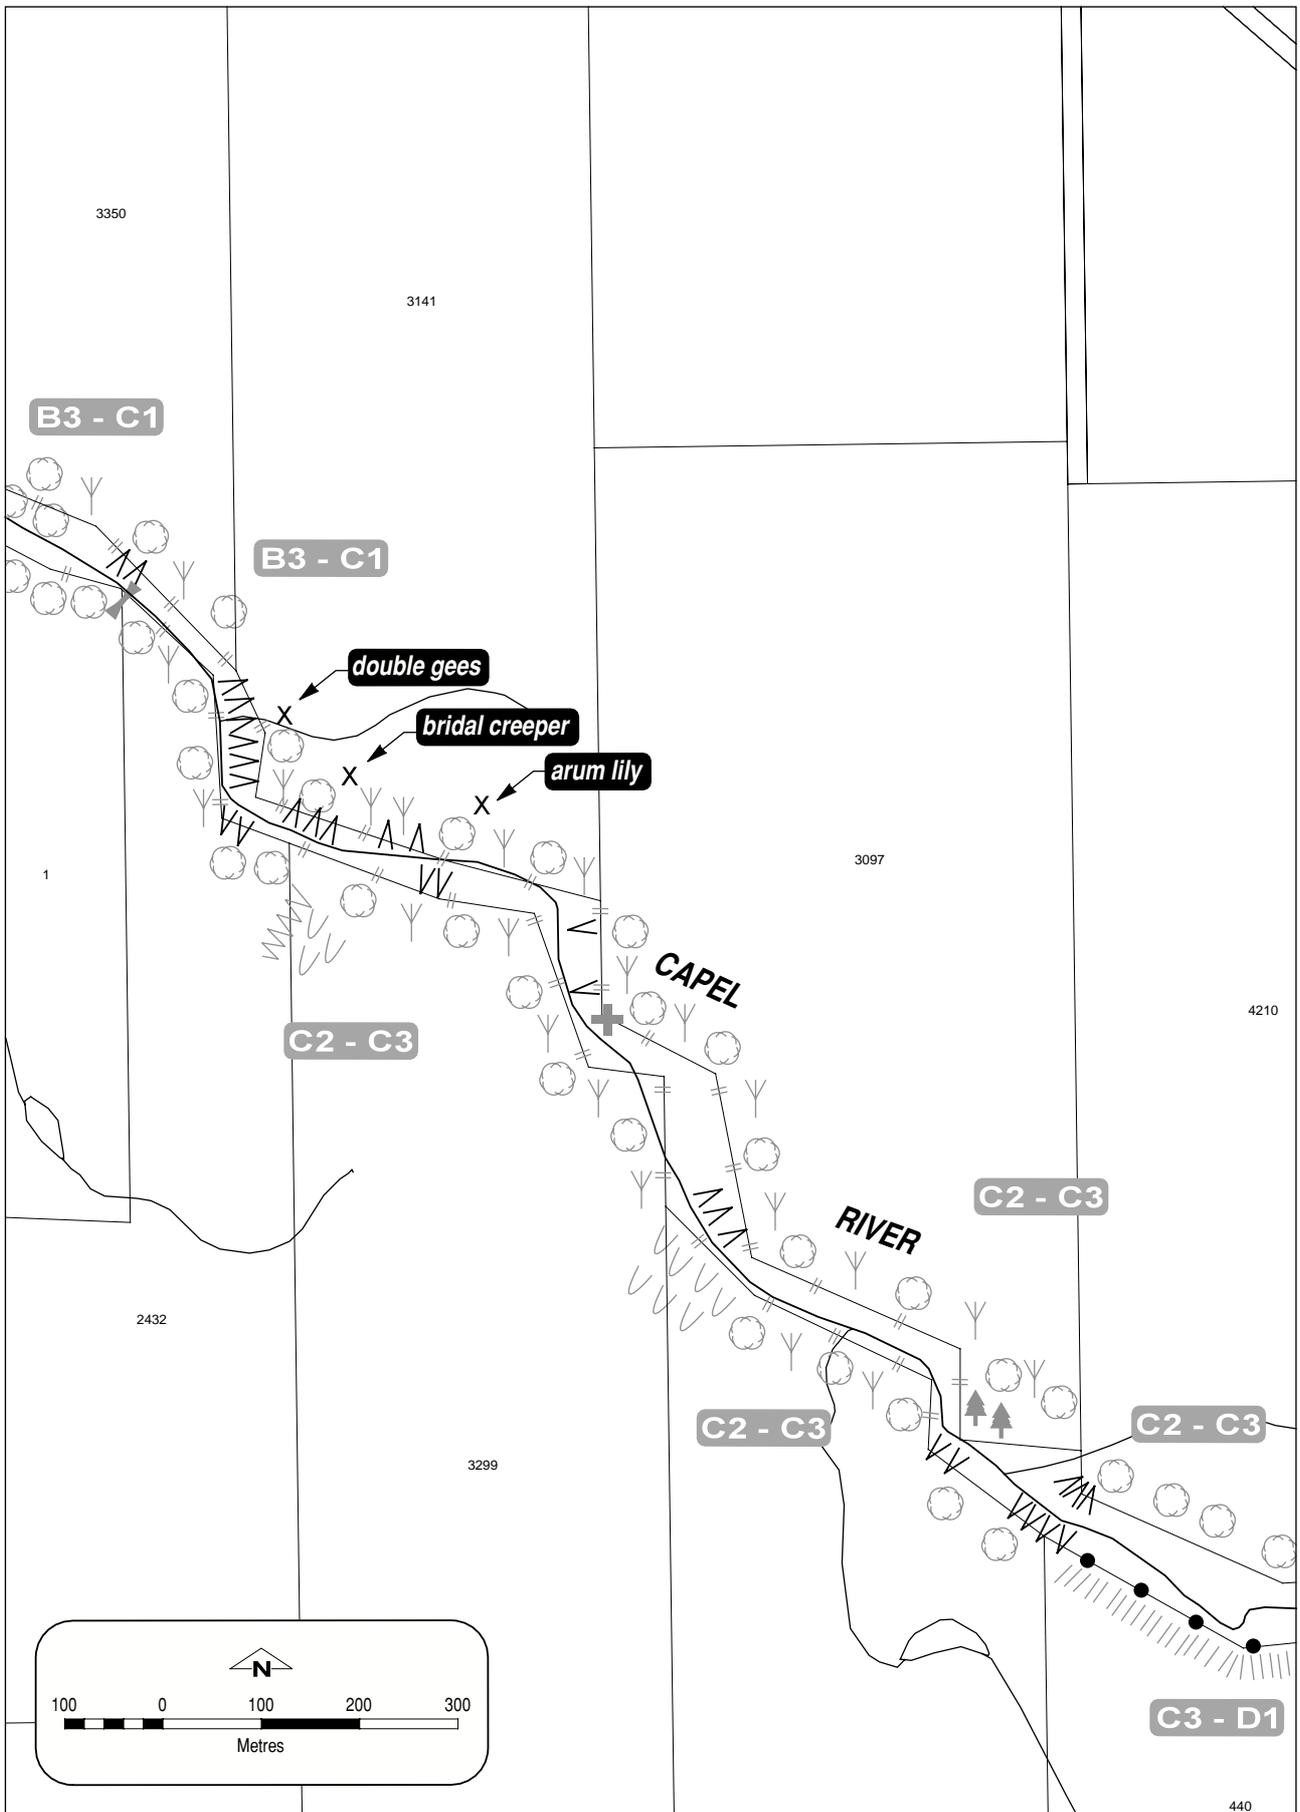
Capel River Map 10

Issues	Comments	Management Advice
General foreshore condition	Much of this foreshore was reasonably homogeneous, with the exception of the extremely degraded area on the southeastern foreshore.	
Fencing	A small section of fencing recommended on the southeastern foreshore. Otherwise all fences in good condition.	Length of fencing recommended: south bank ~ 300 m
Erosion	Frequent sites of scouring along this section. Also, two small areas of sheet erosion noted on the southern bank.	Refer to Erosion control Chapter 8.3, points 1 and 2 (page 33).
Revegetation requirement	Encourage revegetation with local species. Bracken dominates understorey in areas where stock have been restricted for some time.	Select species from community type 1 on the riparian fringe & the floodplain, Table 8.1 (page 28). Control bracken fern in areas where regeneration of understorey is restricted.
Weed invasion	Weeds along much of this section well controlled. Bridal creeper, arum lily and double gees in sections on northern banks.	Refer to Specific weed management advice Chapter 8.1.2 points 5, 2 and 9 (pages 23 & 24).

Other management comments	Some restoration/bunding attempted.

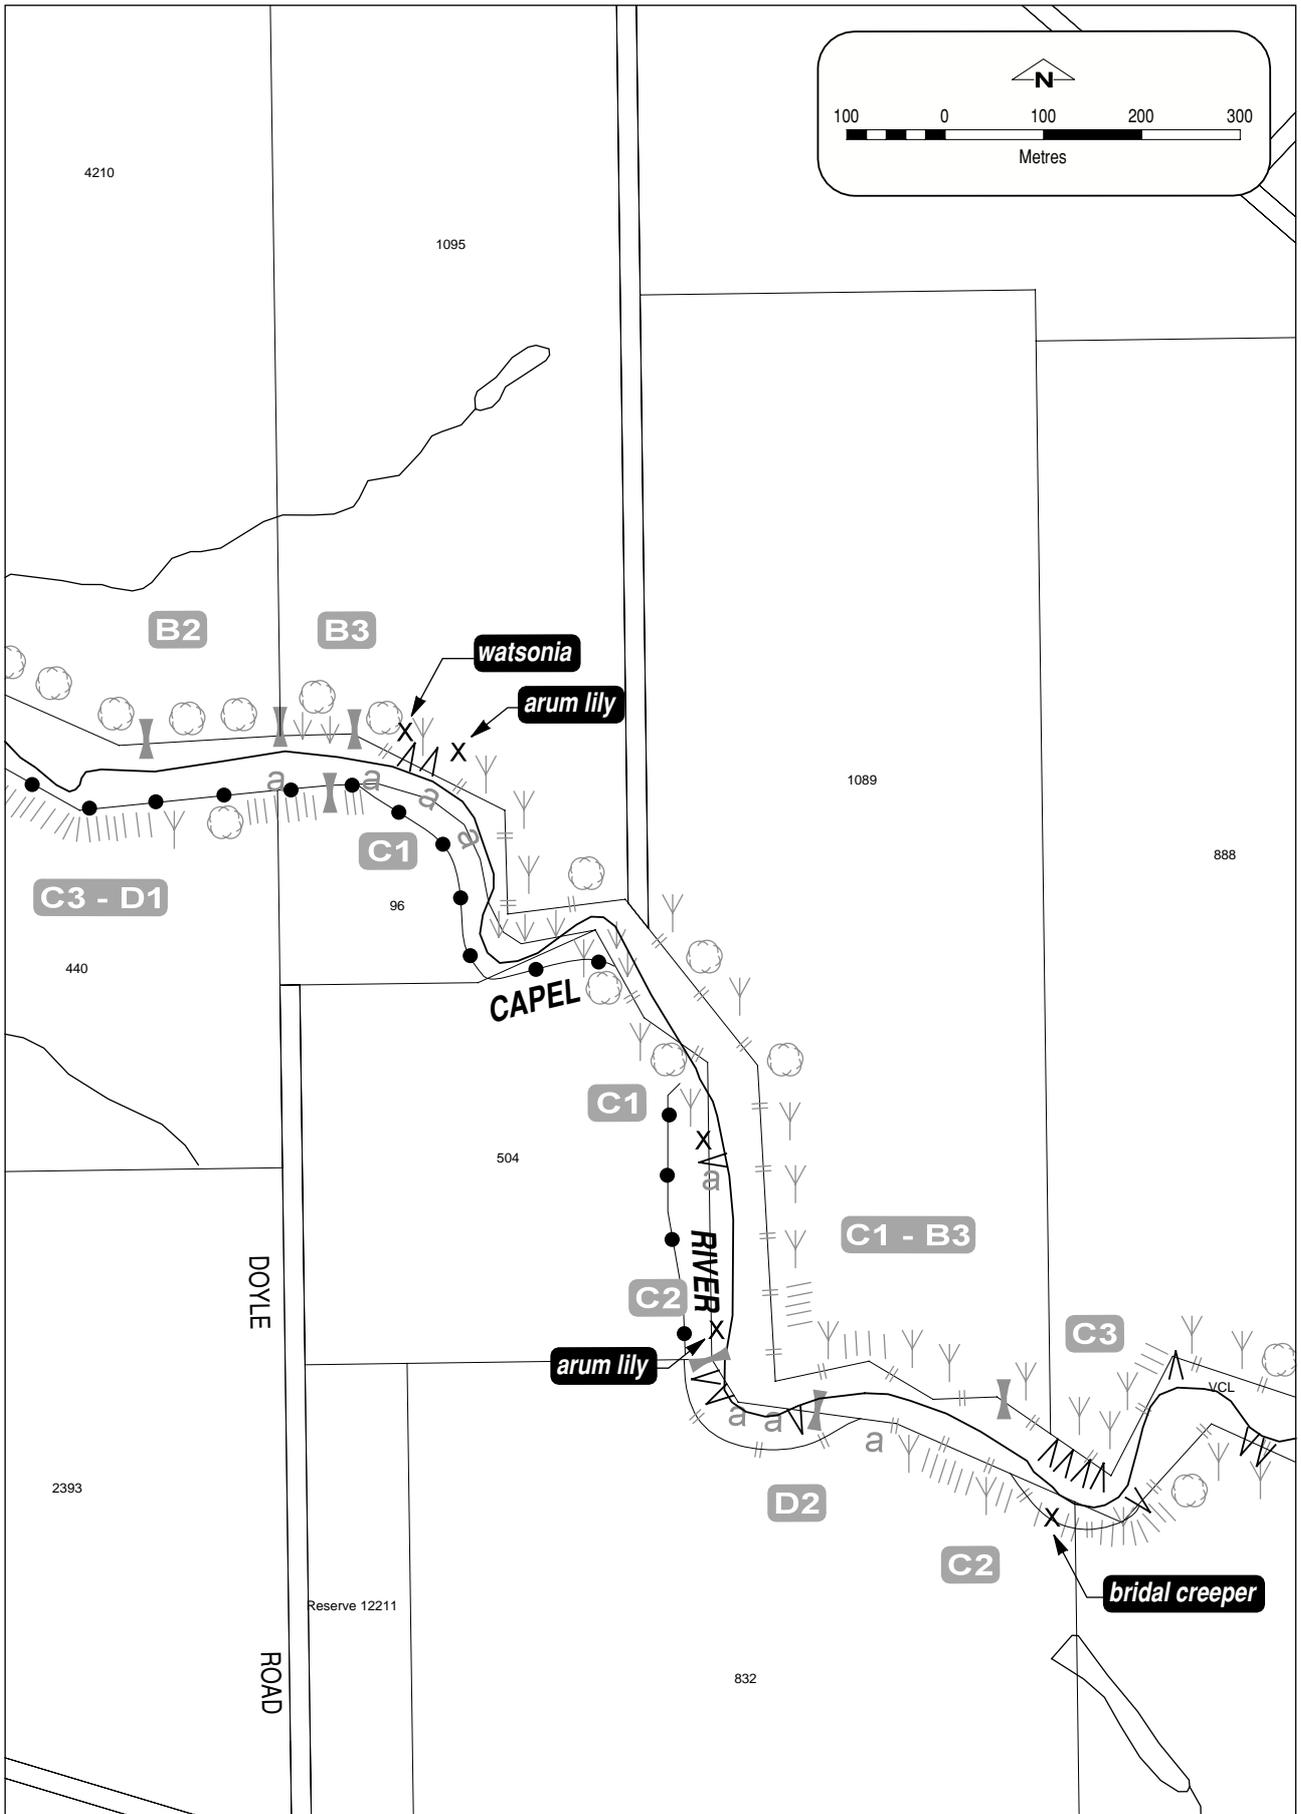
Capel River Map 11

Issues	Comments	Management Advice
General foreshore condition	Areas in this section are severely degraded.	Action to control stock access is a priority.
Fencing	Fencing to restrict access of livestock recommended on the southwestern foreshore of this section.	Approximately 850 m of fencing is recommended on the south bank of this section.
Erosion	Frequent severe scouring was noted on this section. In some cases this was exacerbated by unrestricted livestock access.	Refer to Erosion control Chapter 8.3, 1 and 2 (page 33), and implement recommendations related to stock access points and fencing.
Revegetation requirement	Some areas in this section require extensive revegetation, others require revegetation of understorey species to increase diversity.	Select species from community type 1 on the riparian fringe & 2 on the floodplain, Table 8.1 (pages 28 - 31).
Weed invasion	Occasional outbreaks of bridal creeper and arum lily in this section.	Refer to Specific weed management advice Chapter 8.1.2 points 2 and 5 (page 23).

Other management comments	Areas rated D1 require priority action.	All management advice with respect to fencing, restoration and revegetation is appropriate for this section.

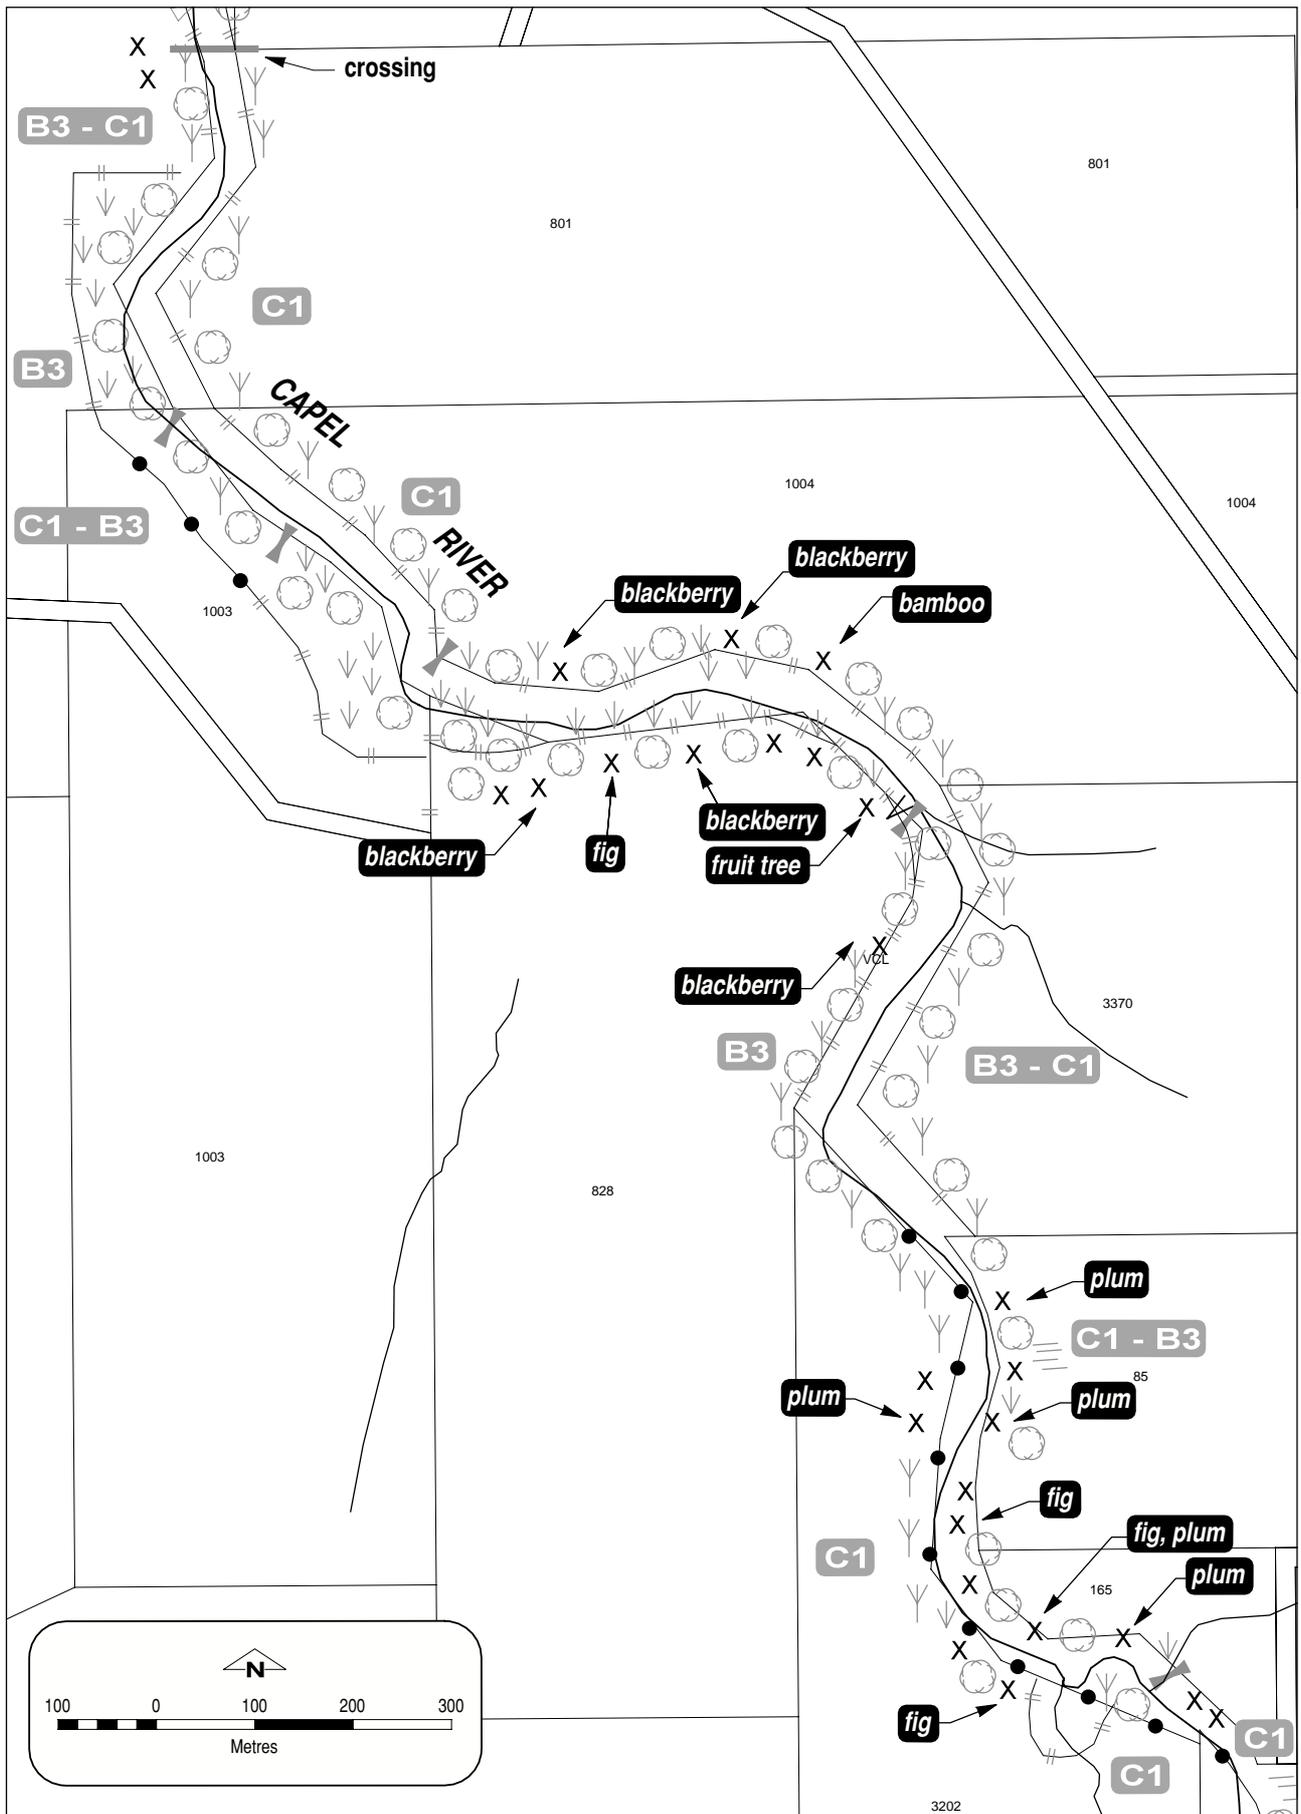
Capel River Map 16

Issues	Comments	Management Advice
General foreshore condition	Riparian vegetation was relatively narrow in this section, though some sections of good understorey were recorded. Weed invasion from fruit trees and blackberry was the primary management concern.	
Fencing	Some fencing required on the southern bank in this section.	Length of fencing recommended: south bank ~ 1150 m.
Erosion	One site of severe scouring was recorded in the middle part of this section.	Refer to Erosion control Chapter 8.3, point 2 (page 33).
Revegetation requirement	Understorey requires revegetation on southern end of this section, in other areas regeneration should occur following weed control	Revegetate with understorey species, and sedges and rushes. Select species from community type 1 on the riparian fringe & 2 on the floodplain, Table 8.1. (pages 28 - 30)
Weed invasion	Blackberry, fig, bamboo and plums all found on this section.	Control weeds where possible. Refer to Specific weed management advice Chapter 8.1.2 points 3, 10, 12, and 20 (pages 23 - 26).

Other management comments	Previous control of blackberry requires follow-up.

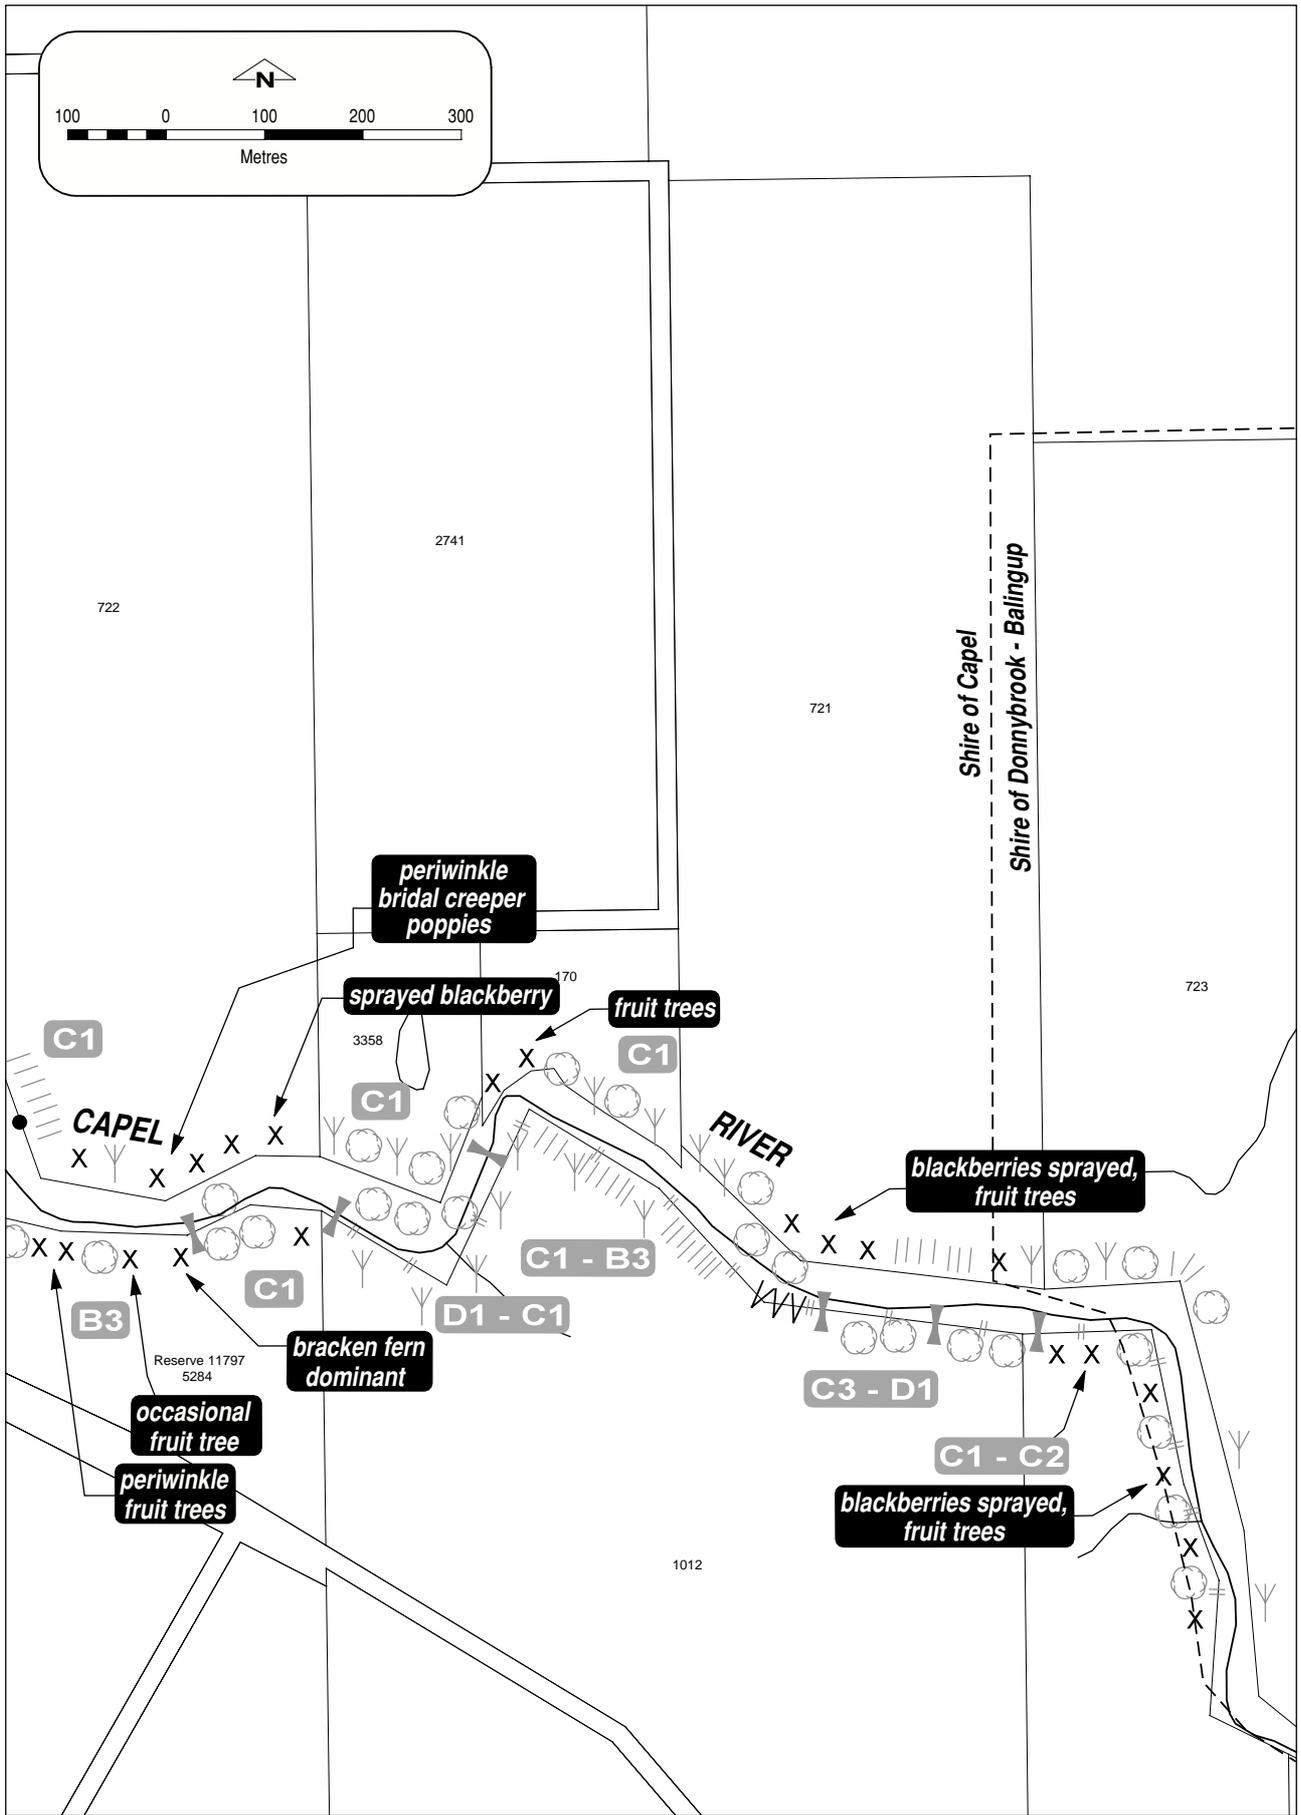
Capel River Map 18

Issues	Comments	Management Advice
General foreshore condition	Varying foreshore condition. Weeds and lack of understorey is biggest problem on this stretch.	N/A
Fencing	Most unfenced areas were orchards and stock access minimal.	Fencing of stock access point required to restrict the area of access; ~ 300 m on southern bank.
Erosion	One site of severe scouring was recorded in this section.	Refer to Erosion control Chapter 8.3, point 2 (page 33).
Revegetation requirement	In some areas understorey requires replanting, also transplanting of sedges and rushes. Grassed areas require planting with canopy species.	Reserve 11797 could act as potential seed source for revegetation of this area. Revegetate with understorey species, and sedges and rushes. Select species for from community type 1, Table 8.1 (page 28).
Weed invasion	Fruit trees, blackberry, California poppies and periwinkle all require control in this section.	Refer to Specific weed management advice Chapter 8.1.2 points 12, 3, 6 and 4 (pages 23 - 25).

Other management comments	Some control of blackberry and fruit trees during summer of 1997-98. This requires follow-up for effectiveness.	Bracken will also require control in some areas to allow diverse range of native understorey species to regenerate.

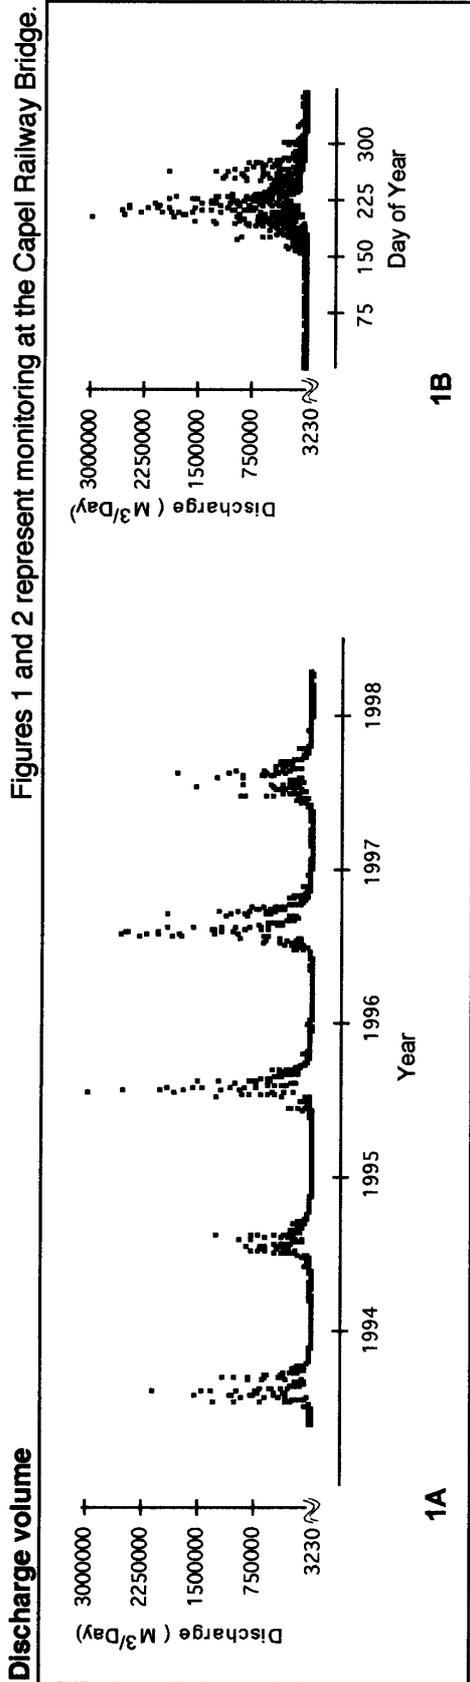
Figure 1A: Capel River discharge (m³) at the railway bridge between 1994 and 1998.

Figure 1B: Capel River seasonal discharge (m³).

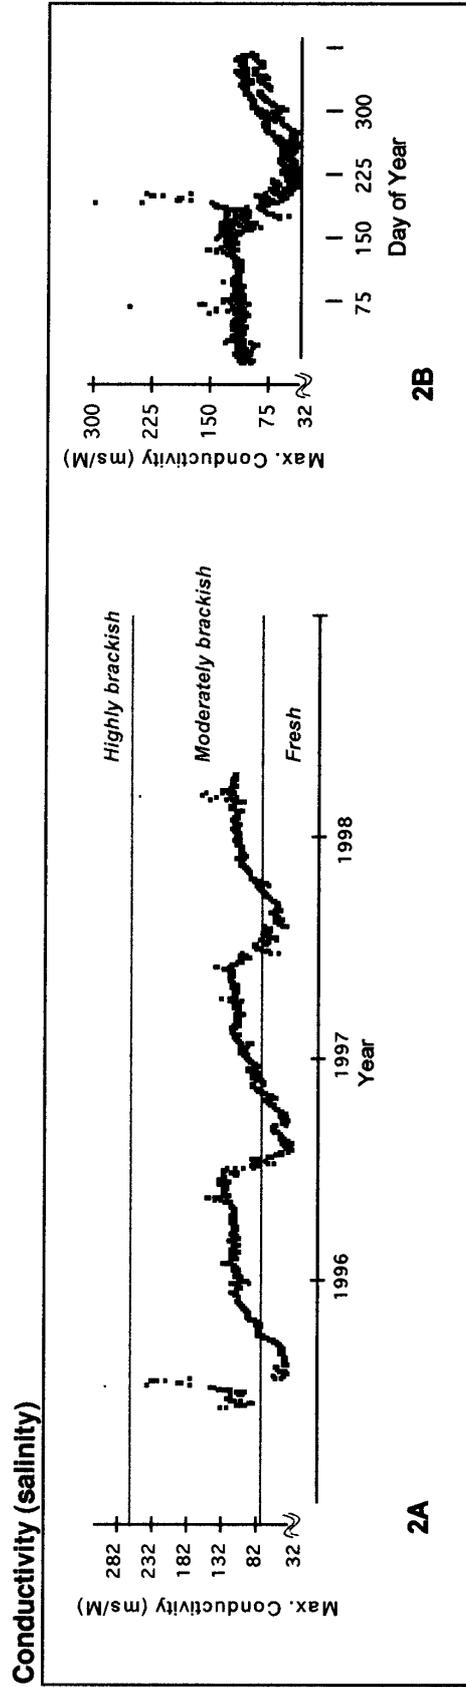
Figure 2A: Capel River maximum conductivity (ms/m) at the railway bridge between 1994 and 1998.

Figure 2B: Capel River seasonal maximum conductivity (ms/m).

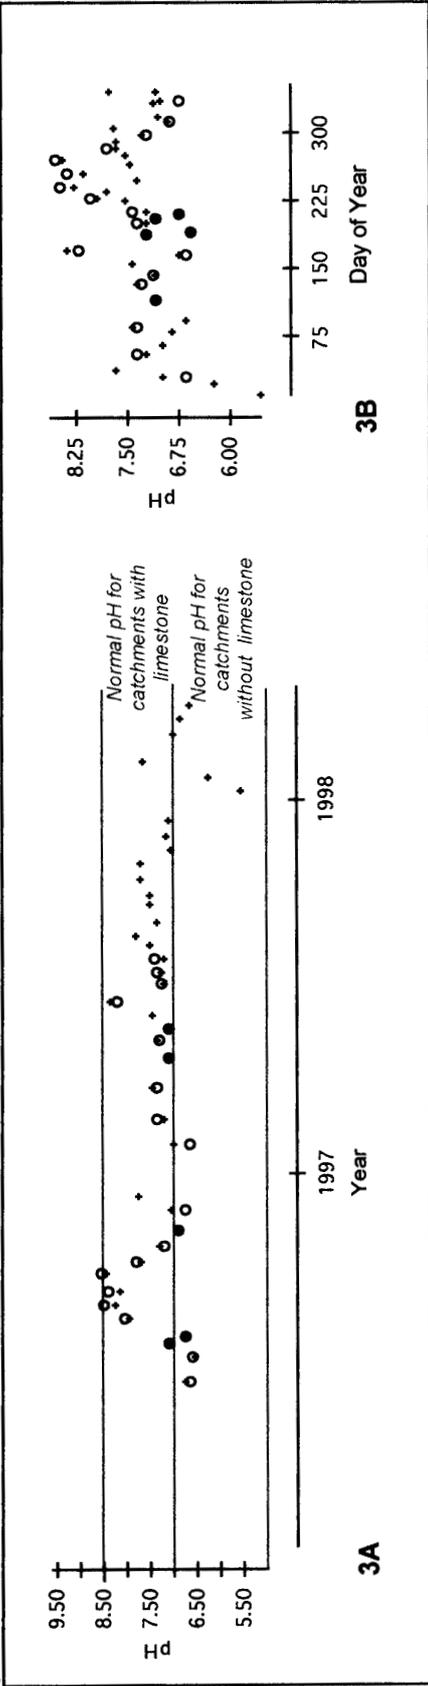
Figure 3A: Capel River pH between 1997 and 1998.

Figure 3B: Capel River seasonal pH.

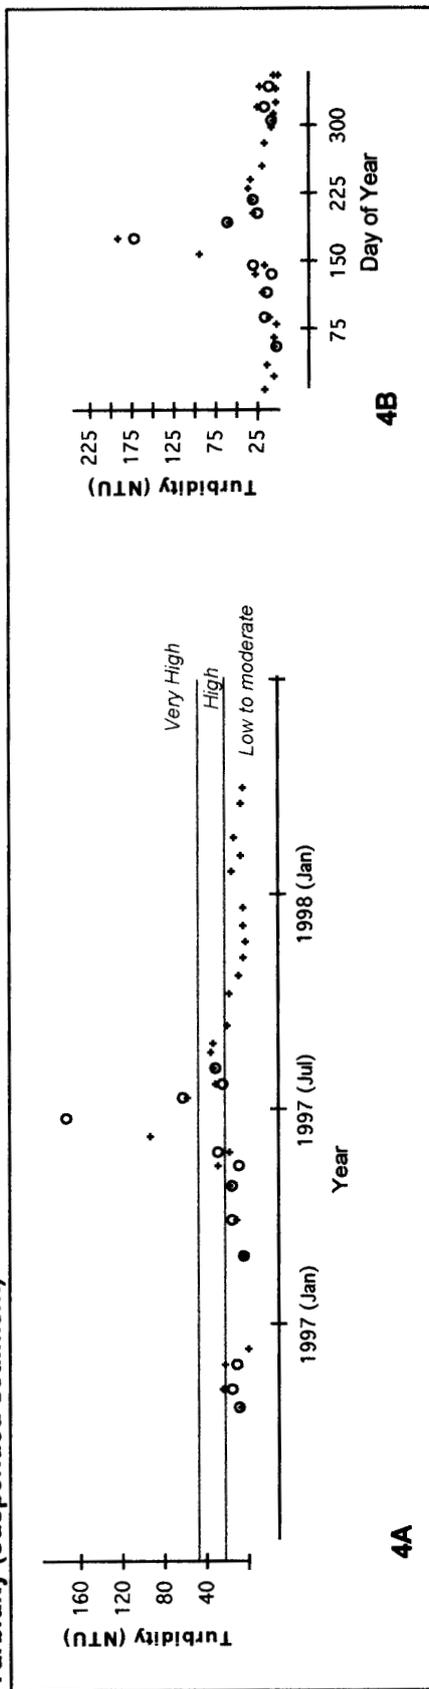
Figure 4A: Capel River turbidity (NTU) between 1997 and 1998.

Figure 4B: Capel River seasonal turbidity (NTU).

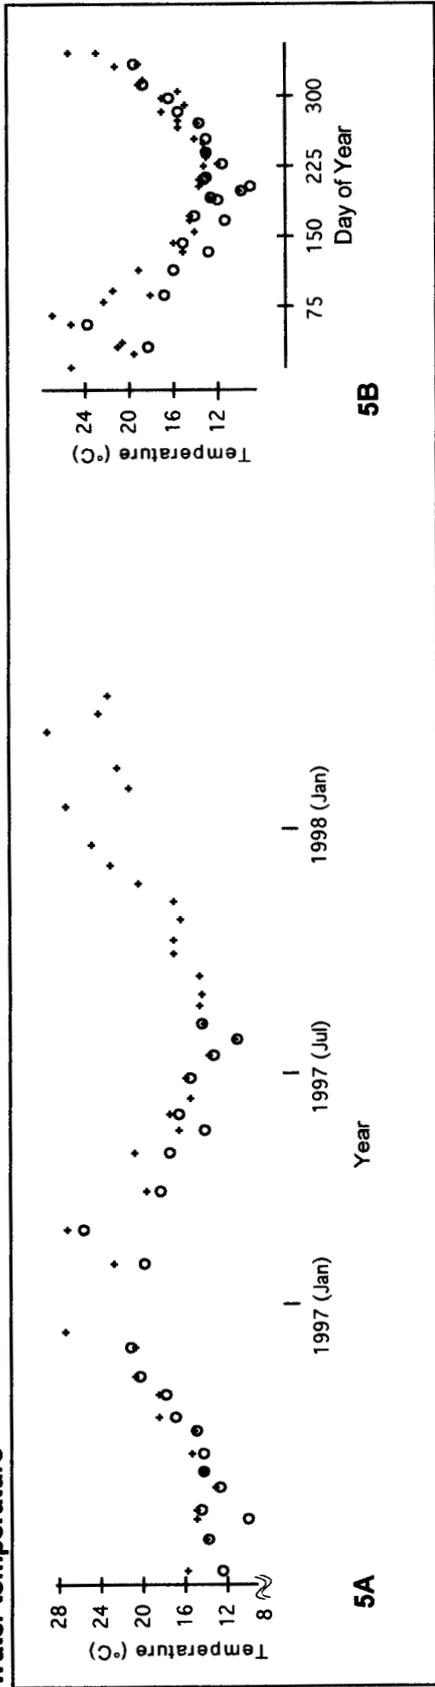
Figure 5A: Capel River temperature (°C) between 1997 and 1998.

Figure 5B: Capel River seasonal temperature (°C).

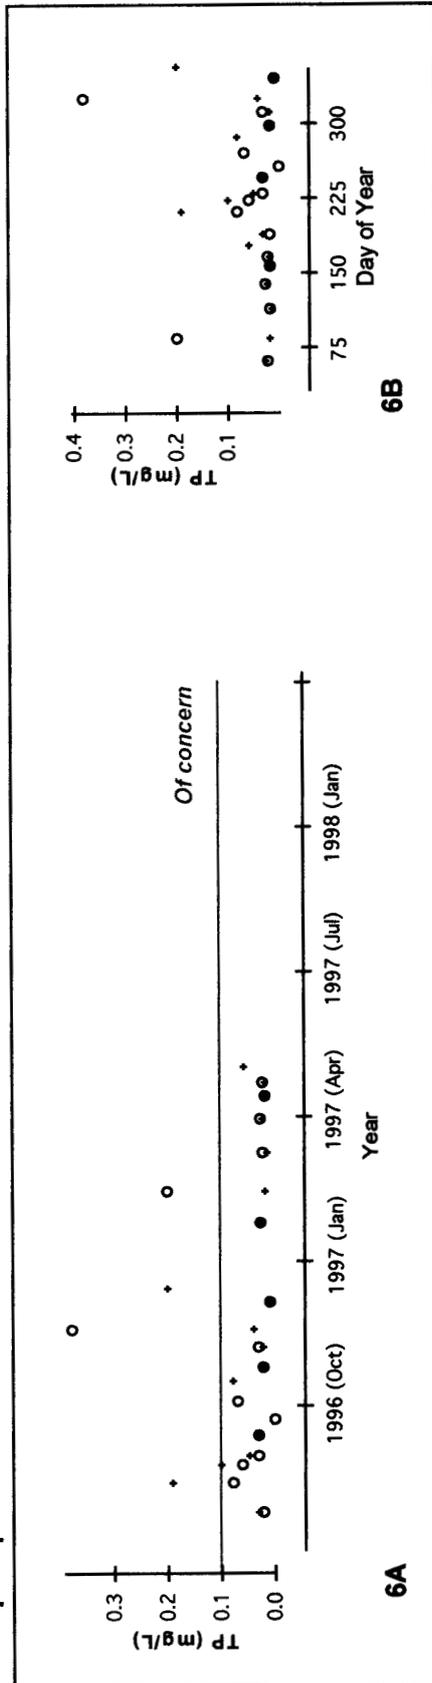
Figure 6A: Capel River total phosphorus (mg/L) between 1997 and 1998.

Figure 6B: Capel River seasonal total phosphorus (mg/L)

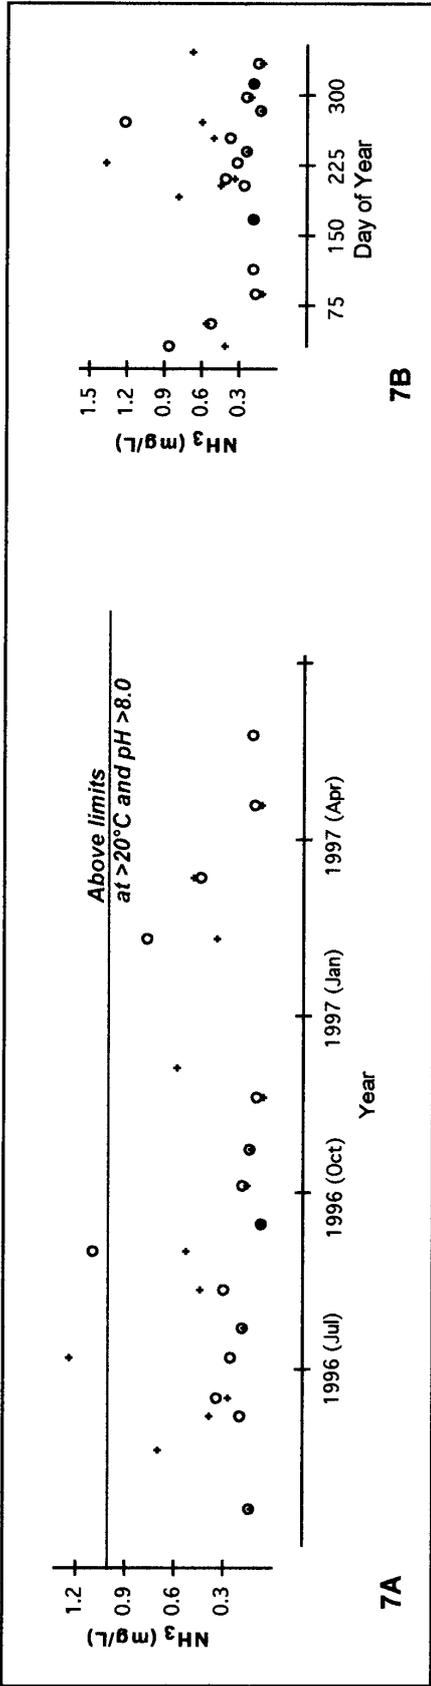
Figure 7A: Capel River ammonia (mg/L) between 1996 and 1997.

Figure 7B: Capel River seasonal ammonia (mg/L)
