Capel River Action Plan

1999

Prepared for Geographe Catchment Council - GeoCatch
and the Capel Land Conservation District Committee

by
Kirrily White and Sarah Comer
in association with
Evangelisti & Associates

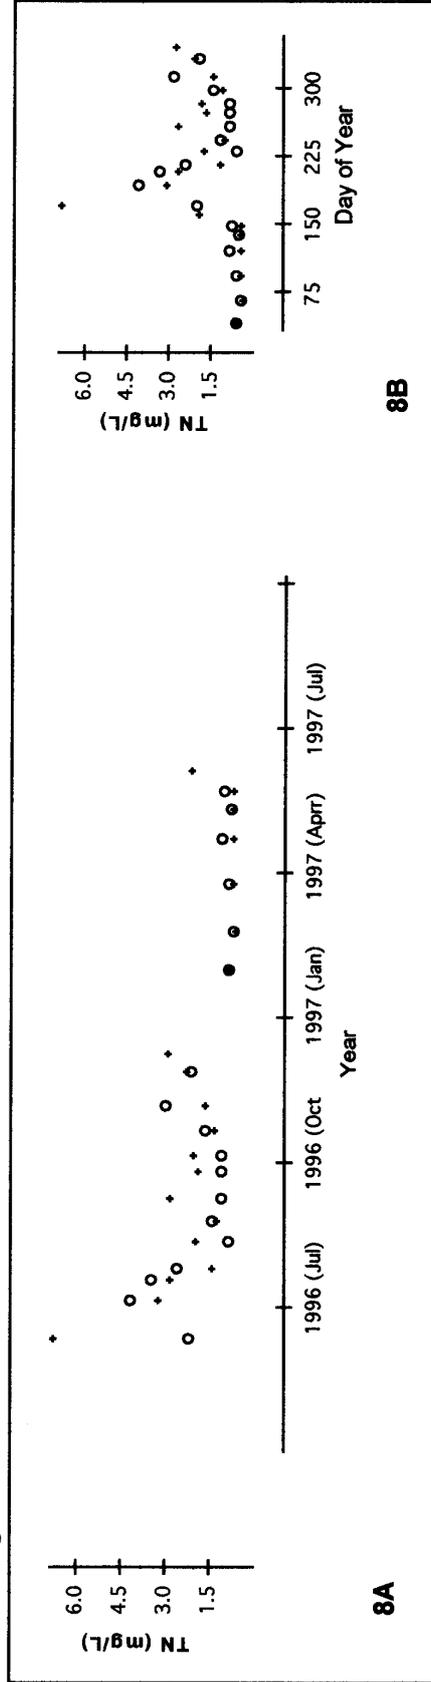
Figure 8A: Capel River total nitrogen (mg/L) between 1996 and 1997.

There are no established criteria for nitrogen levels in southwest waterways since natural levels are often highly varied. The levels of total nitrogen measured in the Capel River during the sampling period appear to be strongly related to the flow (discharge) pattern (Appendix B, Figures 1A and 1B). As for conductivity, there is a strong seasonality in the data, with nitrogen levels increasing rapidly during the early winter rainfall period ('first flush'), then decreasing as winter flow continues to dilute the concentration.

Figure 8B: Capel River seasonal total nitrogen (mg/L)
